## Defect Listing

Pipe Segment Refere... <b>C14-2_C14-1</b>	City <b>Oliver Springs</b>	Street <b>Edmonds Dr</b>	Material <b>Concrete Pipe (non-...</b>	Location C... <b>Yard</b>	Sewer Use <b>Sanitary</b>
Upstream MH <b>C14-2</b>	Total Length <b>213.5</b>	Year Laid	Shape <b>Circular</b>	Location Details	
DS Manhole <b>C14-1</b>	Length surveyed <b>213.5</b>	Year Renewed	Height <b>8</b>	Width <b>8</b>	Pipe Joint... <b>4</b>

SPR <b>N/A</b>	MPR <b>N/A</b>	PO Number <b>4397-03</b>	Customer <b>GRW</b>
SPRI <b>N/A</b>	MPRI <b>N/A</b>	Work Order <b>4397-02</b>	Purpose <b>Pre-Rehabilitation Survey</b>
QSR <b>N/A</b>	QMR <b>N/A</b>		
OPR <b>N/A</b>	Surveyed By <b>Barry Rogers</b>	Direction <b>Downstream</b>	Date <b>20150714</b>
OPRI <b>N/A</b>	Certificate Number <b>U-1012-16405</b>	Pre-Cleaning <b>Jetting</b>	Time <b>10:56</b>
	Date Cleaned <b>20150714</b>	End Time <b>11:11</b>	Weather <b>Light Rain</b>
			Media label
			Additional Info

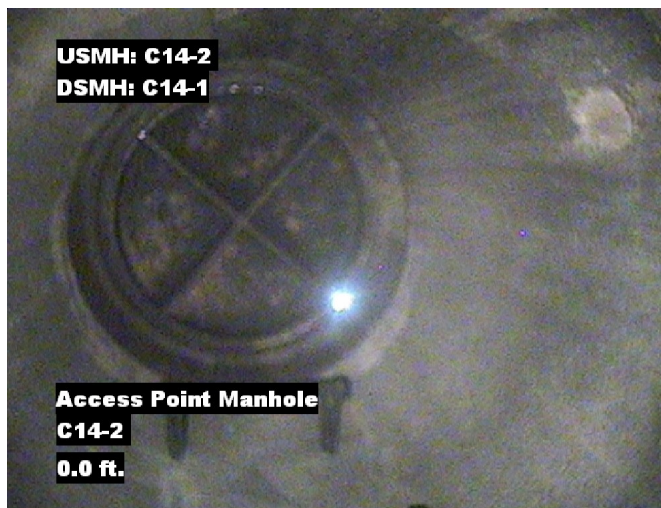
Distance: 0.0 ft. Grade: 0  
Condition: Access Point Manhole  
Remarks: C14-2

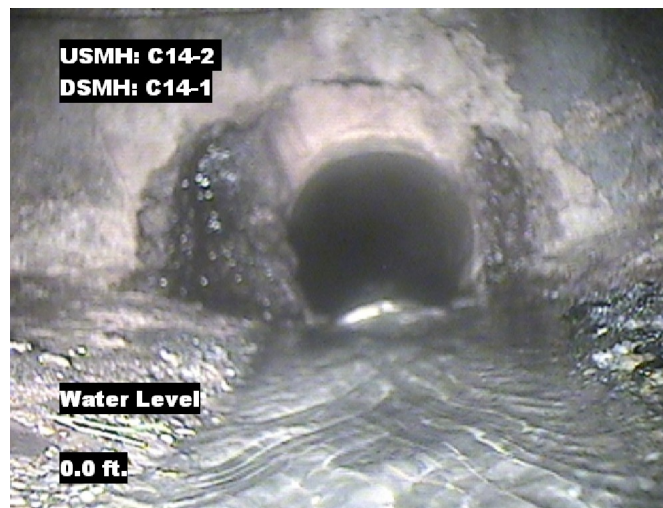
Distance: 0.0 ft. Grade: 0  
Condition: Water Level  
Remarks: N/A

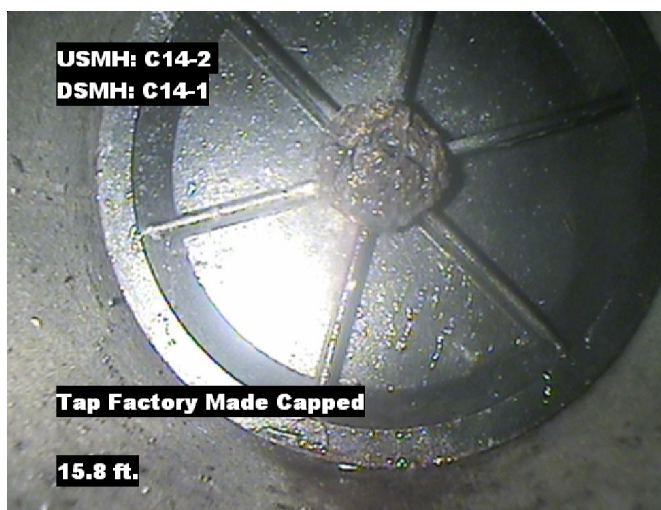
Distance: 15.8 ft. Grade: 0  
Condition: Tap Factory Made Capped  
Remarks: N/A

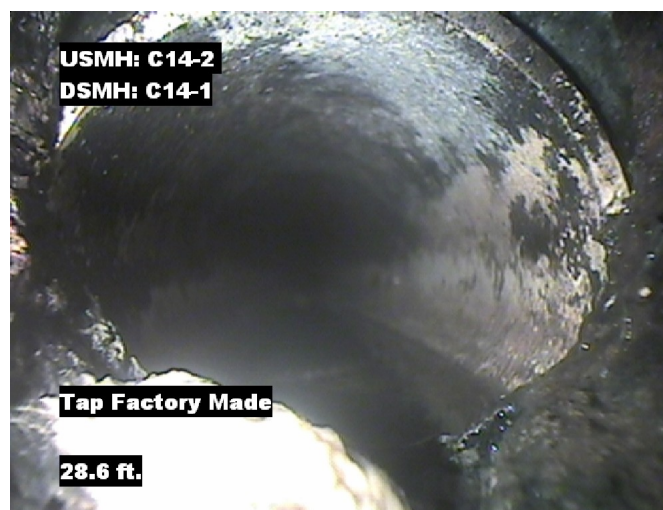
Distance: 28.6 ft. Grade: 0  
Condition: Tap Factory Made  
Remarks: N/A

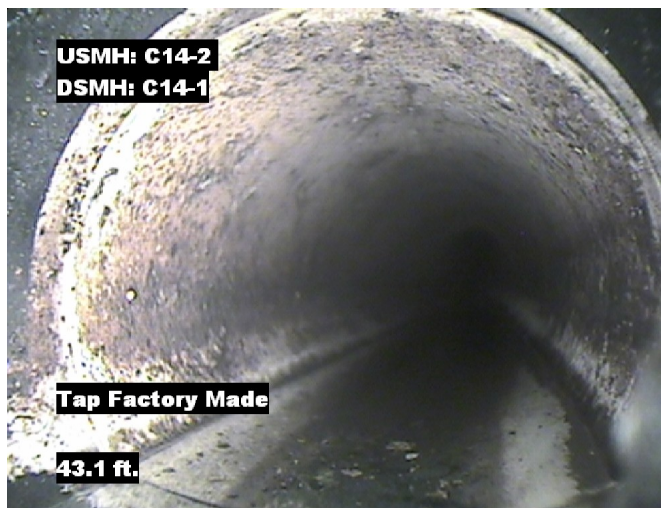
Distance: 43.1 ft. Grade: 0  
Condition: Tap Factory Made  
Remarks: N/A

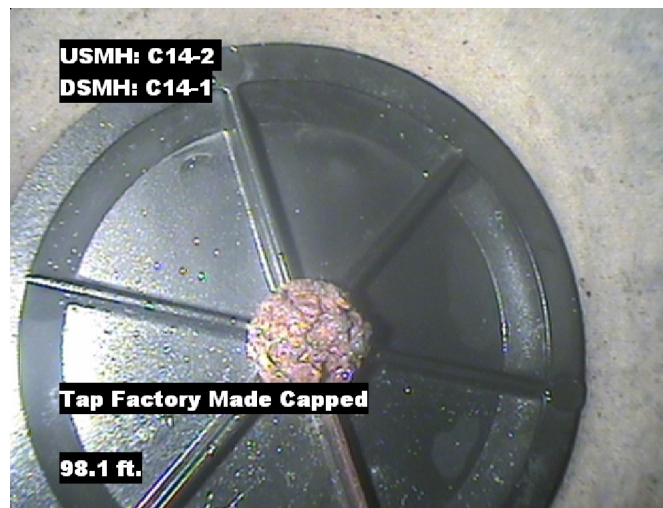
Distance: 98.1 ft. Grade: 0  
Condition: Tap Factory Made Capped  
Remarks: N/A

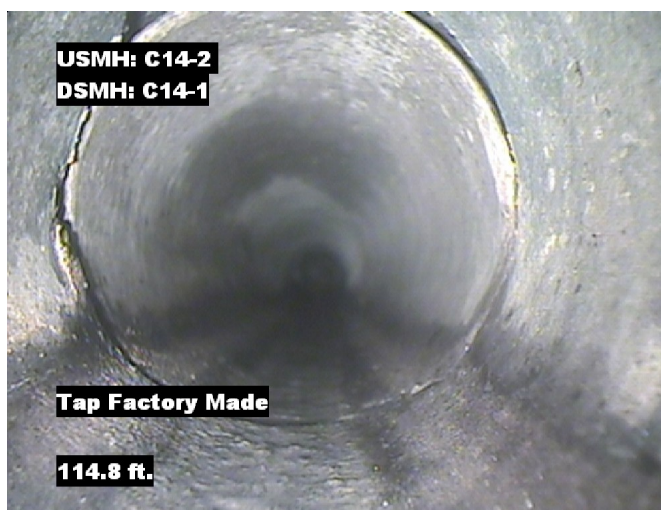
Distance: 114.8 ft. Grade: 0  
Condition: Tap Factory Made  
Remarks: N/A

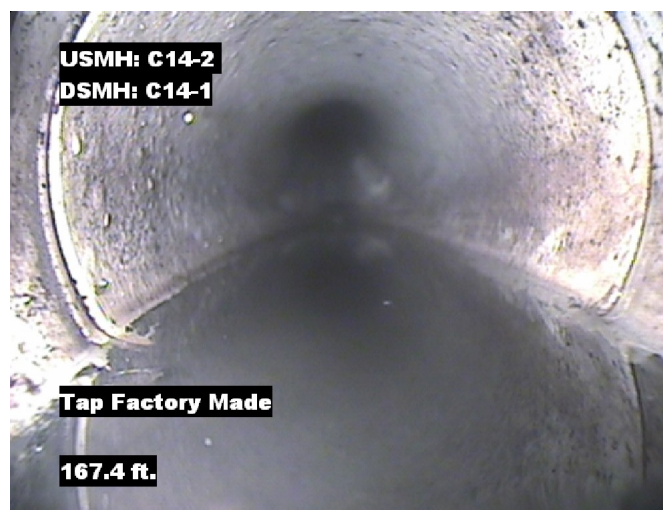
Distance: 167.4 ft. Grade: 0  
Condition: Tap Factory Made  
Remarks: N/A

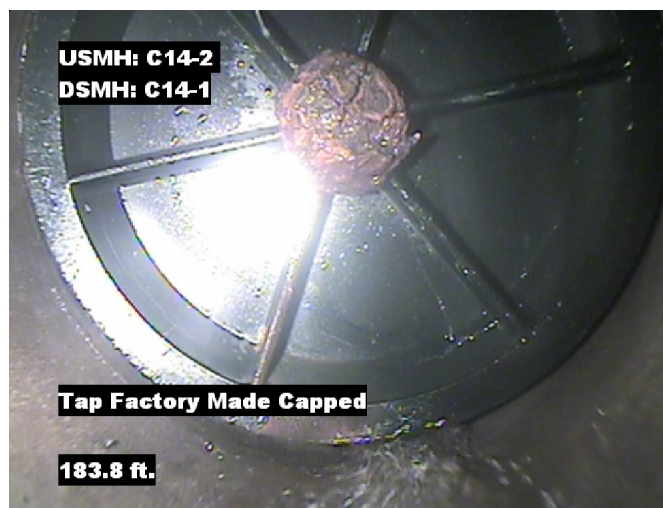
Distance: 183.8 ft. Grade: 0  
Condition: Tap Factory Made Capped  
Remarks: N/A

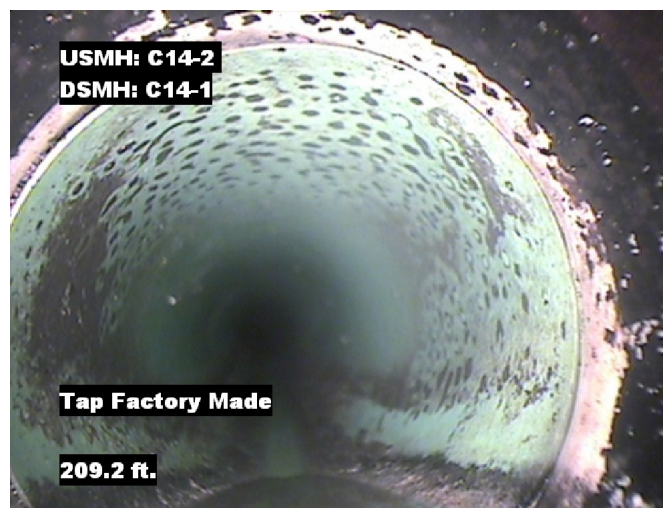
Distance: 209.2 ft. Grade: 0  
Condition: Tap Factory Made  
Remarks: N/A

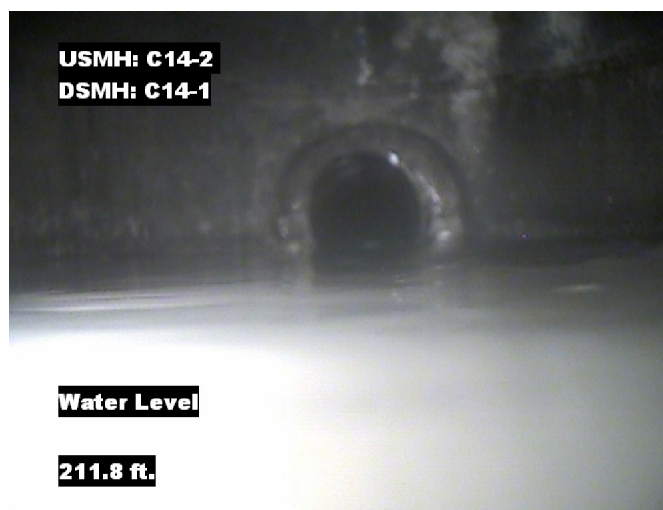
Distance: 211.6 ft. Grade: 0  
Condition: Water Level  
Remarks: N/A

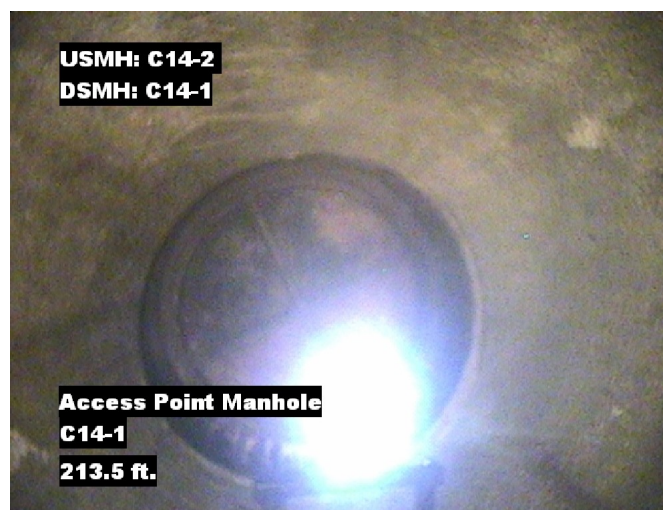
Distance: 213.5 ft. Grade: 0  
Condition: Access Point Manhole  
Remarks: C14-1
