Defect Listing

Pipe Segment Refere... C14-3_C14-2	City Oliver Springs	Street Edmonds DR	Material Fibreglass Reinforc...	Location C... Yard	Sewer Use Sanitary
Upstream MH C14-3	Total Length 169.6	Year Laid	Shape Circular	Location Details	
DS Manhole C14-2	Length surveyed 169.6	Year Renewed	Height 8	Width 8	Pipe Joint... N/A

SPR N/A	MPR 4	PO Number 4397-03	Customer GRW
SPRI N/A	MPRI 2	Work Order 4397-02	Purpose Pre-Rehabilitation Survey
QSR N/A	QMR 2200		
OPR 4	Surveyed By Barry Rogers	Direction Downstream	Date 20150714
OPRI 2	Certificate Number U-1012-16405	Pre-Cleaning Jetting	Time 10:13
	Date Cleaned 20150714	End Time 10:49	Weather Light Rain
			Media label
			Additional Info

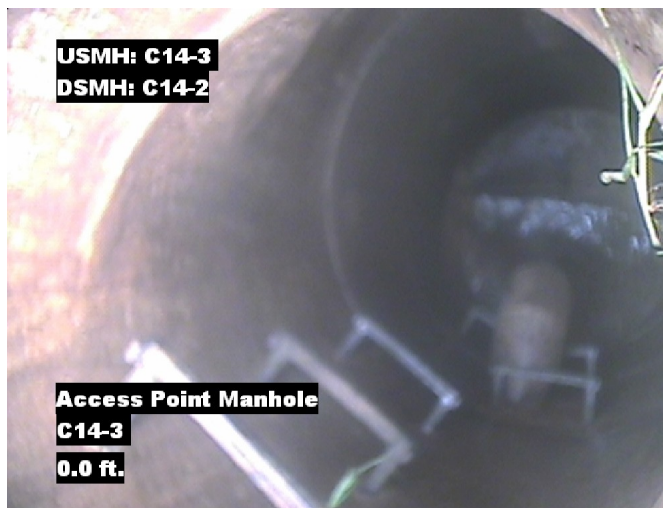
Distance: 0.0 ft. Grade: 0
Condition: Access Point Manhole
Remarks: C14-3

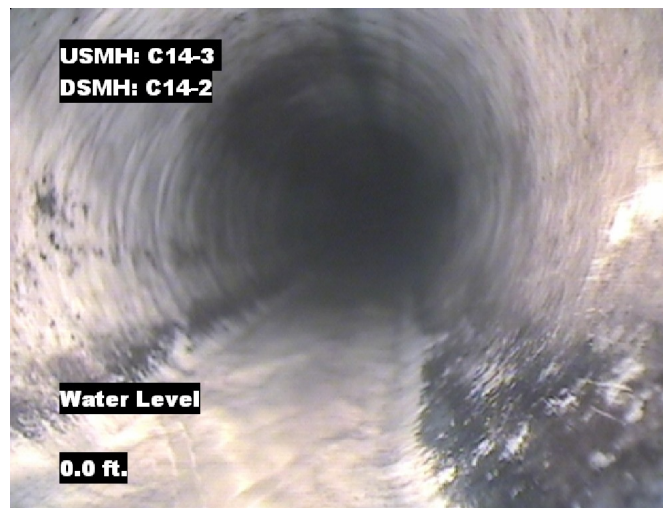
Distance: 0.0 ft. Grade: 0
Condition: Water Level
Remarks: N/A

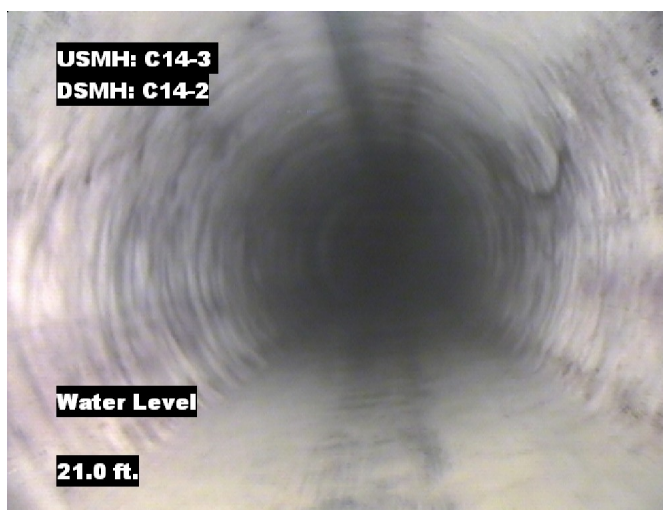
Distance: 21.0 ft. Grade: 0
Condition: Water Level
Remarks: N/A

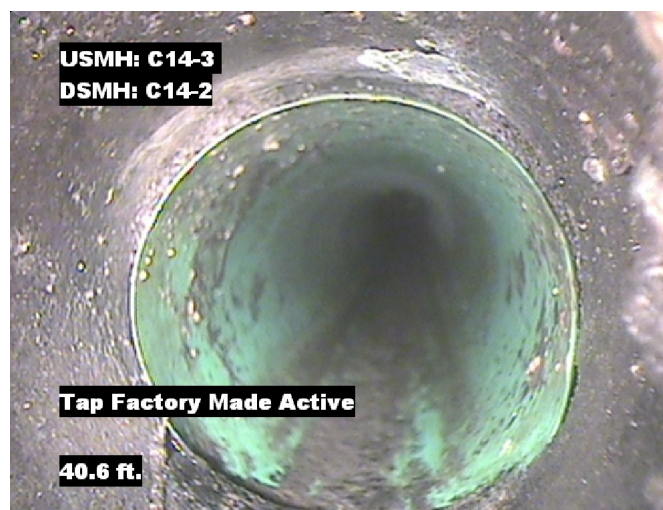
Distance: 40.6 ft. Grade: 0
Condition: Tap Factory Made Active
Remarks: N/A

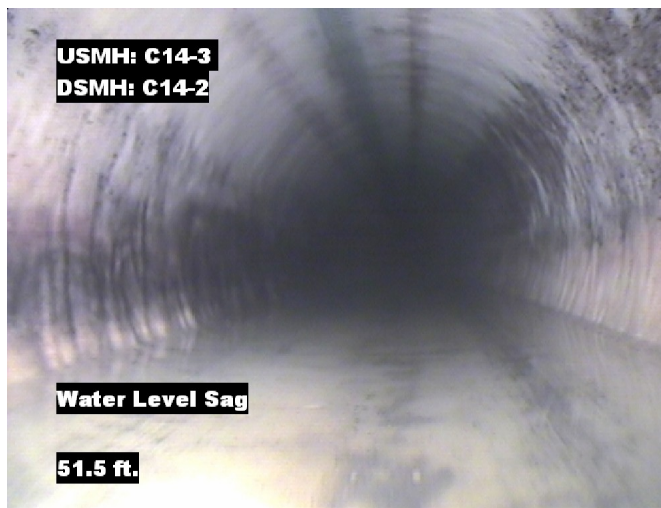
Distance: 51.4 ft. Grade: 2
Condition: Water Level Sag
Remarks: N/A

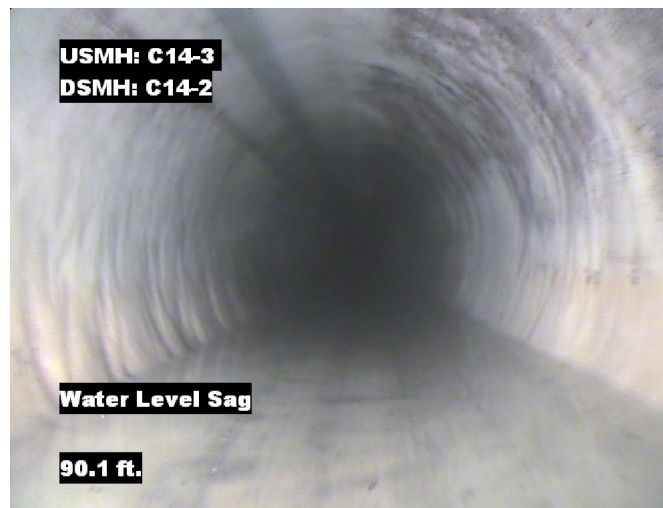
Distance: 90.0 ft. Grade: 2
Condition: Water Level Sag
Remarks: N/A

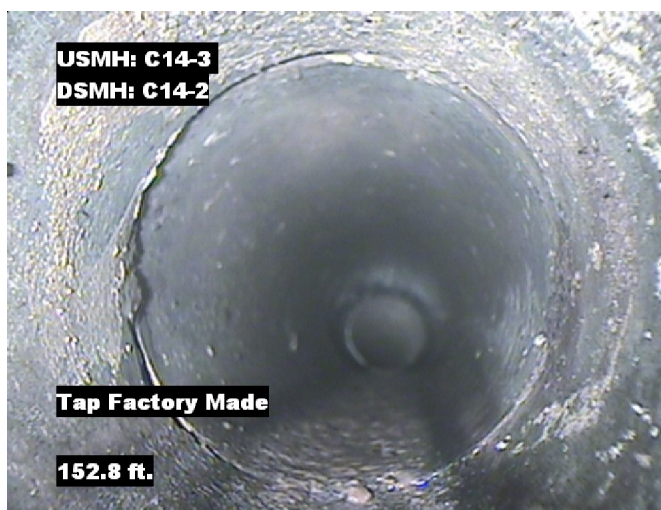
Distance: 152.8 ft. Grade: 0
Condition: Tap Factory Made
Remarks: N/A

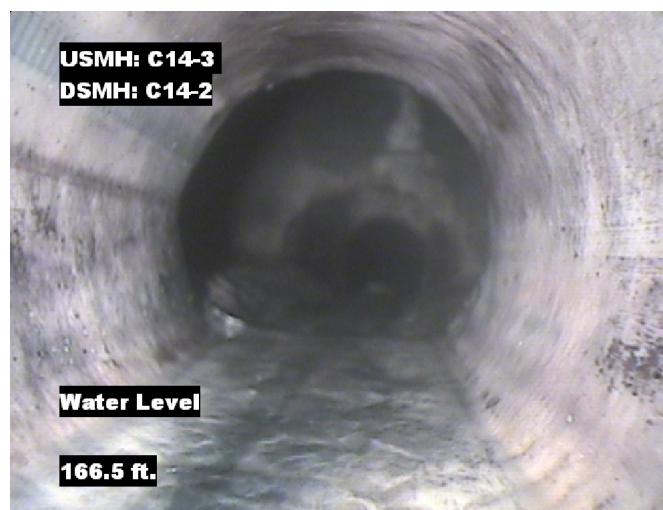
Distance: 166.4 ft. Grade: 0
Condition: Water Level
Remarks: N/A

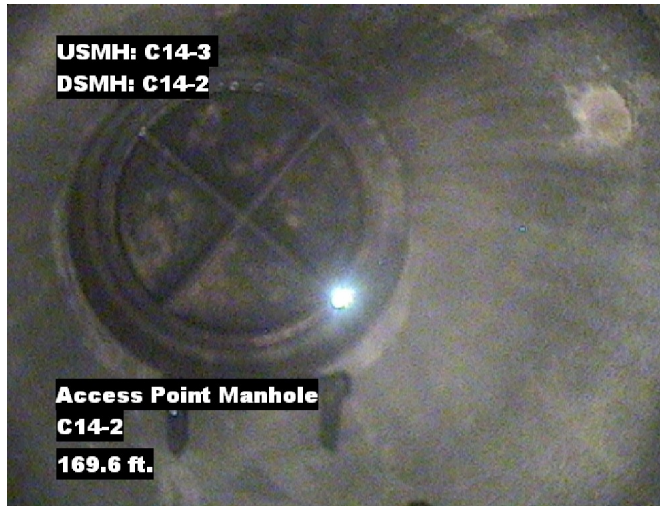
Distance: 169.6 ft. Grade: 0
Condition: Access Point Manhole
Remarks: C14-2
