## Defect Listing

Pipe Segment Refere... <b>C14-4_C14-3</b>	City <b>Oliver Springs</b>	Street <b>Edmonds Dr</b>	Material <b>Fibreglass Reinforc...</b>	Location C... <b>Yard</b>	Sewer Use <b>Sanitary</b>
Upstream MH <b>C14-4</b>	Total Length <b>256.2</b>	Year Laid	Shape <b>Circular</b>	Location Details	
DS Manhole <b>C14-3</b>	Length surveyed <b>256.2</b>	Year Renewed	Height <b>8</b>	Width <b>8</b>	Pipe Joint... <b>N/A</b>

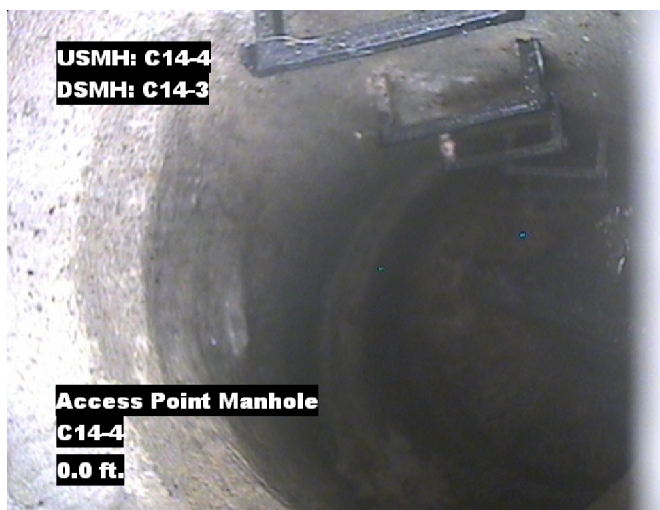
Distance: 0.0 ft. Grade: 0  
Condition: Access Point Manhole  
Remarks: C14-4

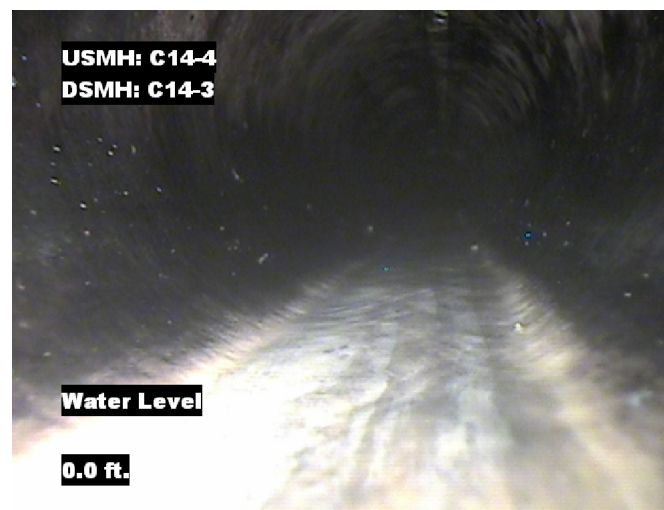
Distance: 0.0 ft. Grade: 0  
Condition: Water Level  
Remarks: N/A

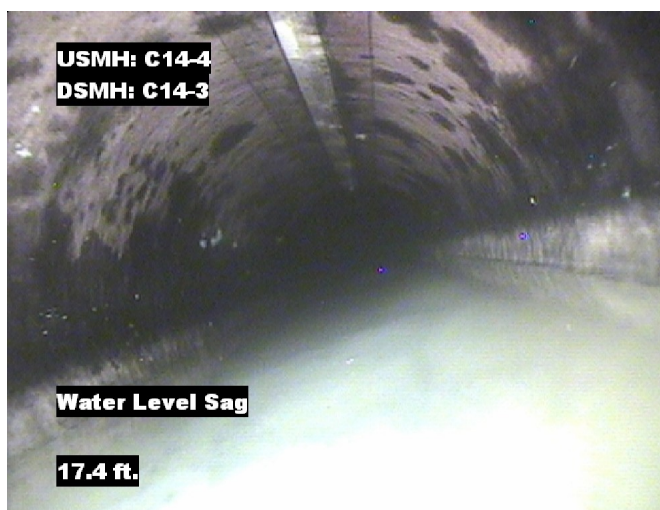
Distance: 17.4 ft. Grade: 2  
Condition: Water Level Sag  
Remarks: N/A

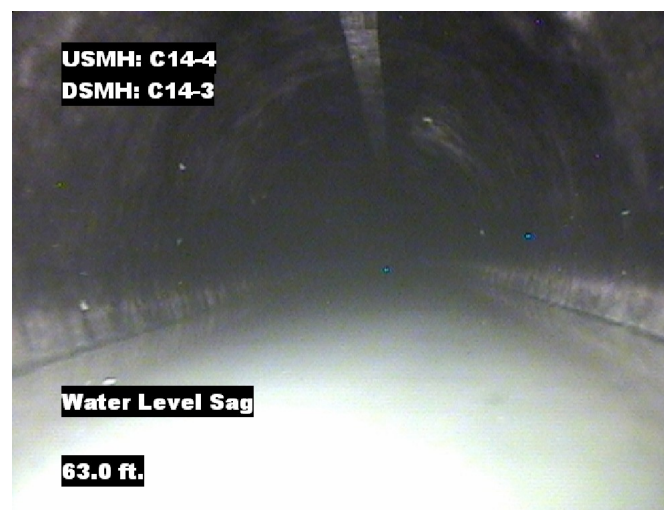
Distance: 63.0 ft. Grade: 2  
Condition: Water Level Sag  
Remarks: N/A

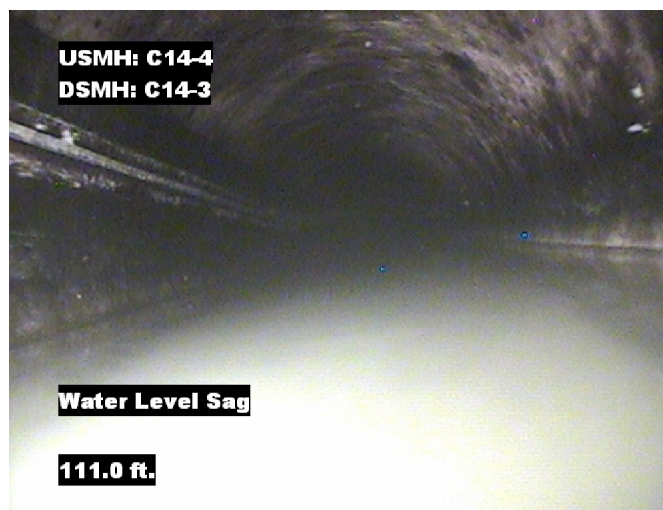
Distance: 111.0 ft. Grade: 2  
Condition: Water Level Sag  
Remarks: N/A

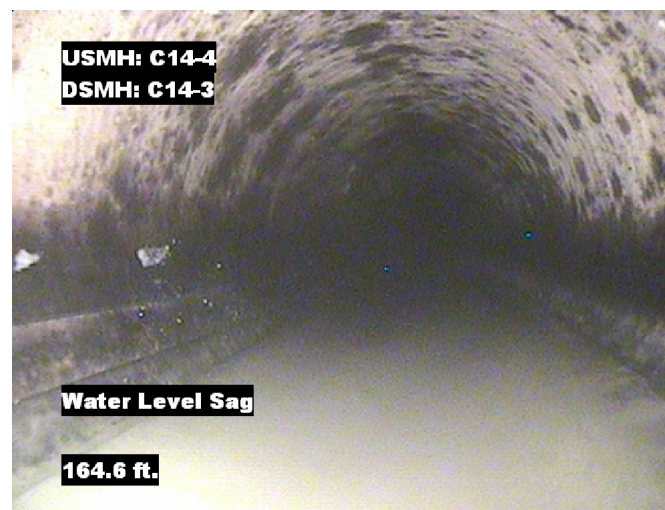
Distance: 164.6 ft. Grade: 2  
Condition: Water Level Sag  
Remarks: N/A

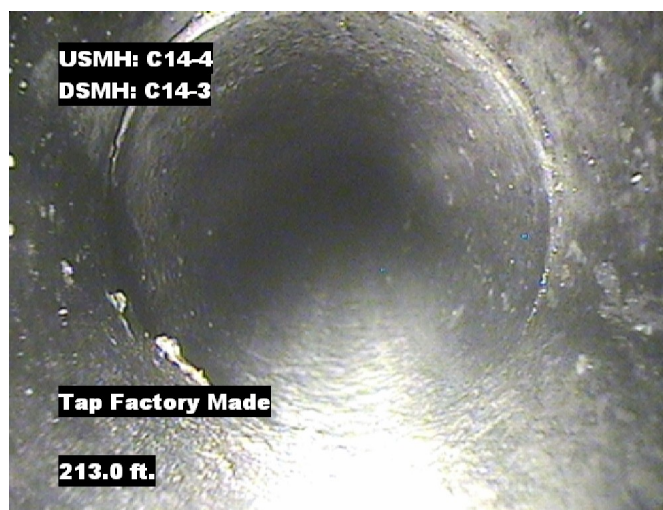
Distance: 213.0 ft. Grade: 0  
Condition: Tap Factory Made  
Remarks: N/A

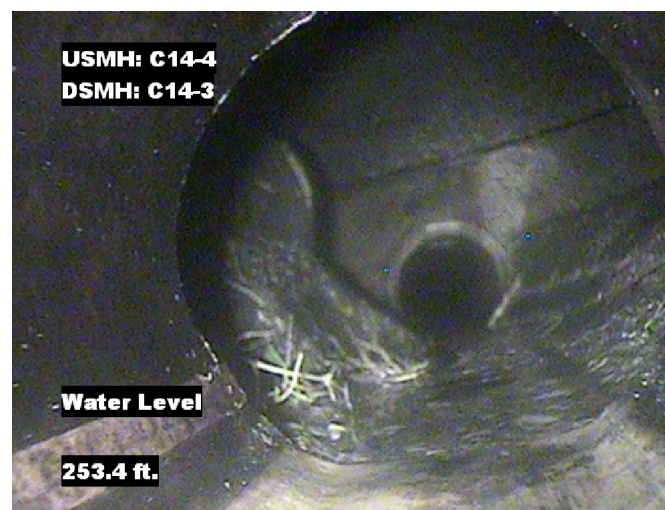
Distance: 253.3 ft. Grade: 0  
Condition: Water Level  
Remarks: N/A

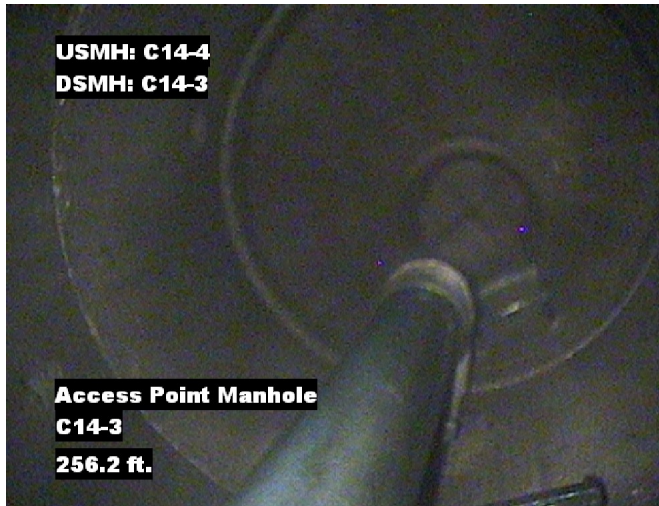
Distance: 256.2 ft.      Grade: 0  
Condition: Access Point Manhole  
Remarks: C14-3
