Defect Listing

Pipe Segment Refere... C14-5_C14-4	City Oliver Springs	Street foster ave	Material Fibreglass Reinforc...	Location C... Easement/R...	Sewer Use Sanitary
Upstream MH C14-5	Total Length 286.5	Year Laid	Shape Circular	Location Details	
DS Manhole C14-4	Length surveyed 286.5	Year Renewed	Height 8	Width 8	Pipe Joint... N/A

SPR N/A	MPR 15	PO Number 4397-03	Customer GRW
SPRI N/A	MPRI 3	Work Order 4397-02	Purpose Pre-Rehabilitation Survey
QSR N/A	QMR 4231		
OPR 15	Surveyed By Barry Rogers	Direction Upstream	Date 20150716
OPRI 3	Certificate Number U-1012-16405	Pre-Cleaning Jetting	Time 09:55
	Date Cleaned 20150716	End Time 10:17	Weather Dry
			Media label
			Additional Info

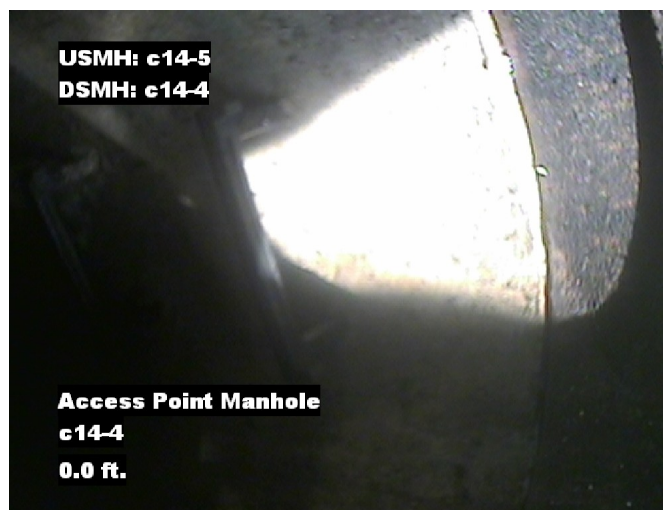
Distance: 0.0 ft. Grade: 0
Condition: Access Point Manhole
Remarks: c14-4

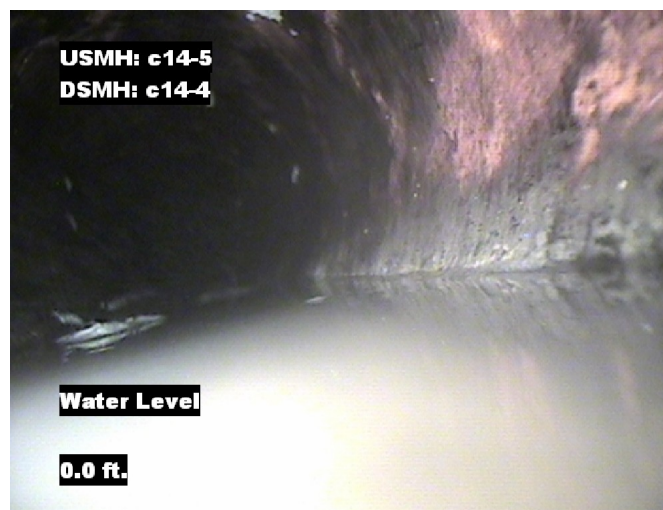
Distance: 0.0 ft. Grade: 0
Condition: Water Level
Remarks: N/A

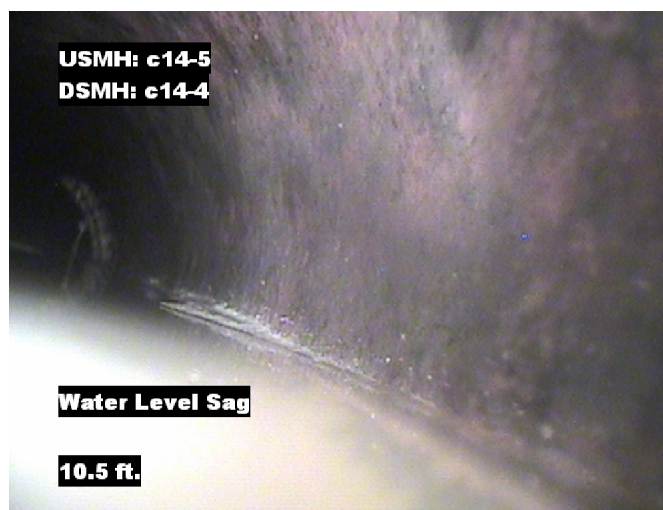
Distance: 10.5 ft. Grade: 3
Condition: Water Level Sag
Remarks: N/A

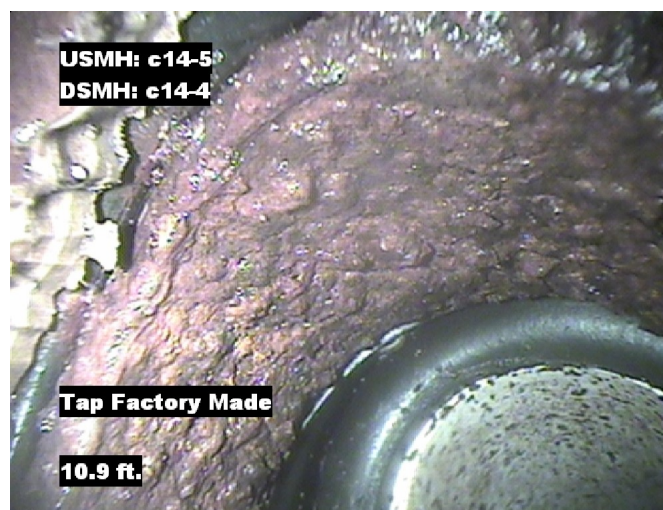
Distance: 10.9 ft. Grade: 0
Condition: Tap Factory Made
Remarks: N/A

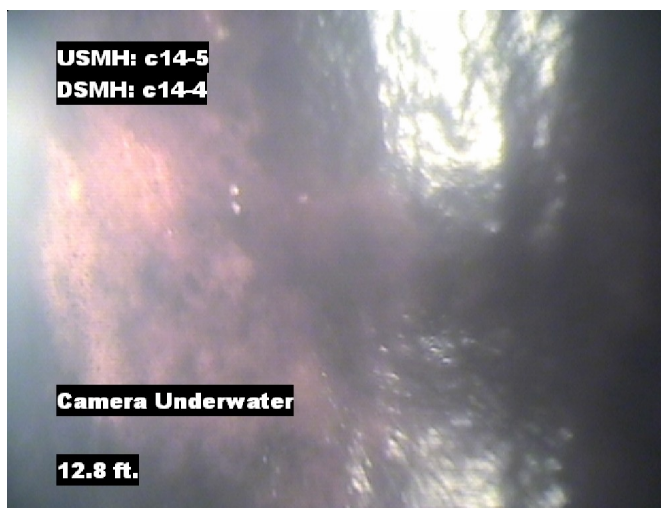
Distance: 12.8 ft. Grade: 4
Condition: Camera Underwater
Remarks: N/A

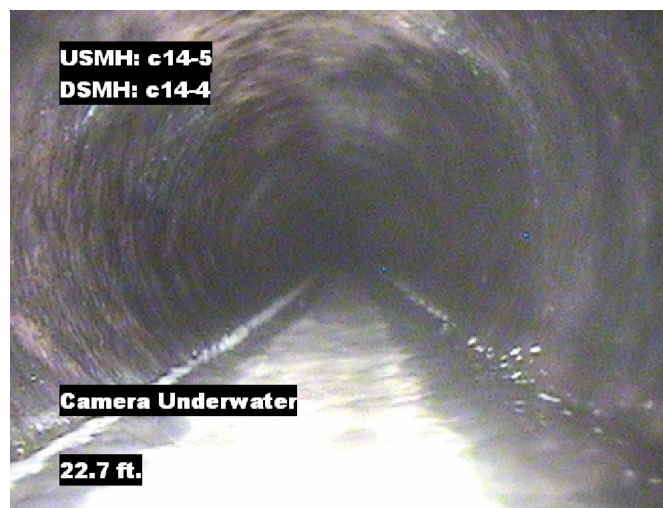
Distance: 22.7 ft. Grade: 4
Condition: Camera Underwater
Remarks: N/A

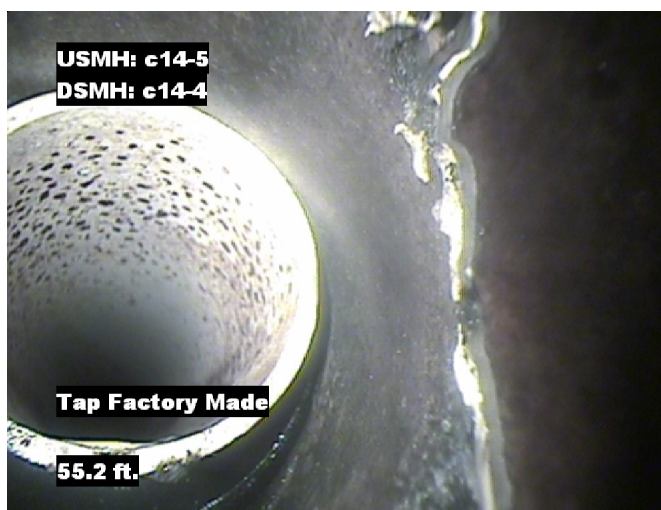
Distance: 55.2 ft. Grade: 0
Condition: Tap Factory Made
Remarks: N/A

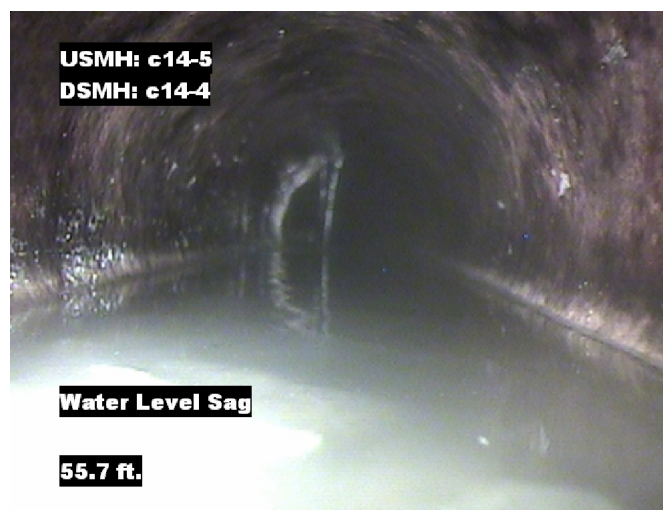
Distance: 55.7 ft. Grade: 2
Condition: Water Level Sag
Remarks: N/A

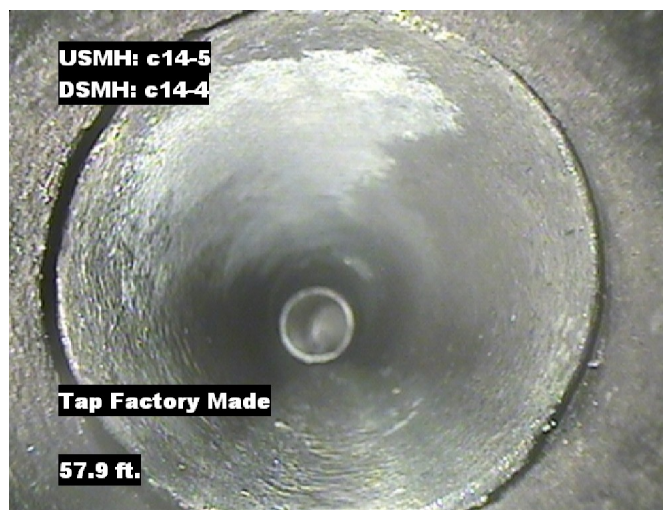
Distance: 57.9 ft. Grade: 0
Condition: Tap Factory Made
Remarks: N/A

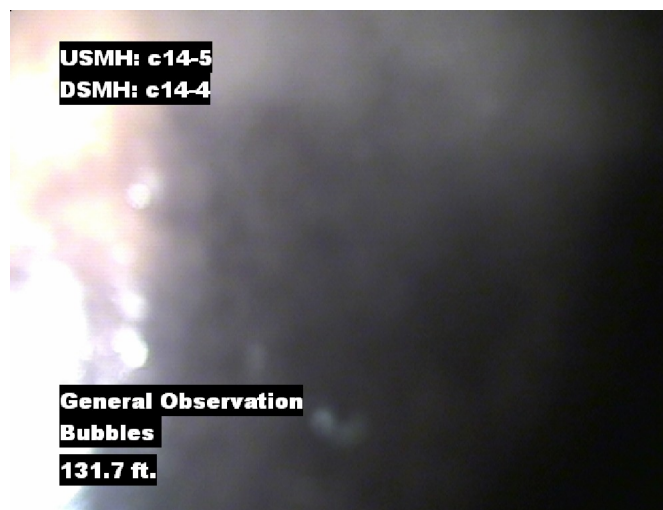
Distance: 131.7 ft. Grade: 0
Condition: General Observation
Remarks: Bubbles

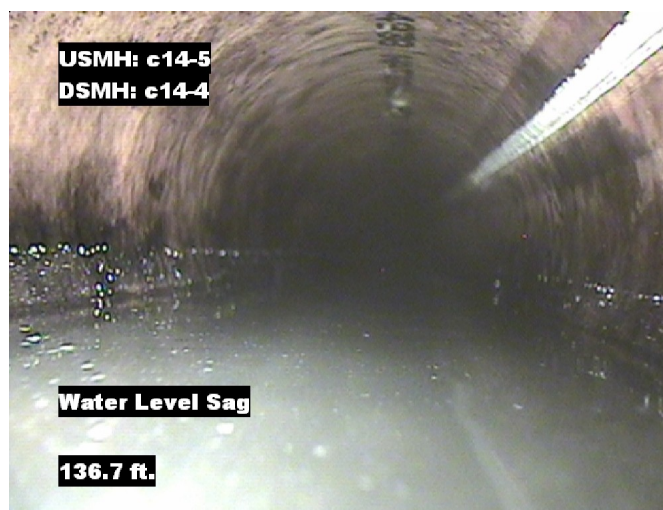
Distance: 136.7 ft. Grade: 2
Condition: Water Level Sag
Remarks: N/A

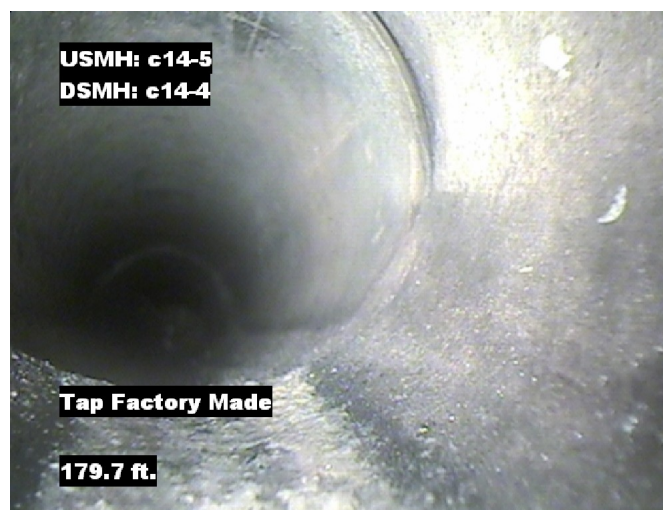
Distance: 179.7 ft. Grade: 0
Condition: Tap Factory Made
Remarks: N/A

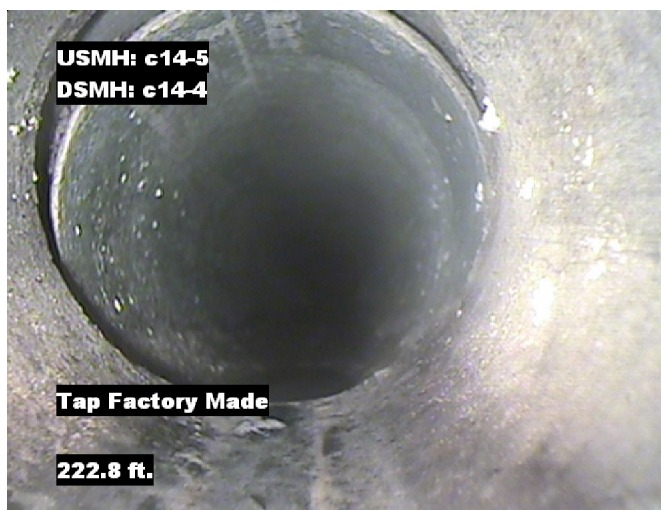
Distance: 222.8 ft. Grade: 0
Condition: Tap Factory Made
Remarks: N/A

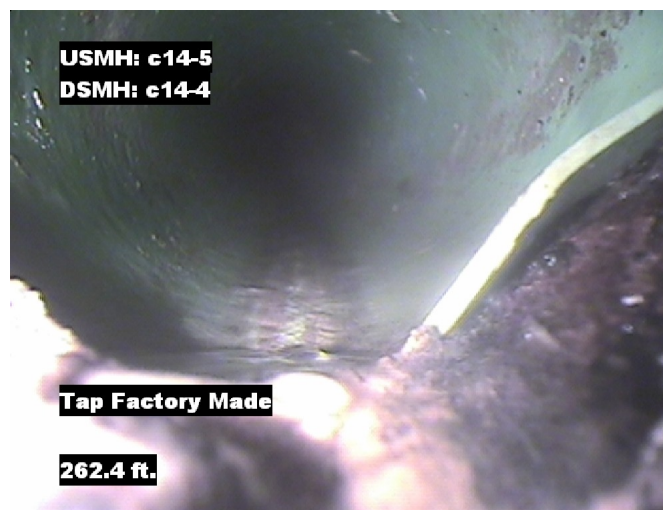
Distance: 262.4 ft. Grade: 0
Condition: Tap Factory Made
Remarks: N/A

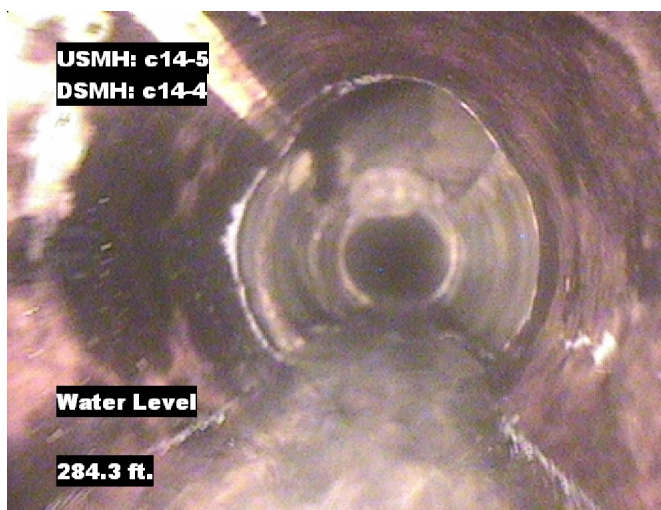
Distance: 284.2 ft. Grade: 0
Condition: Water Level
Remarks: N/A

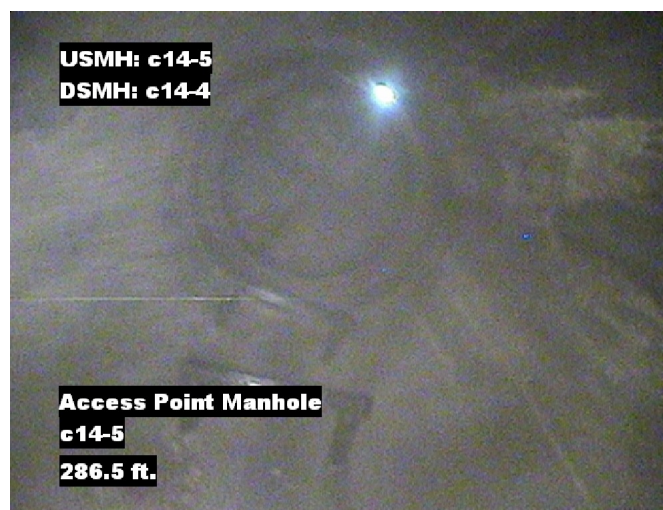
Distance: 286.5 ft. Grade: 0
Condition: Access Point Manhole
Remarks: c14-5
