Defect Listing

Pipe Segment Refere... C14-6_C14-5	City Oliver Springs	Street richards dr	Material Fibreglass Reinforc...	Location C... Easement/R...	Sewer Use Sanitary
Upstream MH C14-6	Total Length 284.7	Year Laid	Shape Circular	Location Details t	
DS Manhole C14-5	Length surveyed 284.7	Year Renewed	Height 8	Width 8	Pipe Joint... N/A

SPR N/A	MPR 2	PO Number 4397-03	Customer GRW
SPRI N/A	MPRI 2	Work Order 4397-02	Purpose Pre-Rehabilitation Survey
QSR N/A	QMR 2100		
OPR 2	Surveyed By Barry Rogers	Direction Downstream	Date 20150716
OPRI 2	Certificate Number U-1012-16405	Pre-Cleaning Jetting	Time 08:59
	Date Cleaned 20150716	End Time 09:27	Weather Dry
			Additional Info

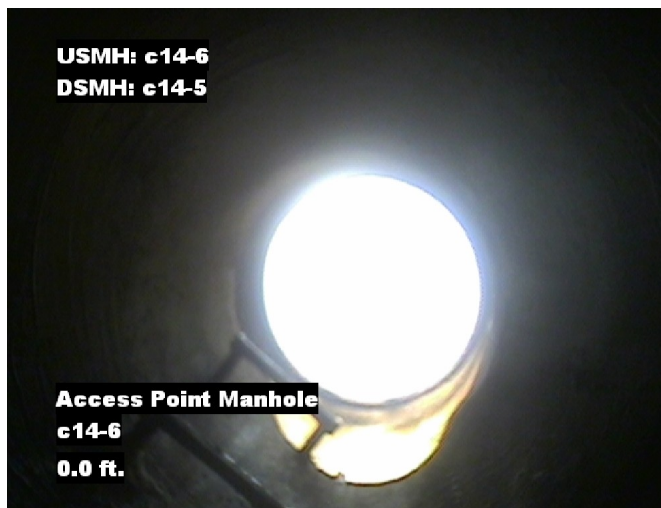
Distance: 0.0 ft. Grade: 0
Condition: Access Point Manhole
Remarks: c14-6

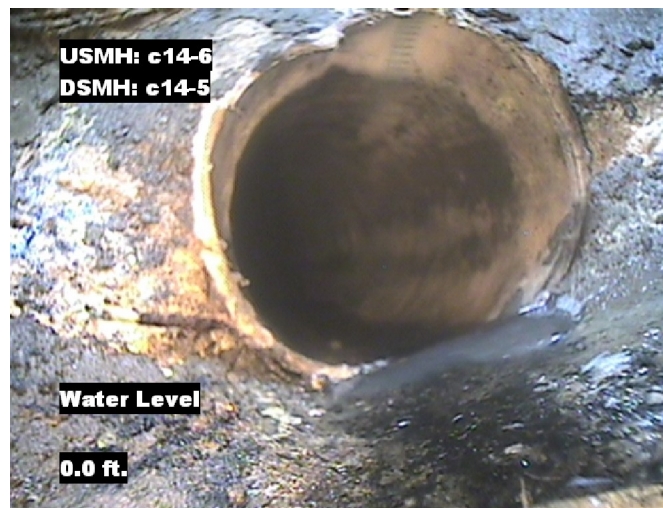
Distance: 0.0 ft. Grade: 0
Condition: Water Level
Remarks: N/A

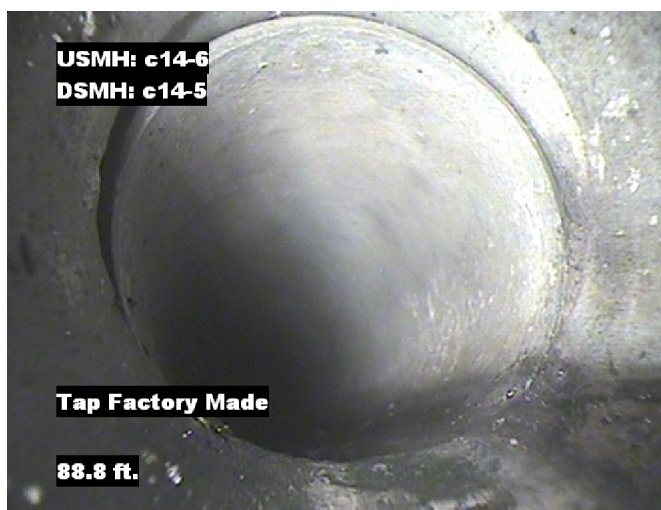
Distance: 88.8 ft. Grade: 0
Condition: Tap Factory Made
Remarks: N/A

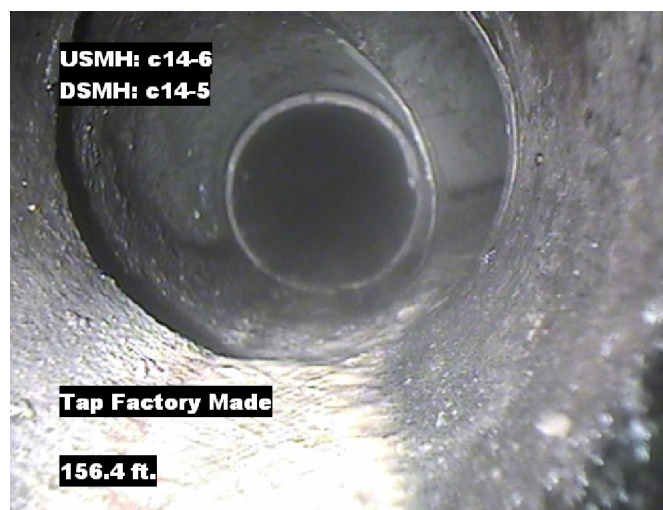
Distance: 156.4 ft. Grade: 0
Condition: Tap Factory Made
Remarks: N/A

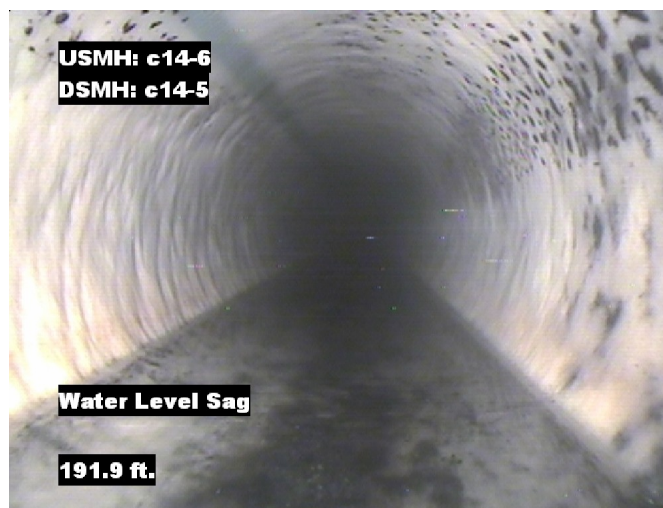
Distance: 191.9 ft. Grade: 2
Condition: Water Level Sag
Remarks: N/A

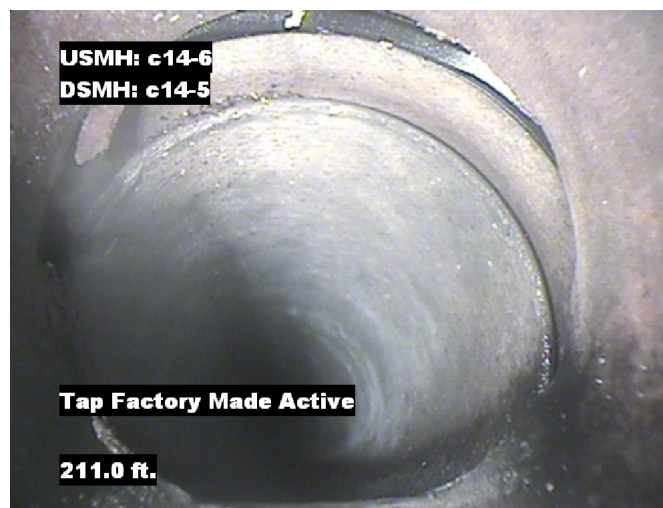
Distance: 211.0 ft. Grade: 0
Condition: Tap Factory Made Active
Remarks: N/A

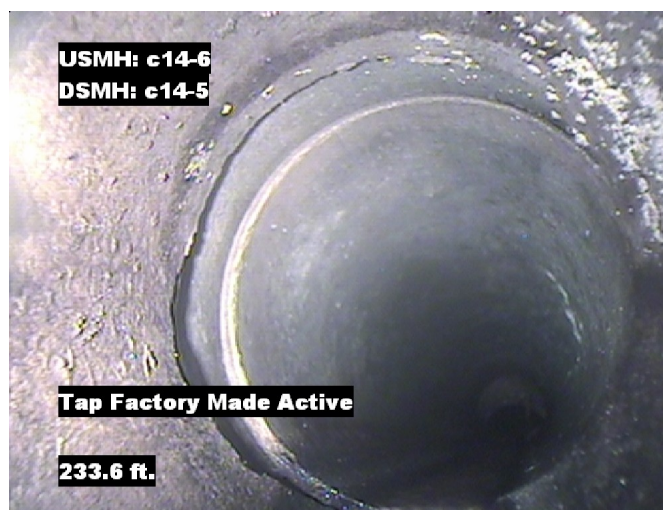
Distance: 233.6 ft. Grade: 0
Condition: Tap Factory Made Active
Remarks: N/A

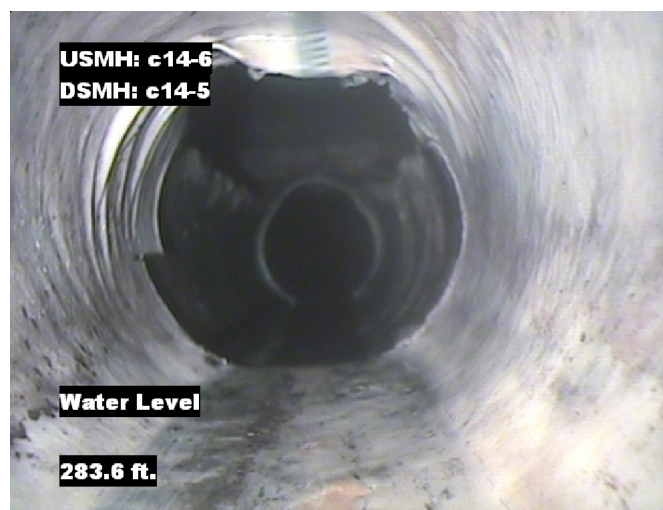
Distance: 283.6 ft. Grade: 0
Condition: Water Level
Remarks: N/A

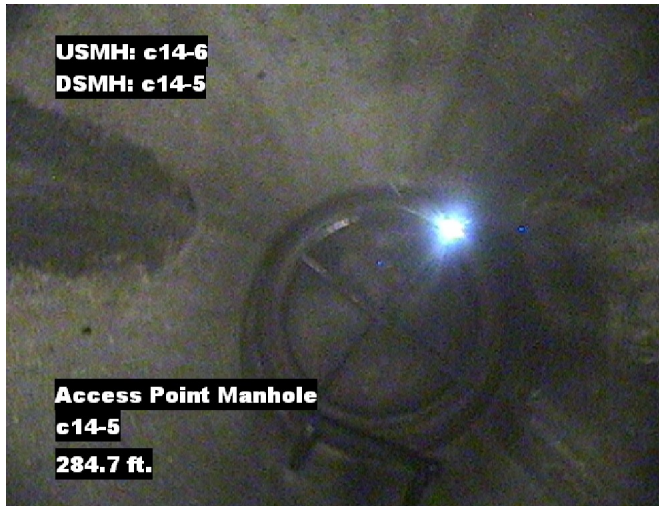
Distance: 284.7 ft. Grade: 0
Condition: Access Point Manhole
Remarks: c14-5
