## Defect Listing

Pipe Segment Refere... <b>C14-7_C14-6</b>	City <b>Oliver Springs</b>	Street <b>richards dr</b>	Material <b>Fibreglass Reinforc...</b>	Location C... <b>Easement/R...</b>	Sewer Use <b>Sanitary</b>
Upstream MH <b>C14-7</b>	Total Length <b>181.3</b>	Year Laid	Shape <b>Circular</b>	Location Details	
DS Manhole <b>C14-6</b>	Length surveyed <b>181.3</b>	Year Renewed	Height <b>8</b>	Width <b>8</b>	Pipe Joint... <b>N/A</b>

## Image Report 4/Page

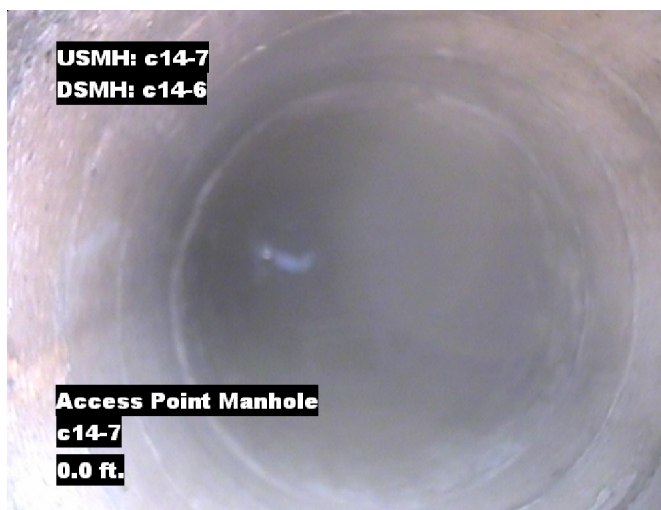
Distance: 0.0 ft. Grade: 0  
Condition: Access Point Manhole  
Remarks: c14-7

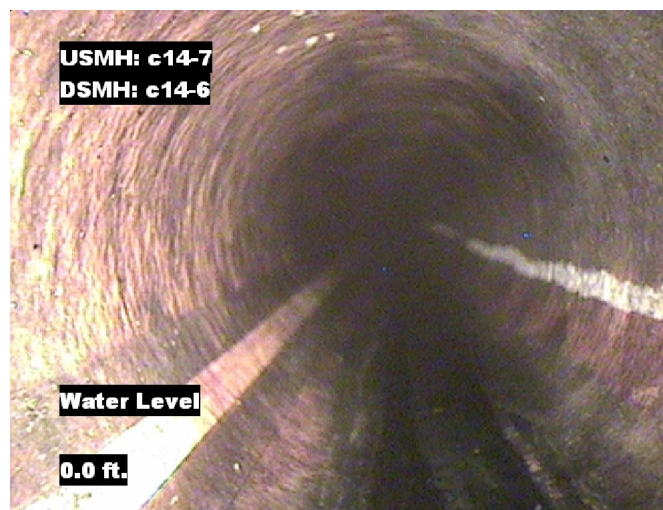
Distance: 0.0 ft. Grade: 0  
Condition: Water Level  
Remarks: N/A

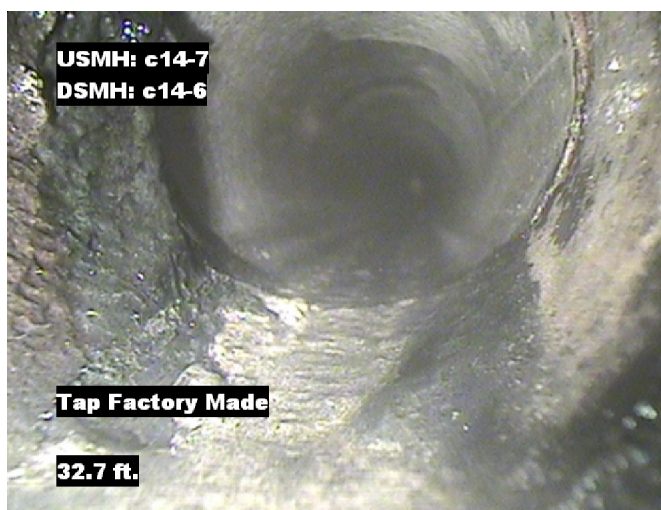
Distance: 32.7 ft. Grade: 0  
Condition: Tap Factory Made  
Remarks: N/A

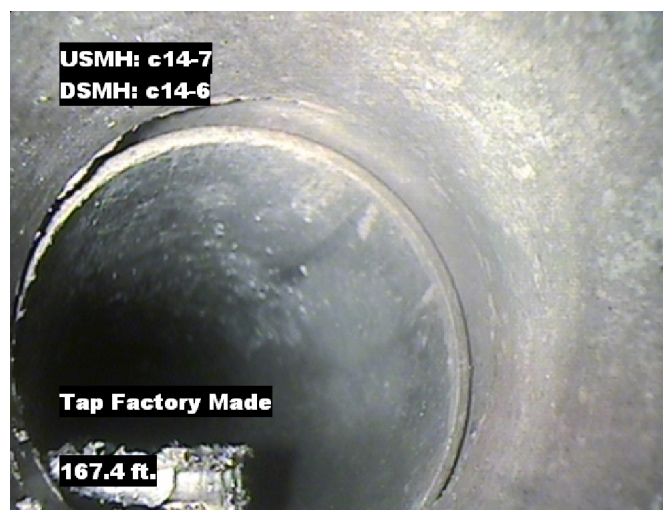
Distance: 167.4 ft. Grade: 0  
Condition: Tap Factory Made  
Remarks: N/A

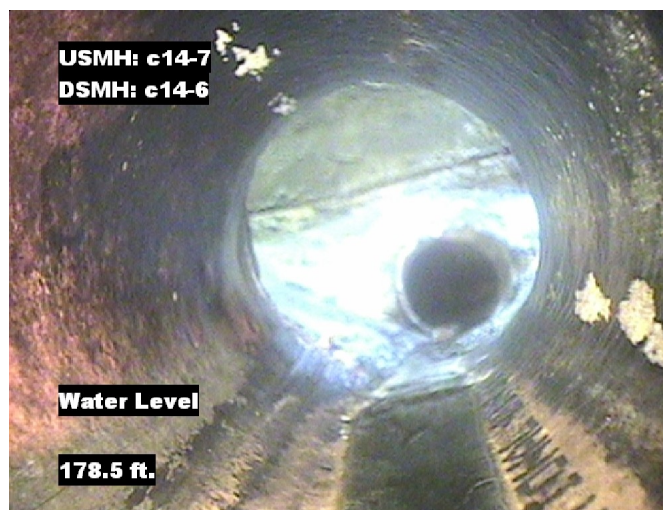
Distance: 178.5 ft. Grade: 0  
Condition: Water Level  
Remarks: N/A

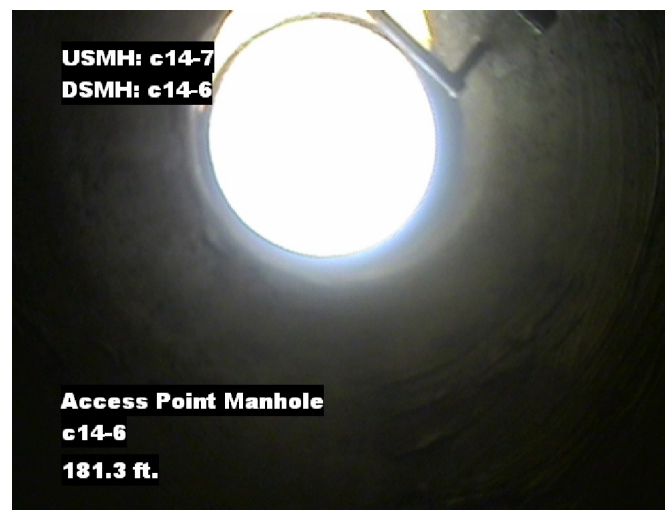
Distance: 181.3 ft. Grade: 0  
Condition: Access Point Manhole  
Remarks: c14-6
