Defect Listing

Pipe Segment Refere... C15-1_C-23	City Oliver Springs	Street Edmonds Dr	Material Concrete Pipe (non-...	Location C... Light High...	Sewer Use Sanitary
Upstream MH C15-1	Total Length 241.5	Year Laid	Shape Circular	Location Details	
DS Manhole C-23	Length surveyed 241.5	Year Renewed	Height 8	Width 8	Pipe Joint... 4

SPR 4	MPR N/A	PO Number 4397-03	Customer GRW
SPRI 2	MPRI N/A	Work Order 4397-02	Purpose Pre-Rehabilitation Survey
QSR 3111	QMR N/A		
OPR 4	Surveyed By Barry Rogers	Direction Downstream	Date 20150715
OPRI 2	Certificate Number U-1012-16405	Pre-Cleaning Jetting	Time 07:10
	Date Cleaned 20150715	End Time 07:30	Weather Damp
			Media label
			Additional Info

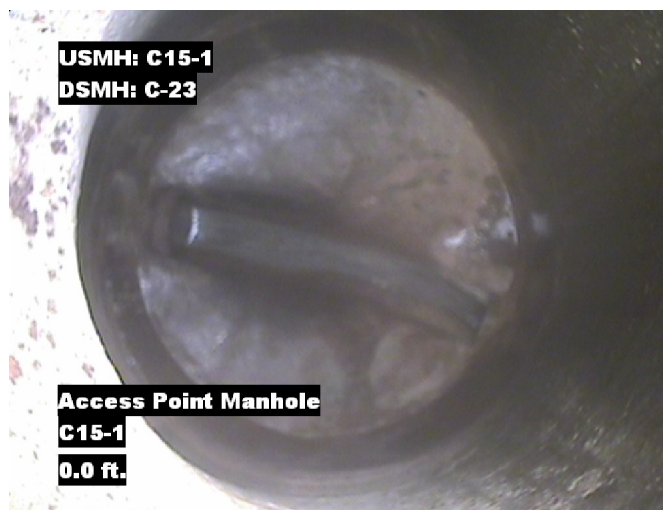
Distance: 0.0 ft. Grade: 0
Condition: Access Point Manhole
Remarks: C15-1

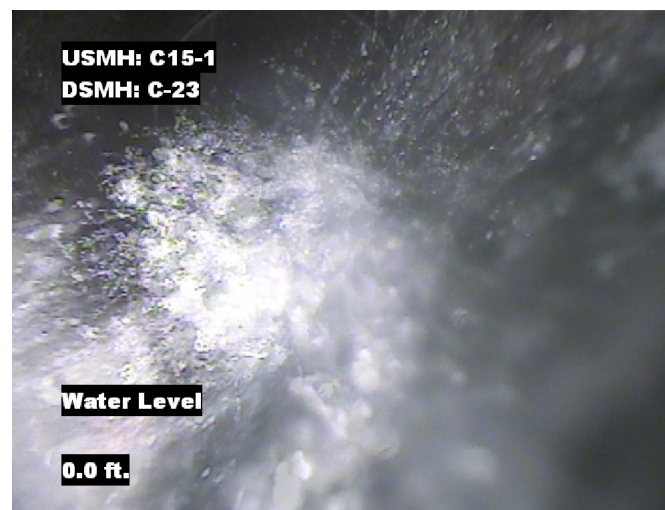
Distance: 0.0 ft. Grade: 0
Condition: Water Level
Remarks: N/A

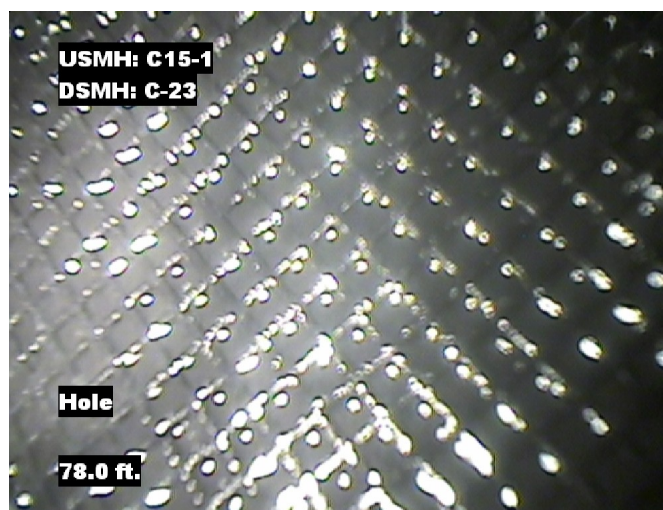
Distance: 78.0 ft. Grade: 3
Condition: Hole
Remarks: N/A

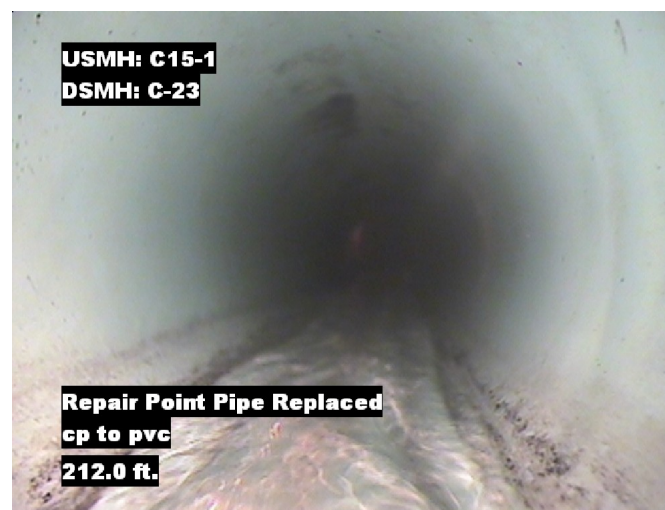
Distance: 212.0 ft. Grade: 0
Condition: Repair Point Pipe Replaced
Remarks: cp to pvc

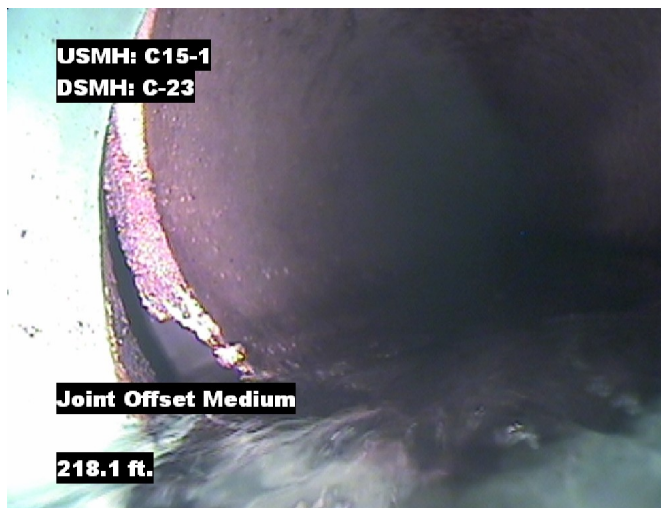
Distance: 218.1 ft. Grade: 1
Condition: Joint Offset Medium
Remarks: N/A

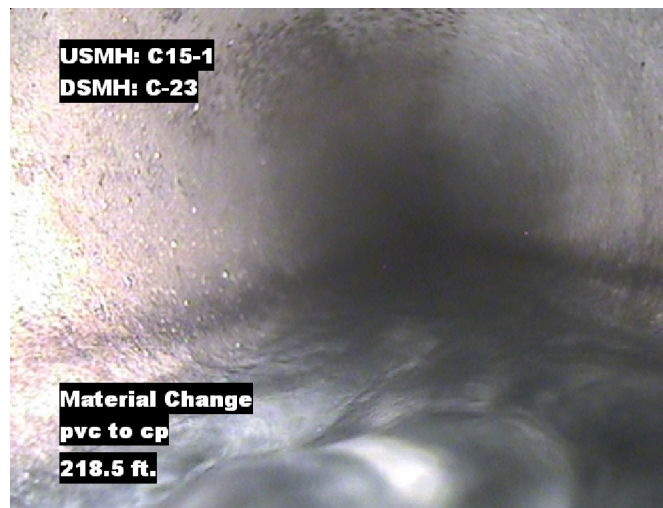
Distance: 218.5 ft. Grade: 0
Condition: Material Change
Remarks: pvc to cp

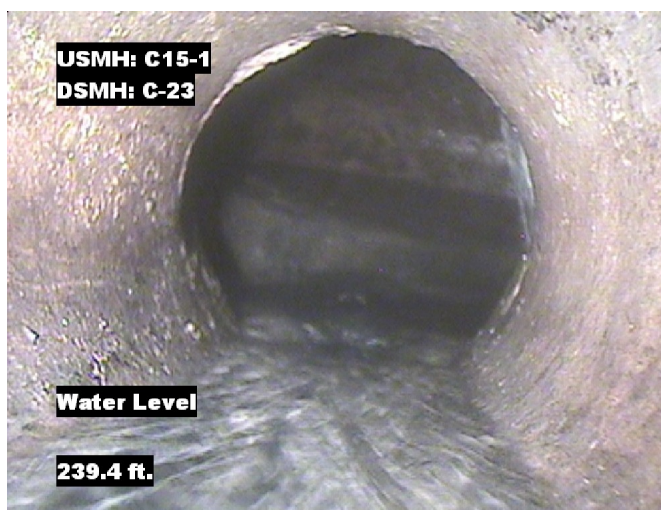
Distance: 239.4 ft. Grade: 0
Condition: Water Level
Remarks: N/A

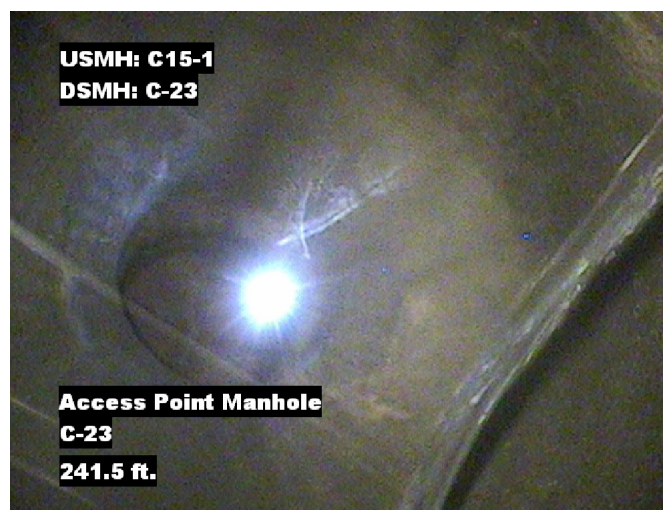
Distance: 241.5 ft. Grade: 0
Condition: Access Point Manhole
Remarks: C-23
