Defect Listing

Pipe Segment Refere... C15-2_C15-1	City Oliver Springs	Street Foster Ave	Material Concrete Pipe (non-...	Location C... Light High...	Sewer Use Sanitary
Upstream MH C15-2	Total Length 181.5	Year Laid	Shape Circular	Location Details	
DS Manhole C15-1	Length surveyed 181.5	Year Renewed	Height 8	Width 8	Pipe Joint... 4

SPR N/A	MPR 7	PO Number 4397-03	Customer GRW
SPRI N/A	MPRI 2.3	Work Order 4397-02	Purpose Pre-Rehabilitation Survey
QSR N/A	QMR 4121		
OPR 7	Surveyed By Barry Rogers	Direction Downstream	Date 20150713
OPRI 2.3	Certificate Number U-1012-16405	Pre-Cleaning Jetting	Time 15:51
	Date Cleaned 20150713	End Time 16:02	Weather Damp
			Media label
			Additional Info

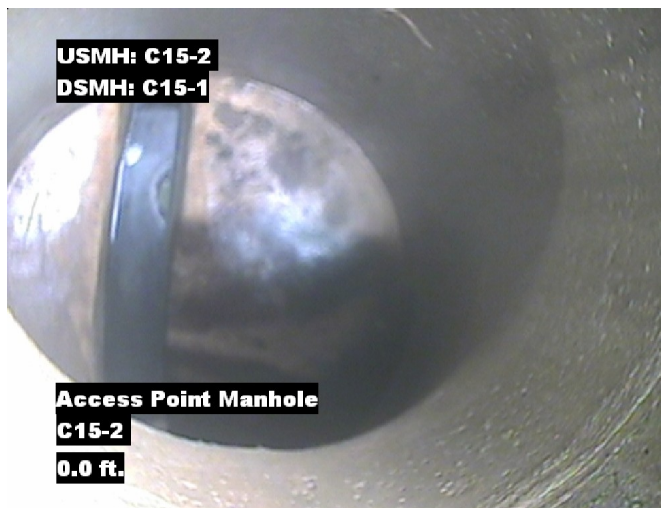
Distance: 0.0 ft. Grade: 0
Condition: Access Point Manhole
Remarks: C15-2

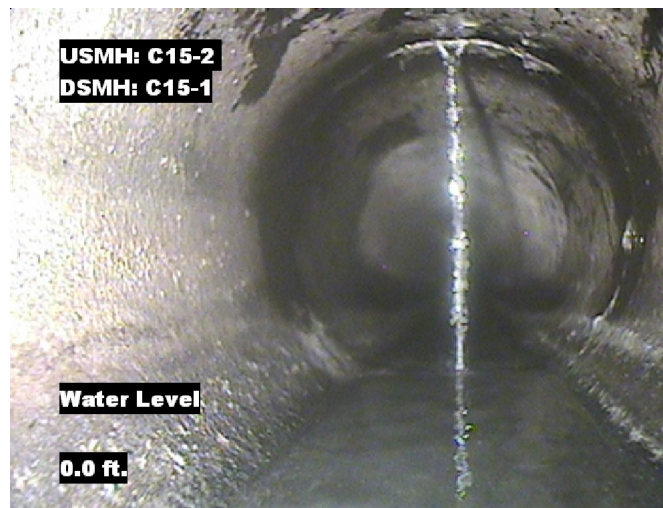
Distance: 0.0 ft. Grade: 0
Condition: Water Level
Remarks: N/A

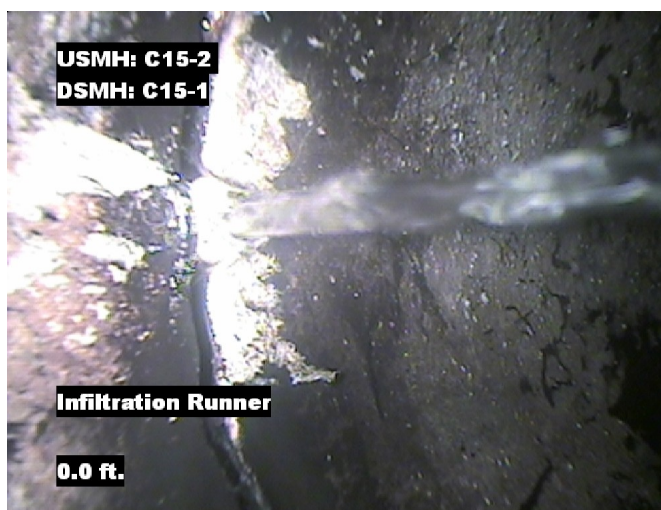
Distance: 3.0 ft. Grade: 4
Condition: Infiltration Runner
Remarks: N/A

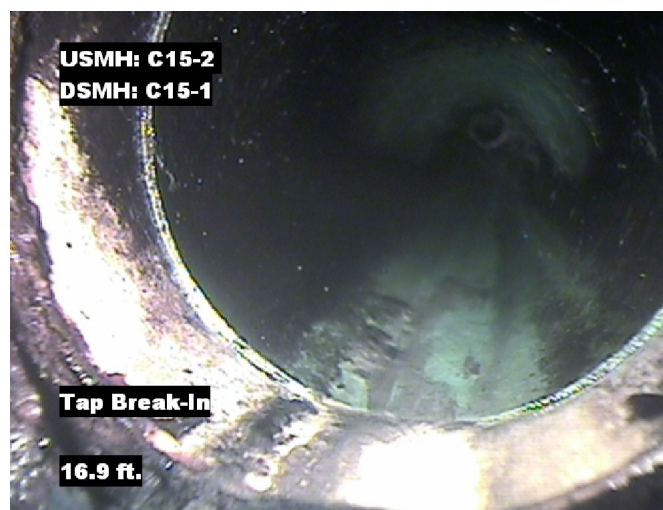
Distance: 16.9 ft. Grade: 0
Condition: Tap Break-In
Remarks: N/A

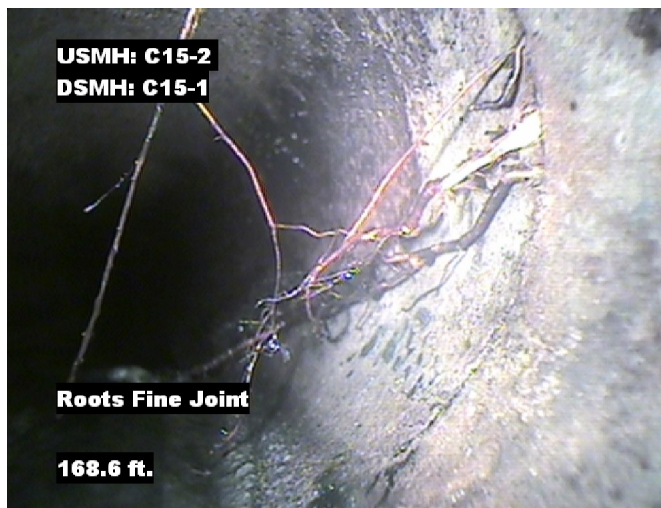
Distance: 168.6 ft. Grade: 1
Condition: Roots Fine Joint
Remarks: N/A

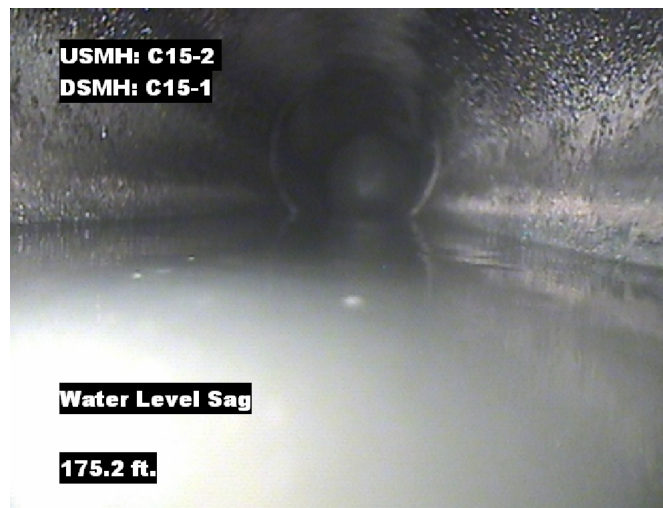
Distance: 175.2 ft. Grade: 2
Condition: Water Level Sag
Remarks: N/A

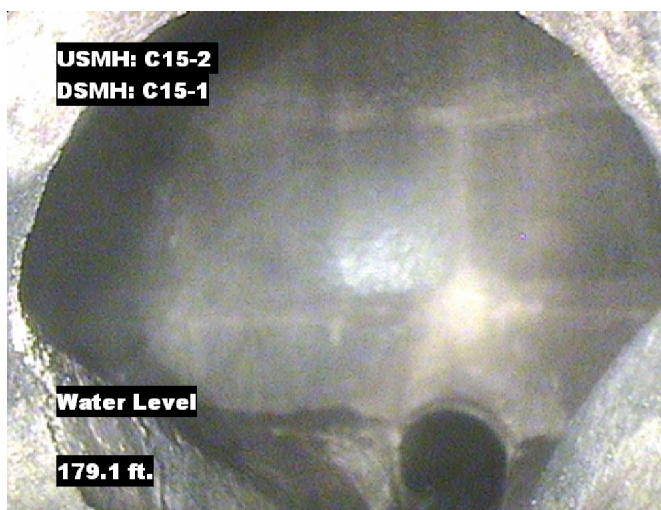
Distance: 179.1 ft. Grade: 0
Condition: Water Level
Remarks: N/A

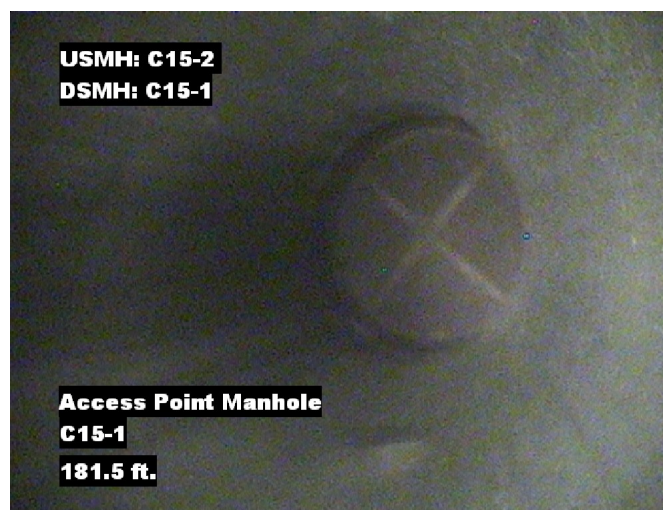
Distance: 181.5 ft. Grade: 0
Condition: Access Point Manhole
Remarks: C15-1
