Defect Listing

Pipe Segment Refere... C15-3_C15-2	City Oliver Springs	Street Hardee's parking lo...	Material Concrete Pipe (non-...	Location C... Easement/R...	Sewer Use Sanitary
Upstream MH C15-3	Total Length 321.9	Year Laid	Shape Circular	Location Details	
DS Manhole C15-2	Length surveyed 321.9	Year Renewed	Height 8	Width 8	Pipe Joint... 4

SPR N/A	MPR 100	PO Number 4397-03	Customer GRW
SPRI N/A	MPRI 2	Work Order 4397-02	Purpose Pre-Rehabilitation Survey
QSR N/A	QMR 2100		
OPR 100	Surveyed By Barry Rogers	Direction Downstream	Date 20150713
OPRI 2	Certificate Number U-1012-16405	Pre-Cleaning Jetting	Time 15:21
	Date Cleaned 20150713	End Time 15:38	Weather Dry
			Additional Info

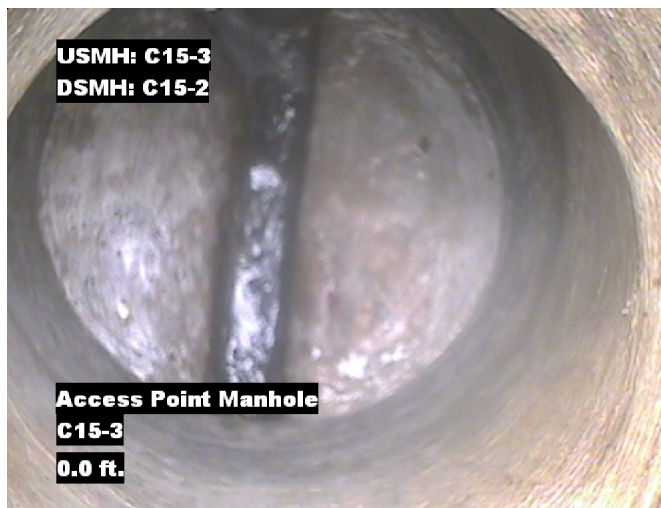
Distance: 0.0 ft. Grade: 0
Condition: Access Point Manhole
Remarks: C15-3

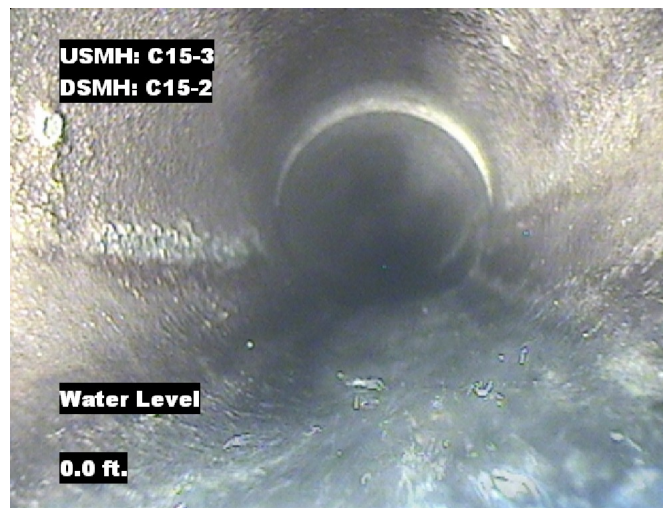
Distance: 0.0 ft. Grade: 0
Condition: Water Level
Remarks: N/A

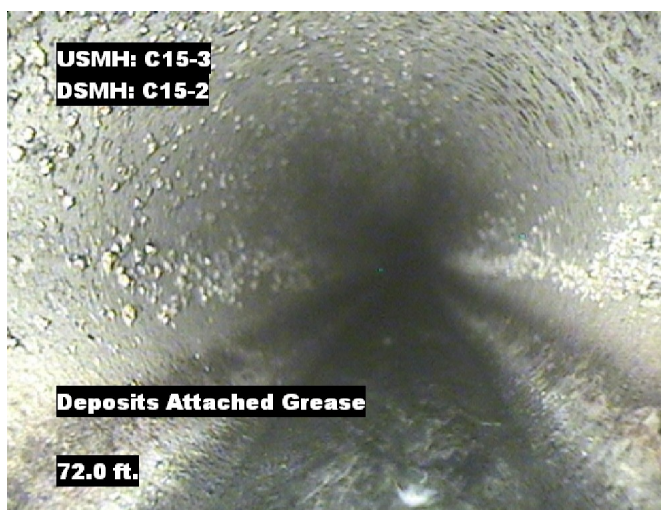
Distance: 72.0 ft. Grade: 2
Condition: Deposits Attached Grease
Remarks: N/A

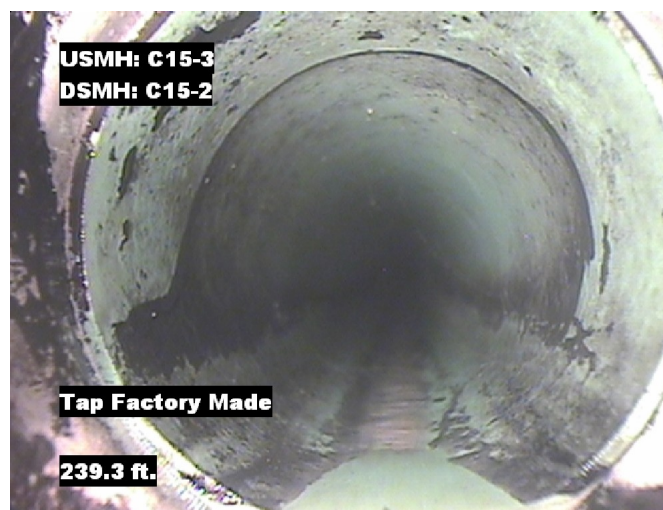
Distance: 239.3 ft. Grade: 0
Condition: Tap Factory Made
Remarks: N/A

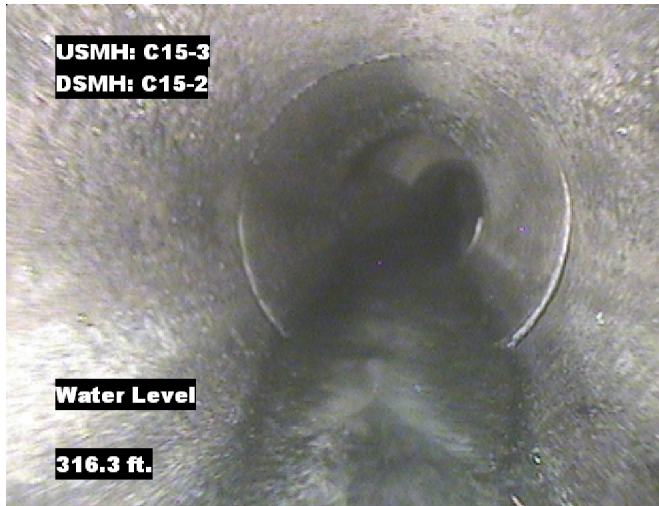
Distance: 316.3 ft. Grade: 0
Condition: Water Level
Remarks: N/A

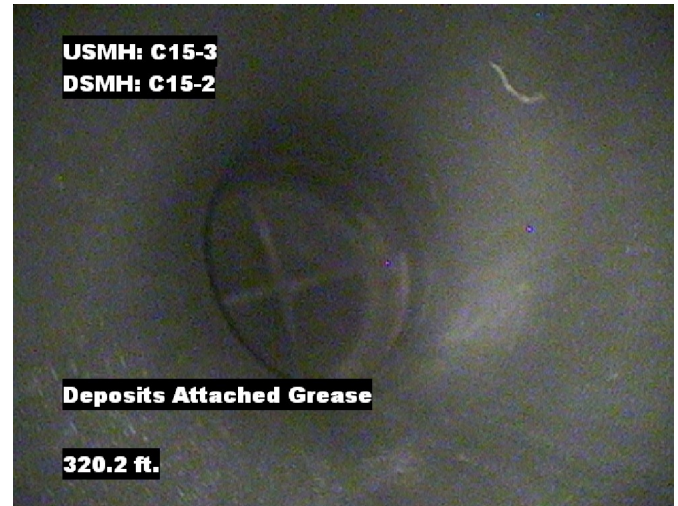
Distance: 320.2 ft. Grade: 2
Condition: Deposits Attached Grease
Remarks: N/A

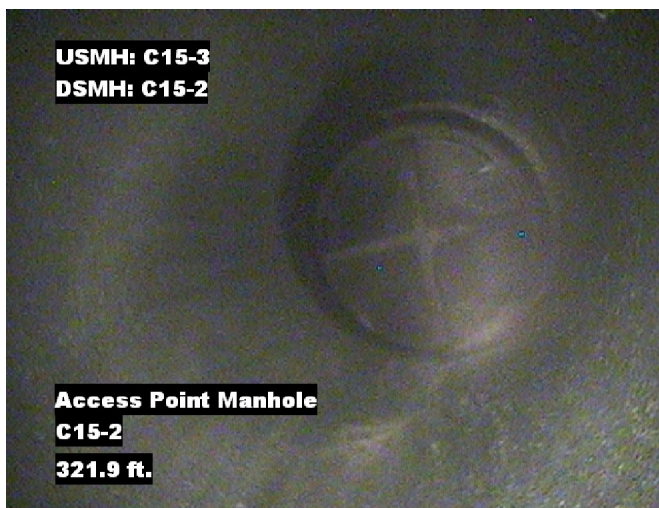
Distance: 321.9 ft. Grade: 0
Condition: Access Point Manhole
Remarks: C15-2
