## Defect Listing

Pipe Segment Refere... <b>C15-4_C15-3</b>	City <b>Oliver Springs</b>	Street <b>Hardee's parking lo...</b>	Material <b>PolyVinyl Chloride</b>	Location C... <b>Parking Lo...</b>	Sewer Use <b>Sanitary</b>
Upstream MH <b>C15-4</b>	Total Length <b>292.5</b>	Year Laid	Shape <b>Circular</b>	Location Details	
DS Manhole <b>C15-3</b>	Length surveyed <b>292.5</b>	Year Renewed	Height <b>8</b>	Width <b>8</b>	Pipe Joint... <b>13</b>

SPR <b>N/A</b>	MPR <b>3</b>	PO Number <b>4397-03</b>	Customer <b>GRW</b>
SPRI <b>N/A</b>	MPRI <b>3</b>	Work Order <b>4397-02</b>	Purpose <b>Pre-Rehabilitation Survey</b>
QSR <b>N/A</b>	QMR <b>3100</b>		
OPR <b>3</b>	Surveyed By <b>Barry Rogers</b>	Direction <b>Downstream</b>	Date <b>20150713</b>
OPRI <b>3</b>	Certificate Number <b>U-1012-16405</b>	Pre-Cleaning <b>Jetting</b>	Time <b>14:49</b>
	Date Cleaned <b>20150713</b>	End Time <b>15:06</b>	Weather <b>Dry</b>
			Media label
			Additional Info

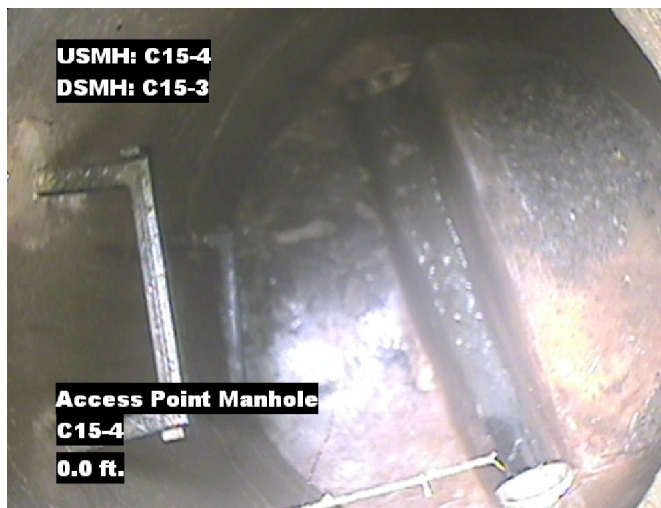
Distance: 0.0 ft. Grade: 0  
Condition: Access Point Manhole  
Remarks: C15-4

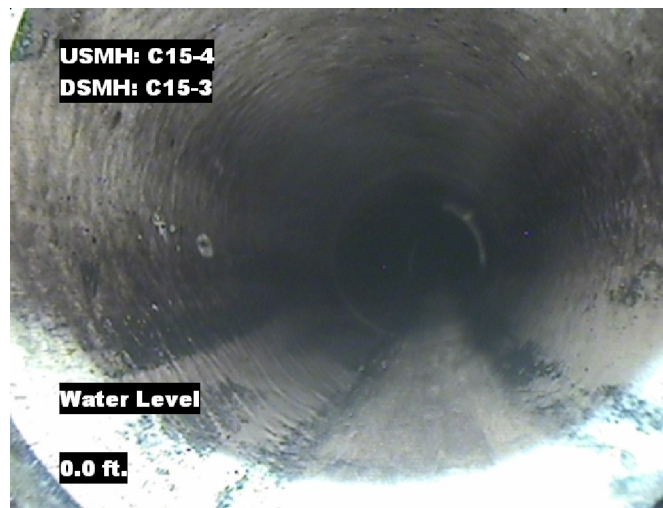
Distance: 0.0 ft. Grade: 0  
Condition: Water Level  
Remarks: N/A

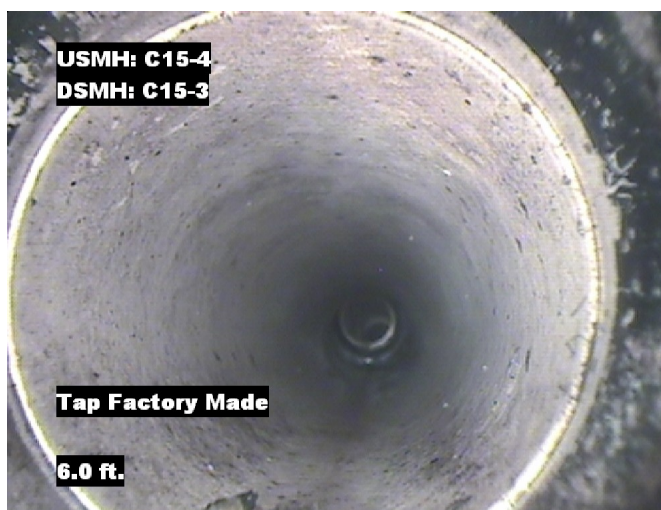
Distance: 6.0 ft. Grade: 0  
Condition: Tap Factory Made  
Remarks: N/A

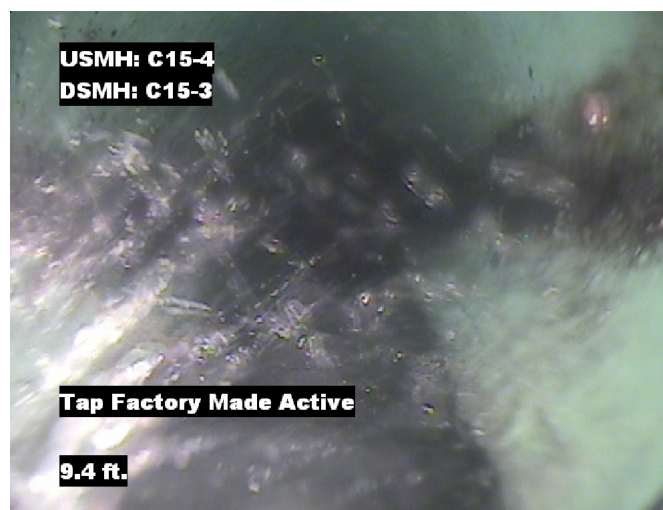
Distance: 9.4 ft. Grade: 0  
Condition: Tap Factory Made Active  
Remarks: N/A

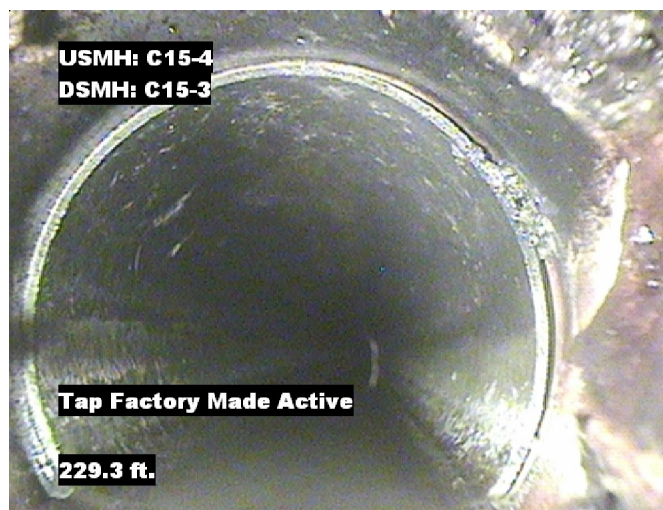
Distance: 229.3 ft. Grade: 0  
Condition: Tap Factory Made Active  
Remarks: N/A

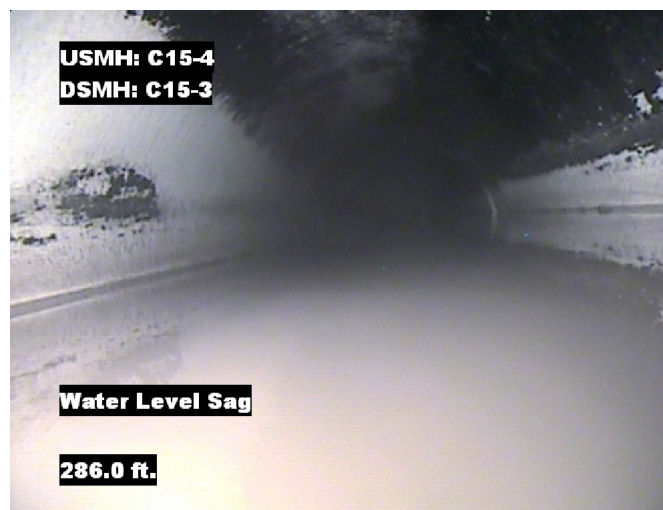
Distance: 286.0 ft. Grade: 3  
Condition: Water Level Sag  
Remarks: N/A

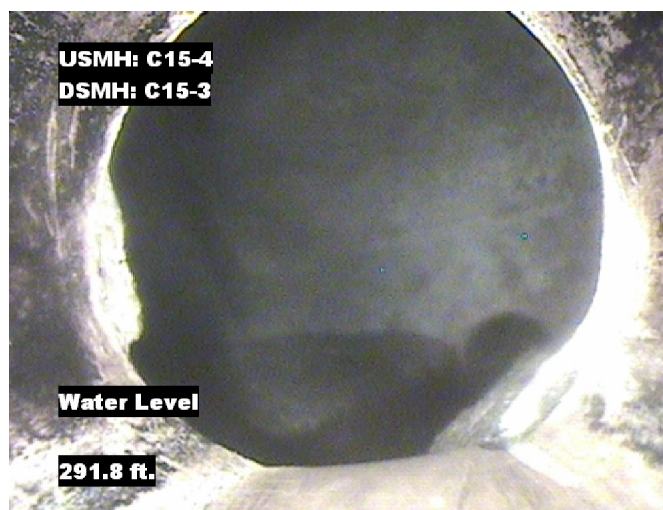
Distance: 291.8 ft. Grade: 0  
Condition: Water Level  
Remarks: N/A

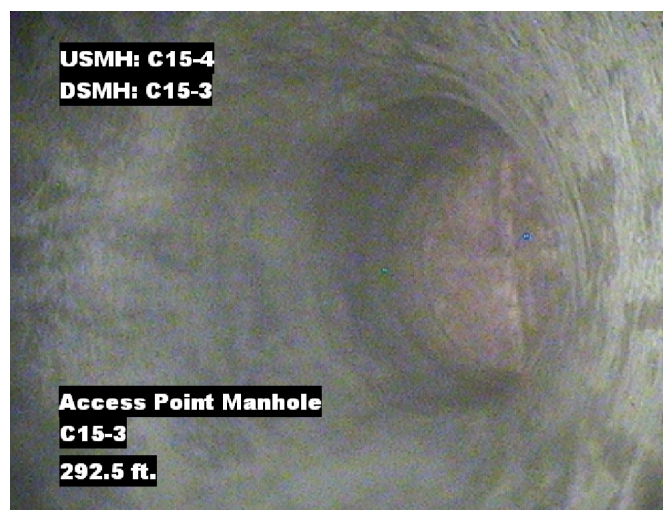
Distance: 292.5 ft. Grade: 0  
Condition: Access Point Manhole  
Remarks: C15-3
