Defect Listing

| Pipe Segment Refere... C15-5_C15-4 | City Oliver Springs | Street Hwy 62 | Material PolyVinyl Chloride | Location C... Easement/R... | Sewer Use Sanitary |

| SPRI 2 | MPRI 3.8 | Work Order 4397-02 | Purpose Pre-Rehabilitation Survey |

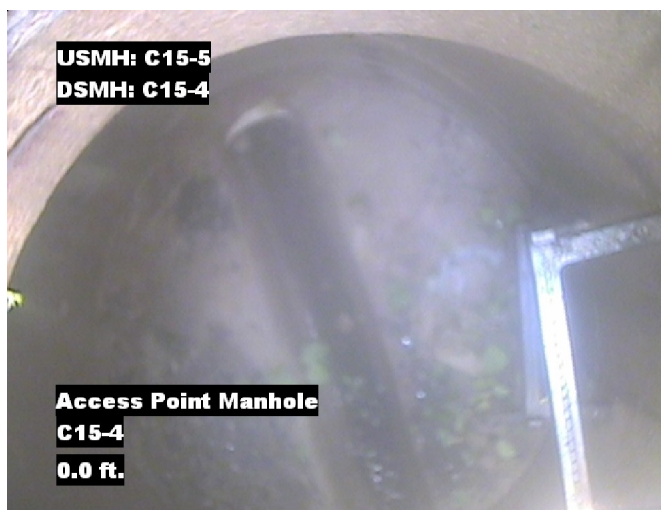
Distance: 0.0 ft. Grade: 0
Condition: Access Point Manhole
Remarks: C15-4

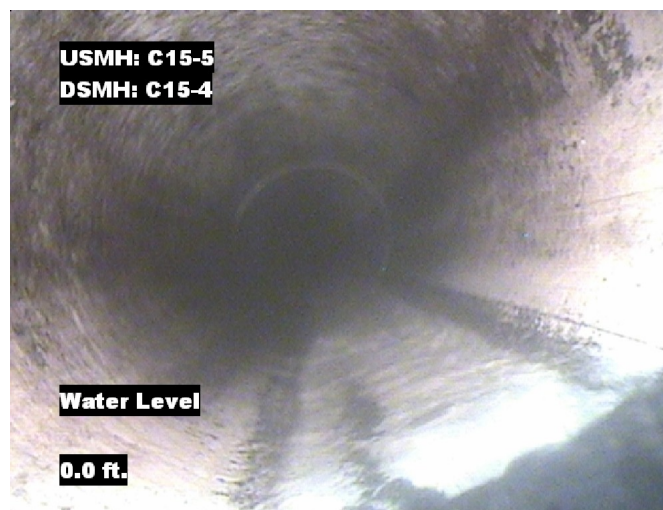
| Distance | Condition | Cont. Dfct. | Values | | | Joint | Clock Position | | Grade |
|---|---|---|---|---|---|---|---|---|---|
| 0.0 ft. | Water Level | | | | 5 | <input type="checkbox"/> | | | |

Distance: 0.0 ft. Grade: 0
Condition: Water Level
Remarks: N/A

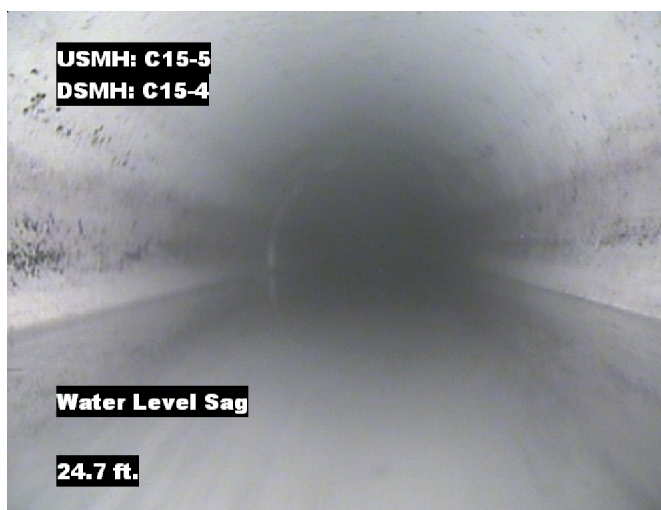
| Distance | Condition | Cont. Dfct. | Values | | | Joint | Clock Position | | Grade |
|---|---|---|---|---|---|---|---|---|---|
| 24.7 ft. | Water Level Sag | | | | 45 | <input type="checkbox"/> | | | 3 |

Distance: 24.7 ft. Grade: 3
Condition: Water Level Sag
Remarks: N/A

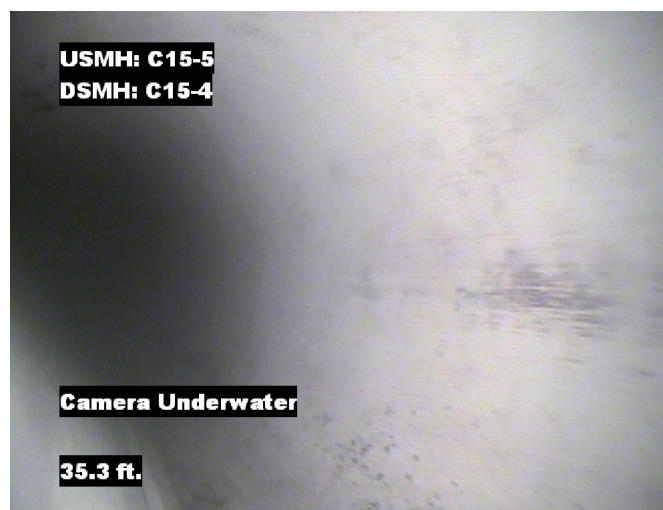
| Distance | Condition | Cont. Dfct. | Values | | | Joint | Clock Position | | Grade |
|---|---|---|---|---|---|---|---|---|---|
| 35.2 ft. | Camera Underwater | | | | 0 | <input type="checkbox"/> | | | 4 |

Distance: 35.2 ft. Grade: 4
Condition: Camera Underwater
Remarks: N/A

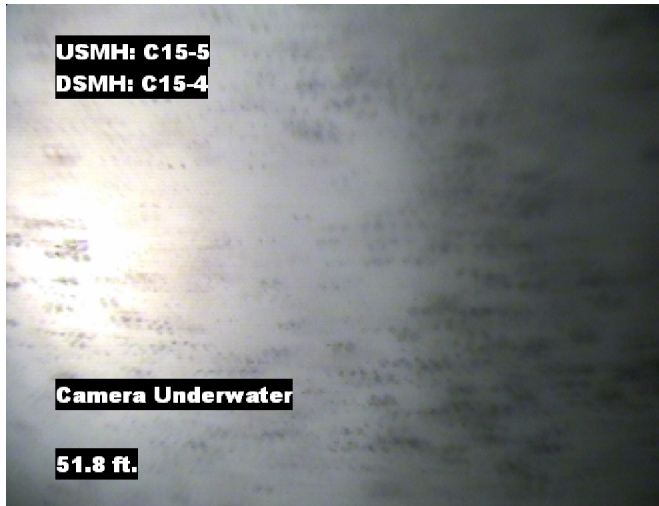
| Distance | Condition | Cont. Dfct. | Values | | | Joint | Clock Position | | Grade |
|---|---|---|---|---|---|---|---|---|---|
| 51.7 ft. | Camera Underwater | | | | 0 | <input type="checkbox"/> | | | 4 |

Distance: 51.7 ft. Grade: 4
Condition: Camera Underwater
Remarks: N/A

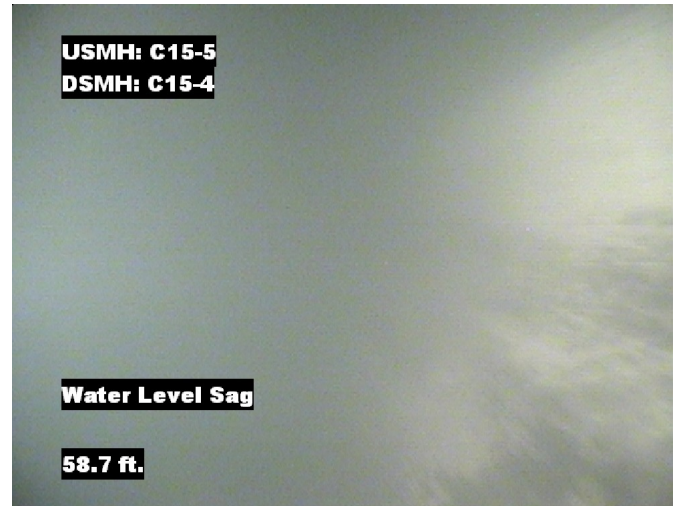
| Distance | Condition | Cont. Dfct. | Values | | | Joint | Clock Position | | Grade |
|---|---|---|---|---|---|---|---|---|---|
| 58.6 ft. | Water Level Sag | | | | 65 | <input type="checkbox"/> | | | 4 |

Distance: 58.6 ft. Grade: 4
Condition: Water Level Sag
Remarks: N/A

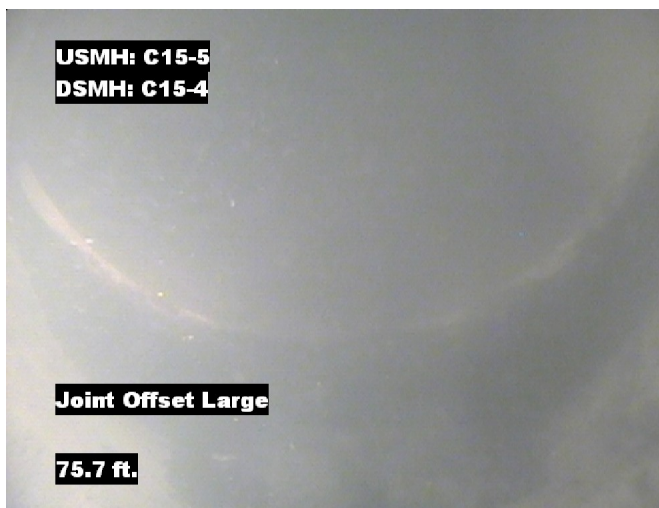
| Distance | Condition | Cont. Dfct. | Values | | | Joint | Clock Position | | Grade |
|---|---|---|---|---|---|---|---|---|---|
| 75.7 ft. | Joint Offset Large | | | | 0 | <input type="checkbox"/> | | | 2 |

Distance: 75.7 ft. Grade: 2
Condition: Joint Offset Large
Remarks: N/A

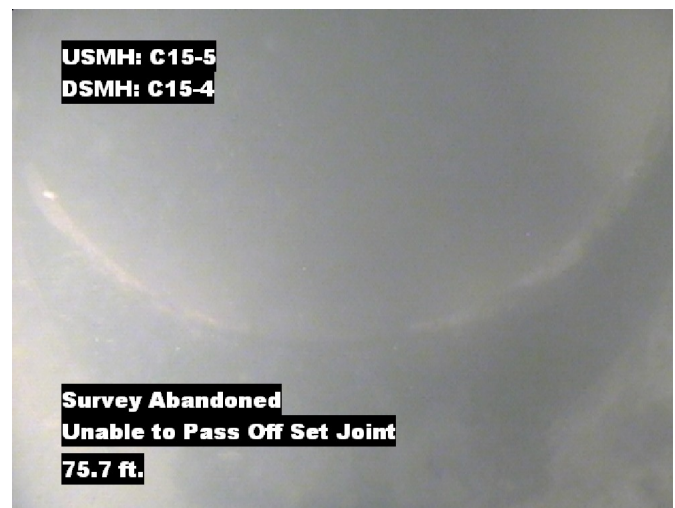
| Distance | Condition | Cont. Dfct. | Values | | | Joint | Clock Position | | Grade |
|---|---|---|---|---|---|---|---|---|---|
| 75.7 ft. | Survey Abandoned | | | | 0 | <input type="checkbox"/> | | | |
| Remarks: Unable to Pass Off Set Joint | | | | | | | | | |

Distance: 75.7 ft. Grade: 0
Condition: Survey Abandoned
Remarks: Unable to Pass Off Set Joint
