Defect Listing

Pipe Segment Refere... C15-6_C15-5	City Oliver Springs	Street HWy 62	Material PolyVinyl Chloride	Location C... Easement/R...	Sewer Use Sanitary
Upstream MH C15-6	Total Length 193.2	Year Laid	Shape Circular	Location Details	
DS Manhole C15-5	Length surveyed 193.2	Year Renewed	Height 8	Width 8	Pipe Joint... 13

SPR N/A	MPR N/A	PO Number 4397-03		Customer GRW	
SPRI N/A	MPRI N/A	Work Order 4397-02		Purpose Pre-Rehabilitation Survey	
QSR N/A	QMR N/A				
OPR N/A	Surveyed By Barry Rogers	Direction Downstream	Date 20150727	Media label	
OPRI N/A	Certificate Number U-1012-16405	Pre-Cleaning Jetting	Time 08:44	Weather Dry	
Date Cleaned 20150727			End Time 08:53	Additional Info

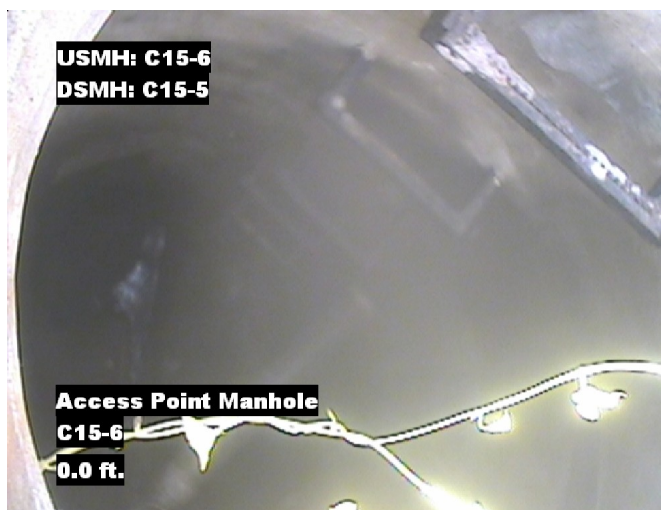
Distance: 0.0 ft. Grade: 0
Condition: Access Point Manhole
Remarks: C15-6

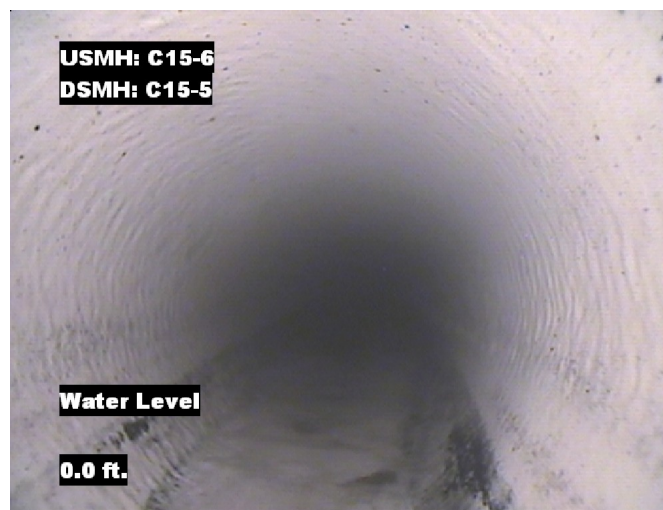
Distance: 0.0 ft. Grade: 0
Condition: Water Level
Remarks: N/A

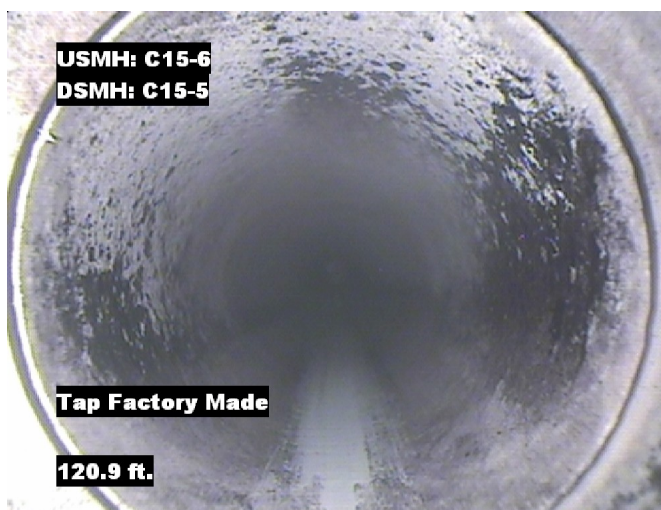
Distance: 120.9 ft. Grade: 0
Condition: Tap Factory Made
Remarks: N/A

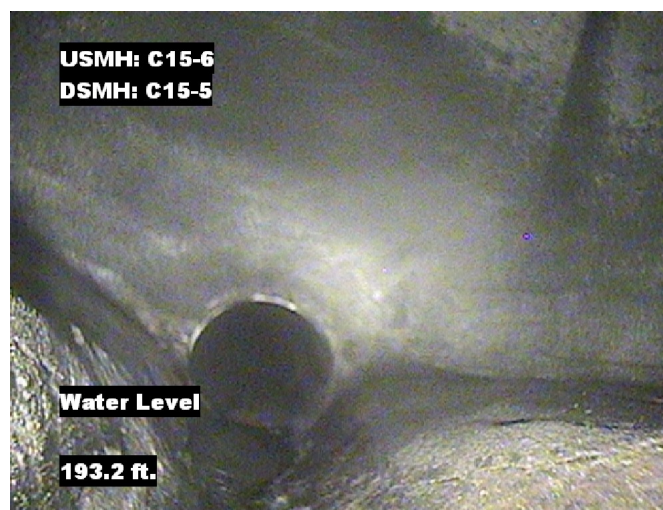
Distance: 193.2 ft. Grade: 0
Condition: Water Level
Remarks: N/A

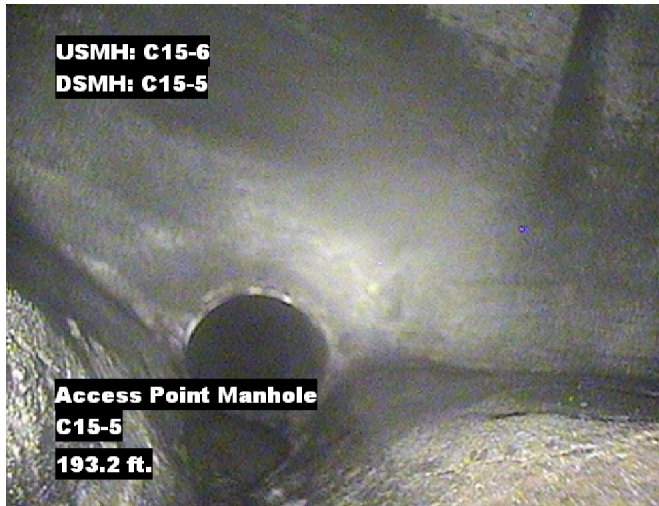
Distance: 193.2 ft. Grade: 0
Condition: Access Point Manhole
Remarks: C15-5
