Defect Listing

Pipe Segment Refere... C15-7_C15-6	City Oliver Springs	Street FoodCity Parking Lo...	Material PolyVinyl Chloride	Location C... Parking Lo...	Sewer Use Sanitary
Upstream MH C15-7	Total Length 256.6	Year Laid	Shape Circular	Location Details	
DS Manhole C15-6	Length surveyed 256.6	Year Renewed	Height 8	Width 8	Pipe Joint... 13

SPR N/A	MPR 2	PO Number 4397-03	Customer GRW
SPRI N/A	MPRI 2	Work Order 4397-02	Purpose Pre-Rehabilitation Survey
QSR N/A	QMR 2100		
OPR 2	Surveyed By Barry Rogers	Direction Downstream	Date 20150713
OPRI 2	Certificate Number U-1012-16405	Pre-Cleaning Jetting	Time 13:52
	Date Cleaned 20150713	End Time 14:09	Weather Dry
		Additional Info

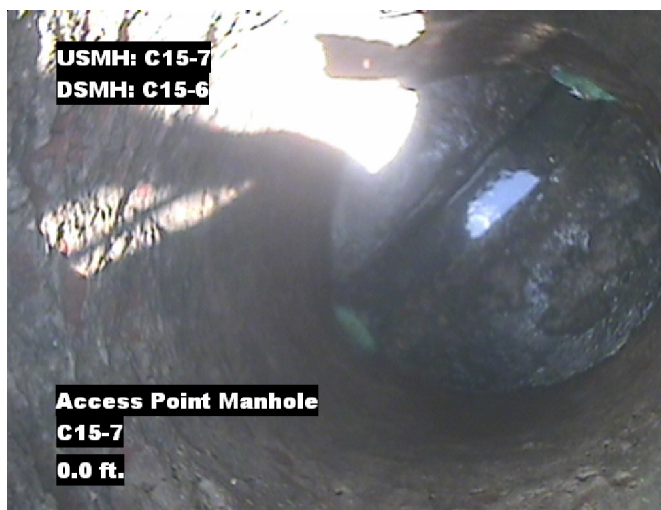
Distance: 0.0 ft. Grade: 0
Condition: Access Point Manhole
Remarks: C15-7

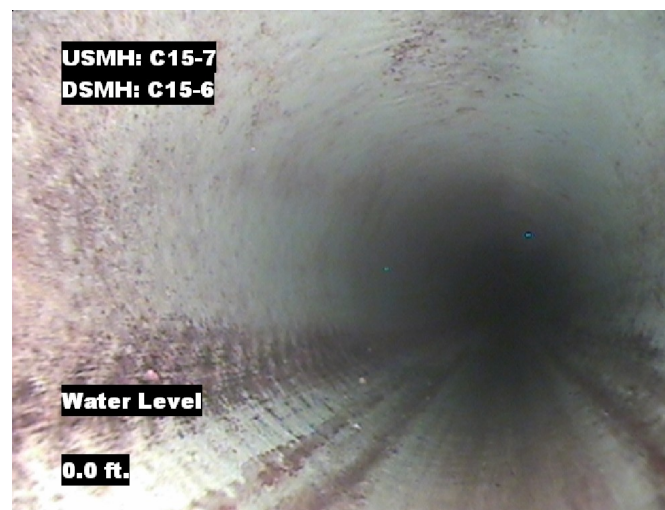
Distance: 0.0 ft. Grade: 0
Condition: Water Level
Remarks: N/A

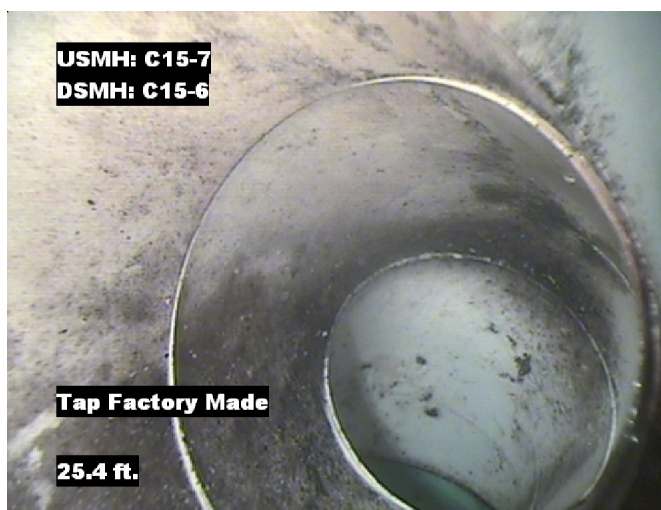
Distance: 25.4 ft. Grade: 0
Condition: Tap Factory Made
Remarks: N/A

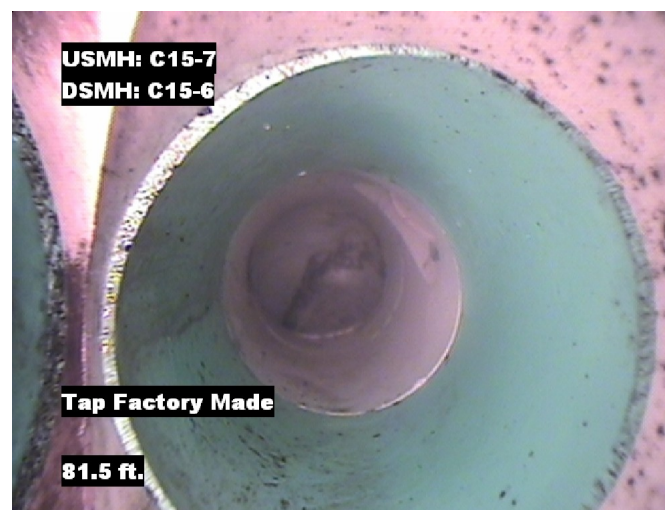
Distance: 81.5 ft. Grade: 0
Condition: Tap Factory Made
Remarks: N/A

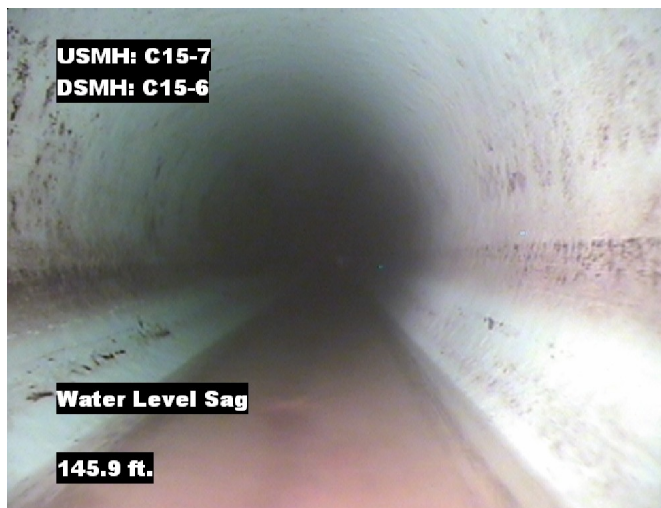
Distance: 145.9 ft. Grade: 2
Condition: Water Level Sag
Remarks: N/A

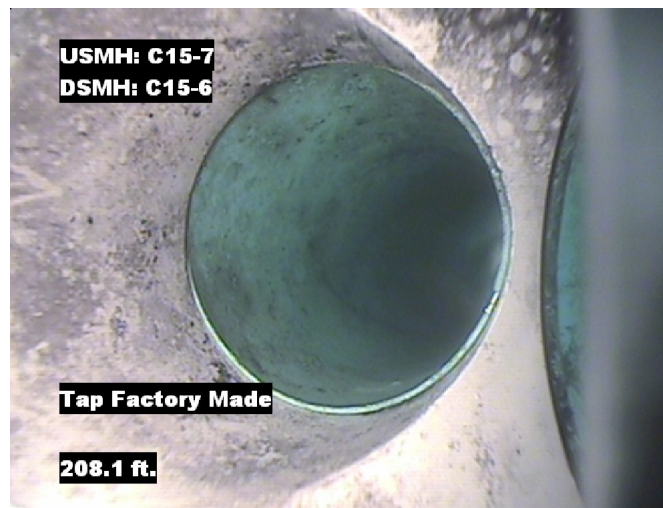
Distance: 208.1 ft. Grade: 0
Condition: Tap Factory Made
Remarks: N/A

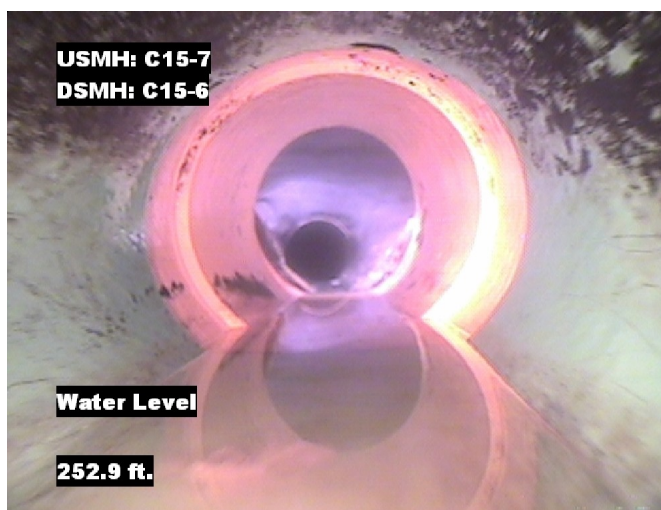
Distance: 252.6 ft. Grade: 0
Condition: Water Level
Remarks: N/A

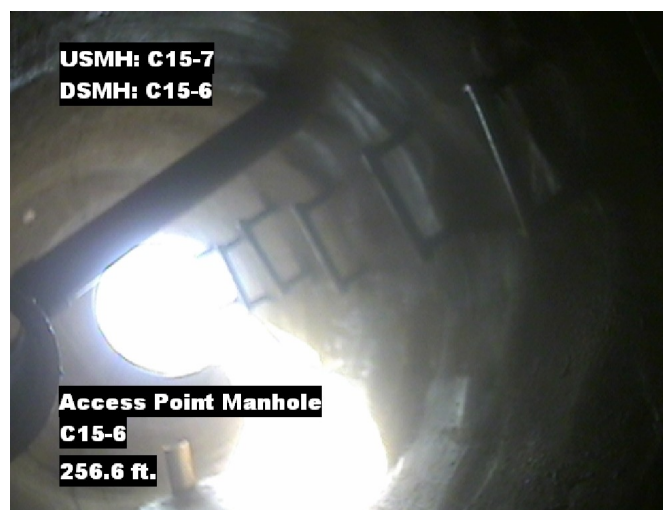
Distance: 256.6 ft. Grade: 0
Condition: Access Point Manhole
Remarks: C15-6
