Defect Listing

Pipe Segment Refere... C16-1_C-25	City Oliver Springs	Street Foxwood Cir	Material Concrete Pipe (non-...	Location C... Yard	Sewer Use Sanitary
Upstream MH C16-1	Total Length 134.3	Year Laid	Shape Circular	Location Details	
DS Manhole C-25	Length surveyed 134.3	Year Renewed	Height 8	Width 8	Pipe Joint... 4

Image Report 4/Page

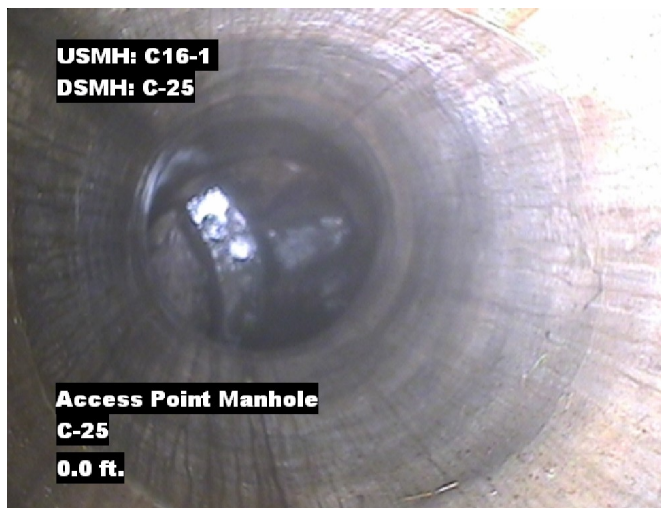
Distance: 0.0 ft. Grade: 0
Condition: Access Point Manhole
Remarks: C-25

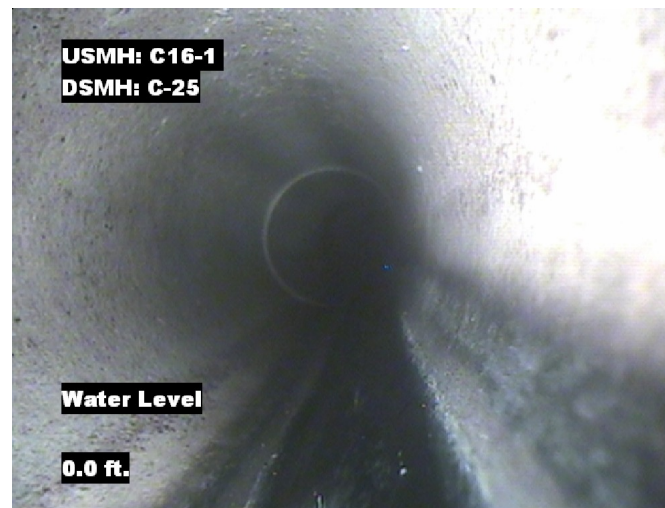
Distance: 0.0 ft. Grade: 0
Condition: Water Level
Remarks: N/A

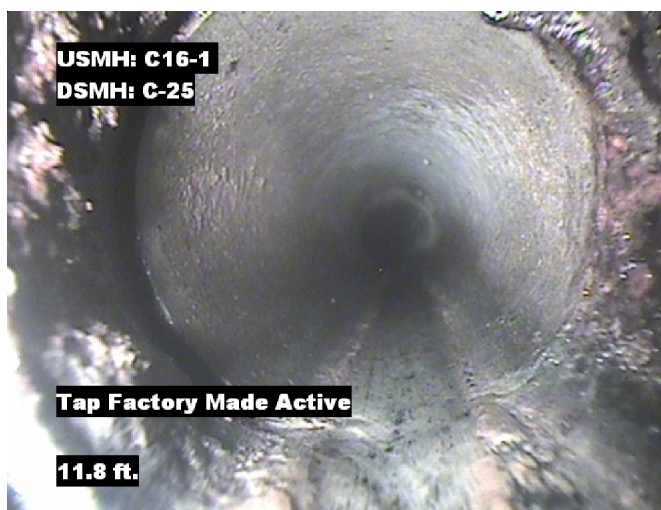
Distance: 11.8 ft. Grade: 0
Condition: Tap Factory Made Active
Remarks: N/A

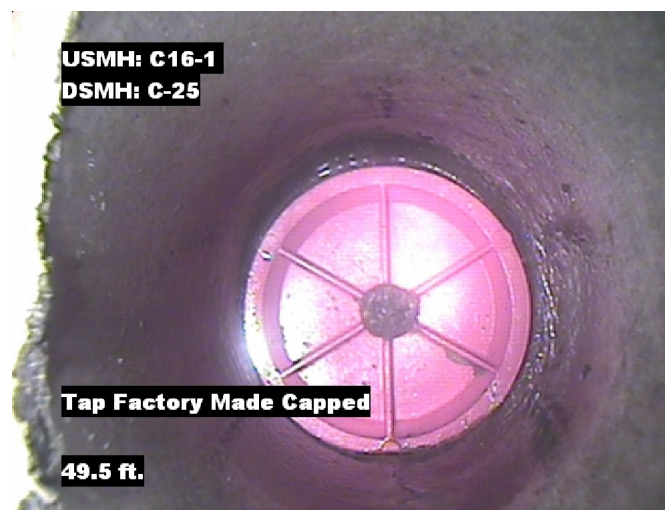
Distance: 49.5 ft. Grade: 0
Condition: Tap Factory Made Capped
Remarks: N/A

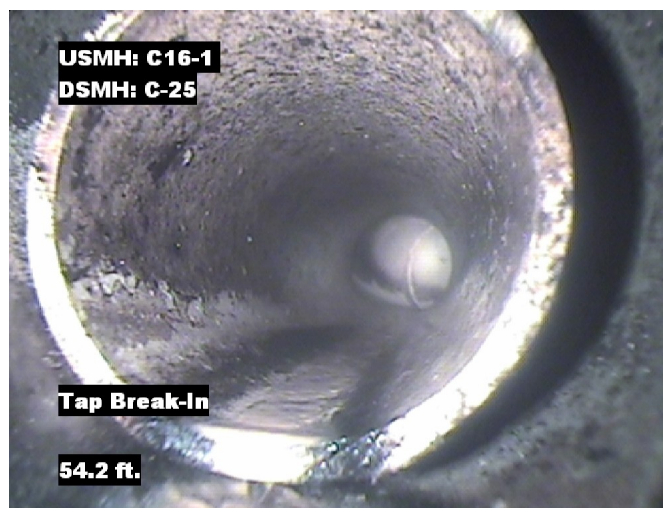
Distance: 54.2 ft. Grade: 0
Condition: Tap Break-In
Remarks: N/A

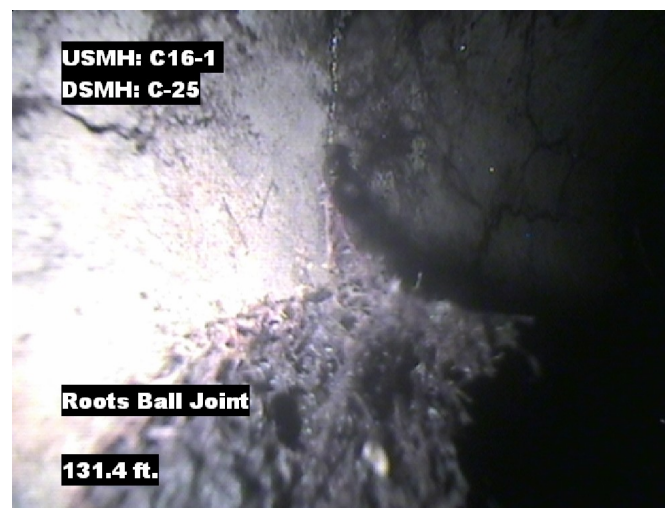
Distance: 131.4 ft. Grade: 4
Condition: Roots Ball Joint
Remarks: N/A

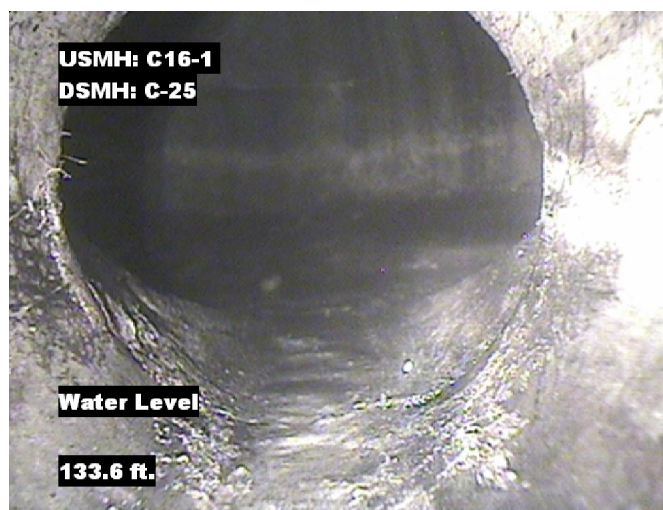
Distance: 133.6 ft. Grade: 0
Condition: Water Level
Remarks: N/A

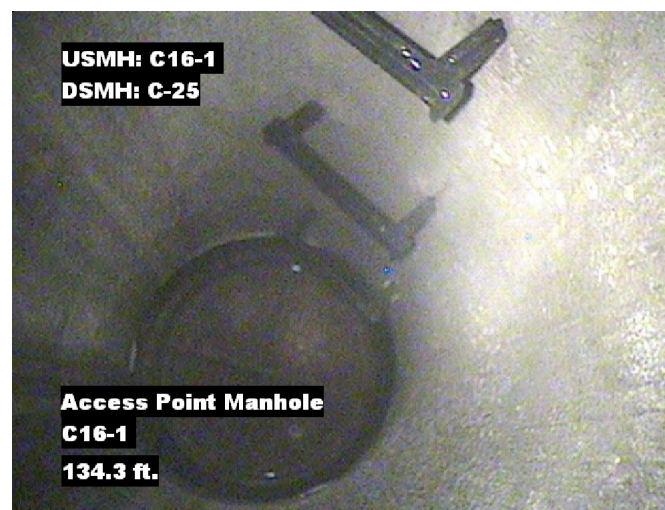
Distance: 134.3 ft. Grade: 0
Condition: Access Point Manhole
Remarks: C16-1
