## Defect Listing

Pipe Segment Refere... <b>C17-1_C-26</b>	City <b>Oliver Springs</b>	Street <b>Foxwood Cir</b>	Material <b>Concrete Pipe (non-...</b>	Location C... <b>Easement/R...</b>	Sewer Use <b>Sanitary</b>
Upstream MH <b>C17-1</b>	Total Length <b>67.5</b>	Year Laid	Shape <b>Circular</b>	Location Details	
DS Manhole <b>C-26</b>	Length surveyed <b>67.5</b>	Year Renewed	Height <b>8</b>	Width <b>8</b>	Pipe Joint... <b>4</b>

SPR <b>N/A</b>	MPR <b>3</b>	PO Number <b>4397-03</b>	Customer <b>GRW</b>
SPRI <b>N/A</b>	MPRI <b>1.5</b>	Work Order <b>4397-02</b>	Purpose <b>Pre-Rehabilitation Survey</b>
QSR <b>N/A</b>	QMR <b>2111</b>		
OPR <b>3</b>	Surveyed By <b>Barry Rogers</b>	Direction <b>Upstream</b>	Date <b>20150713</b>
OPRI <b>1.5</b>	Certificate Number <b>U-1012-16405</b>	Pre-Cleaning <b>Jetting</b>	Time <b>08:24</b>
	Date Cleaned <b>20150713</b>	End Time <b>08:33</b>	Weather <b>Damp</b>
			Media label
			Additional Info

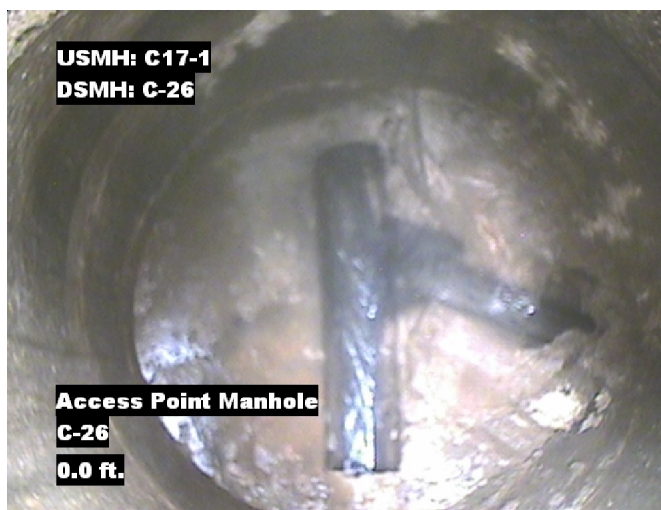
Distance: 0.0 ft. Grade: 0  
Condition: Access Point Manhole  
Remarks: C-26

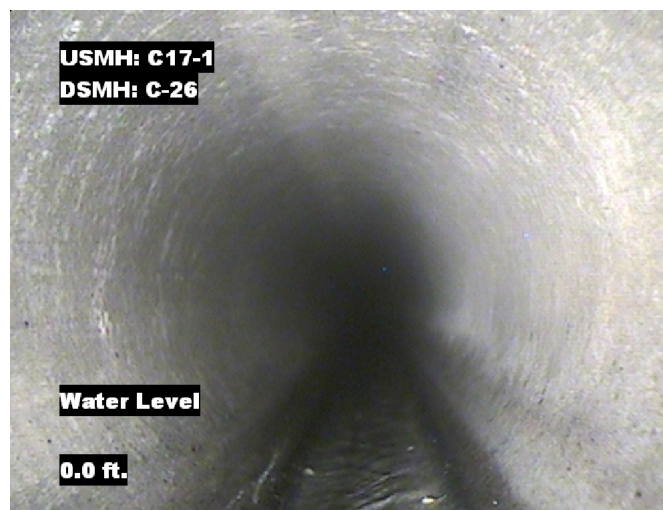
Distance: 0.0 ft. Grade: 0  
Condition: Water Level  
Remarks: N/A

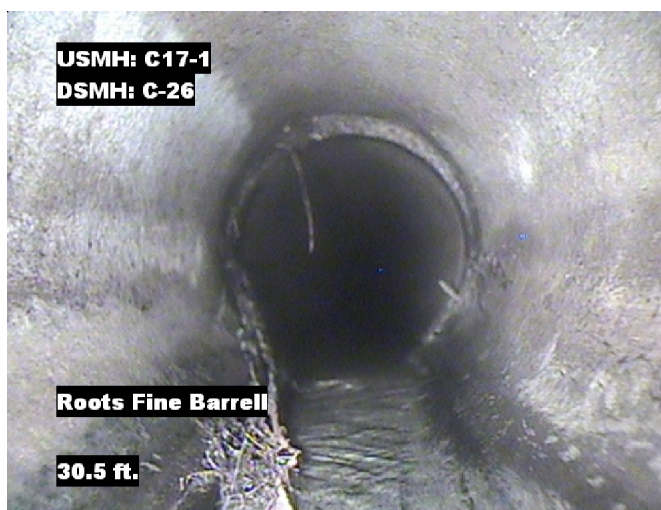
Distance: 30.5 ft. Grade: 2  
Condition: Roots Fine Barrell  
Remarks: N/A

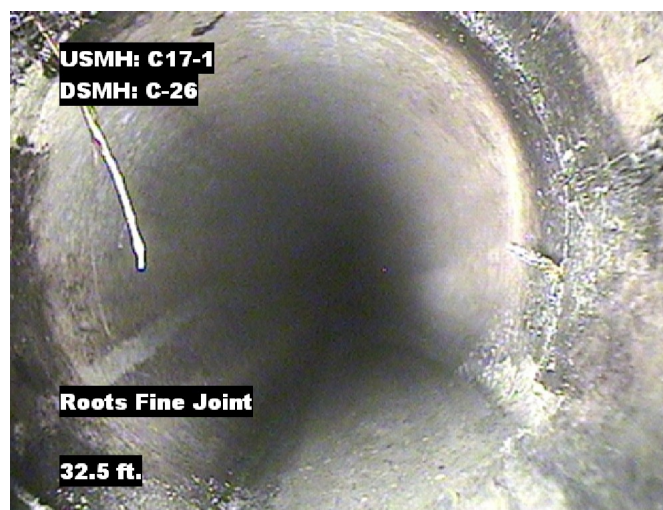
Distance: 32.5 ft. Grade: 1  
Condition: Roots Fine Joint  
Remarks: N/A

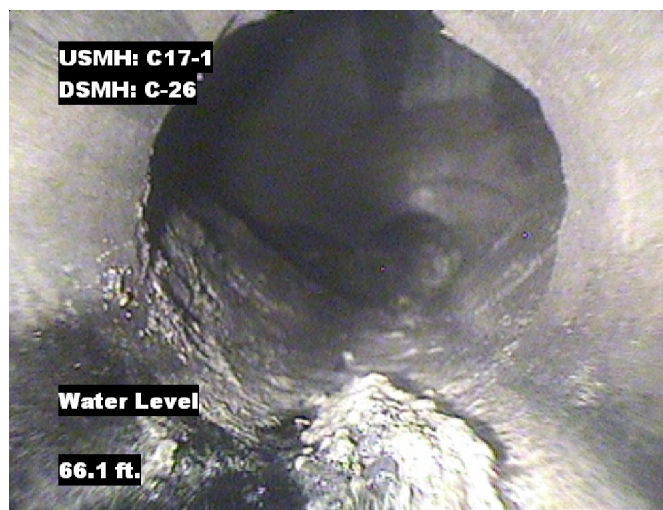
Distance: 65.8 ft.      Grade: 0  
Condition: Water Level  
Remarks: N/A

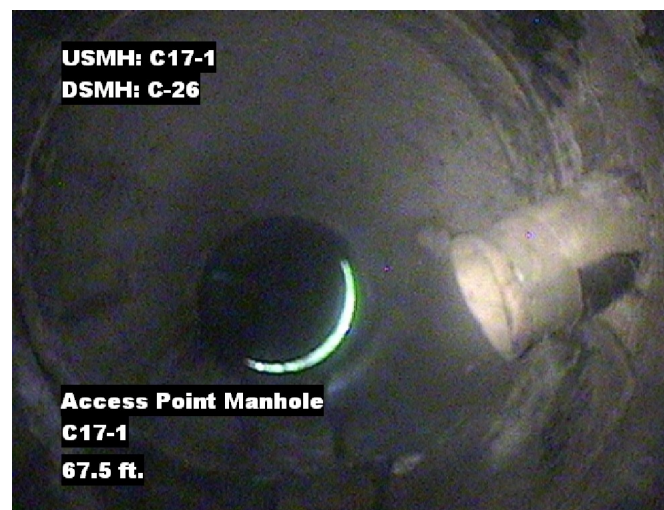
Distance: 67.5 ft.      Grade: 0  
Condition: Access Point Manhole  
Remarks: C17-1
