Defect Listing

Pipe Segment Refere... C17-2_C17-1	City Oliver Springs	Street Park Lane	Material Fibreglass Reinf...	Location C... Easement/R...	Sewer Use Sanitary
Upstream MH C17-2	Total Length 223.7	Year Laid	Shape Circular	Location Details	
DS Manhole C17-1	Length surveyed 223.7	Year Renewed	Height 8	Width 8	Pipe Joint... N/A

SPR N/A	MPR N/A	PO Number 4397-03	Customer GRW
SPRI N/A	MPRI N/A	Work Order 4397-02	Purpose Pre-Rehabilitation Survey
QSR N/A	QMR N/A		
OPR N/A	Surveyed By Barry Rogers	Direction Downstream	Date 20150713
OPRI N/A	Certificate Number U-1012-16405	Pre-Cleaning Jetting	Time 09:30
	Date Cleaned 20150713	End Time 09:45	Weather Damp
			Media label
			Additional Info

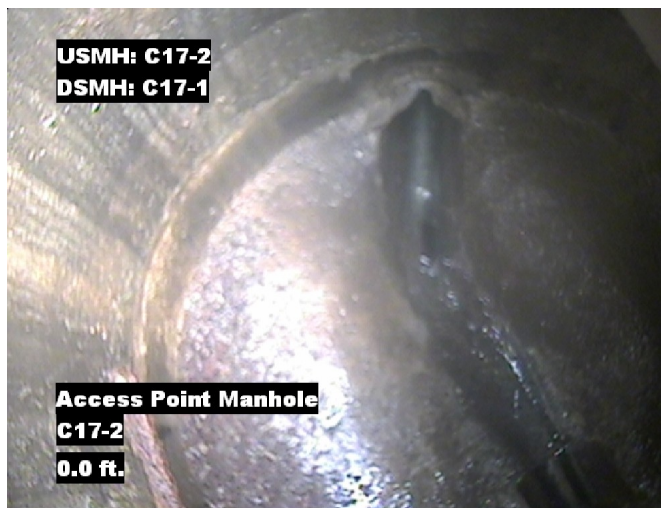
Distance: 0.0 ft. Grade: 0
Condition: Access Point Manhole
Remarks: C17-2

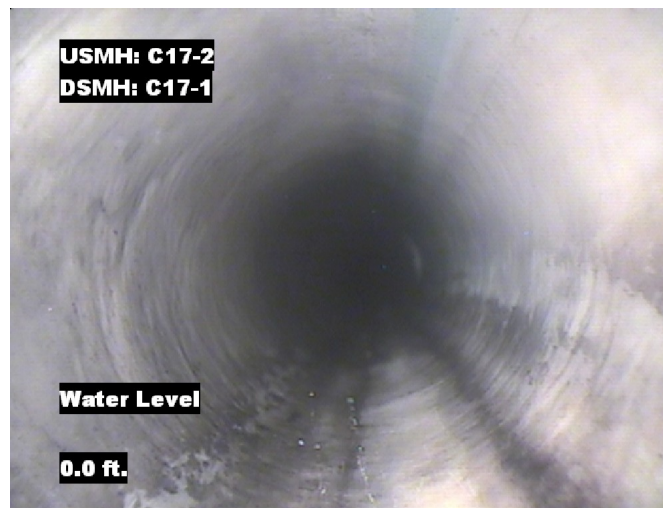
Distance: 0.0 ft. Grade: 0
Condition: Water Level
Remarks: N/A

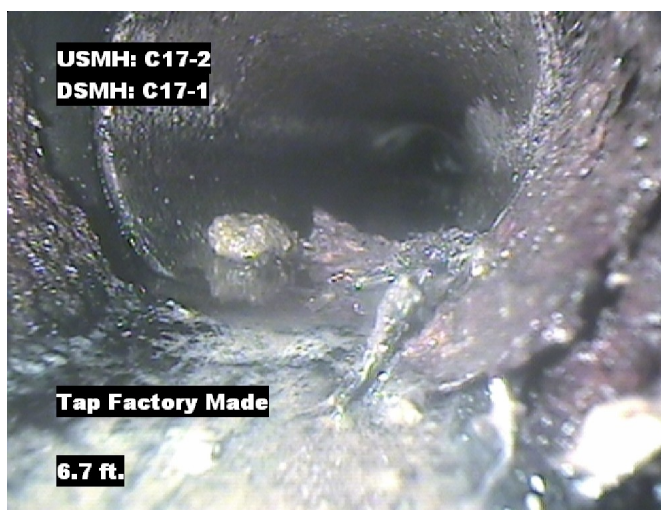
Distance: 6.7 ft. Grade: 0
Condition: Tap Factory Made
Remarks: N/A

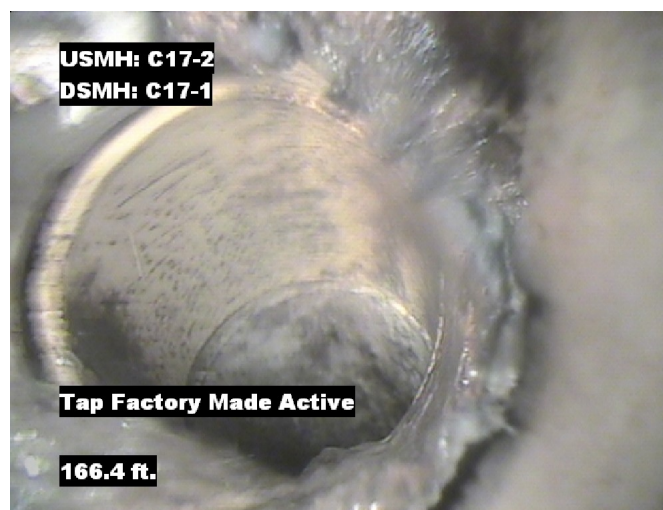
Distance: 166.4 ft. Grade: 0
Condition: Tap Factory Made Active
Remarks: N/A

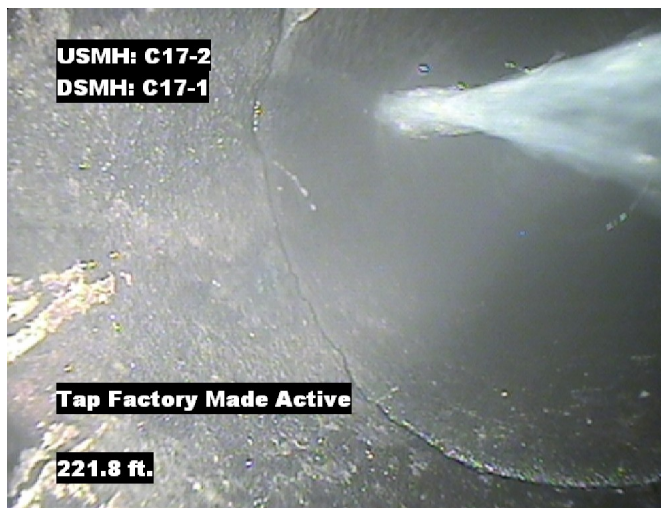
Distance: 221.8 ft. Grade: 0
Condition: Tap Factory Made Active
Remarks: N/A

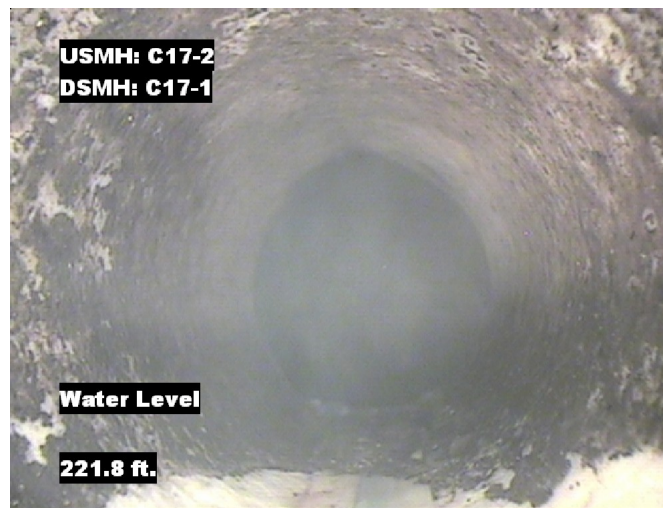
Distance: 221.8 ft. Grade: 0
Condition: Water Level
Remarks: N/A

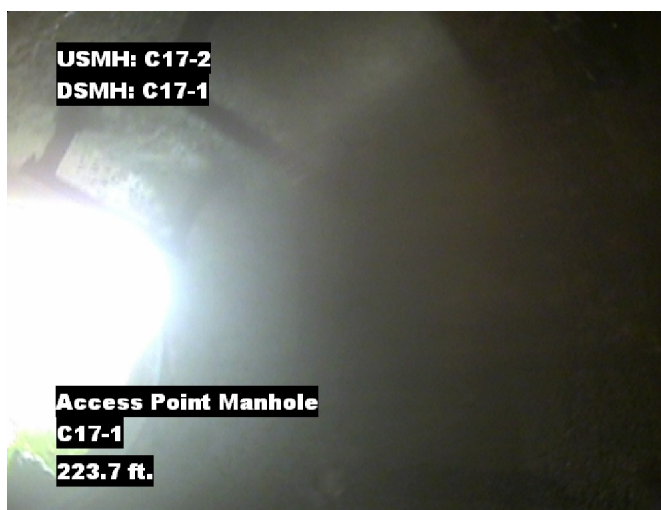
Distance: 223.7 ft. Grade: 0
Condition: Access Point Manhole
Remarks: C17-1
