## Defect Listing

Pipe Segment Refere... <b>C17-3_C17-2</b>	City <b>Oliver Springs</b>	Street <b>Park Lane</b>	Material <b>Concrete Pipe (non-...</b>	Location C... <b>Light High...</b>	Sewer Use <b>Sanitary</b>
Upstream MH <b>C17-3</b>	Total Length <b>356.3</b>	Year Laid	Shape <b>Circular</b>	Location Details	
DS Manhole <b>C17-2</b>	Length surveyed <b>356.3</b>	Year Renewed	Height <b>8</b>	Width <b>8</b>	Pipe Joint... <b>4</b>

SPR <b>N/A</b>	MPR <b>N/A</b>	PO Number <b>4397-03</b>	Customer <b>GRW</b>
SPRI <b>N/A</b>	MPRI <b>N/A</b>	Work Order <b>4397-02</b>	Purpose <b>Pre-Rehabilitation Survey</b>
QSR <b>N/A</b>	QMR <b>N/A</b>		
OPR <b>N/A</b>	Surveyed By <b>Barry Rogers</b>	Direction <b>Downstream</b>	Date <b>20150710</b>
OPRI <b>N/A</b>	Certificate Number <b>U-1012-16405</b>	Pre-Cleaning <b>Jetting</b>	Time <b>14:38</b>
	Date Cleaned <b>20150710</b>	End Time <b>14:58</b>	Weather <b>Dry</b>
			Additional Info

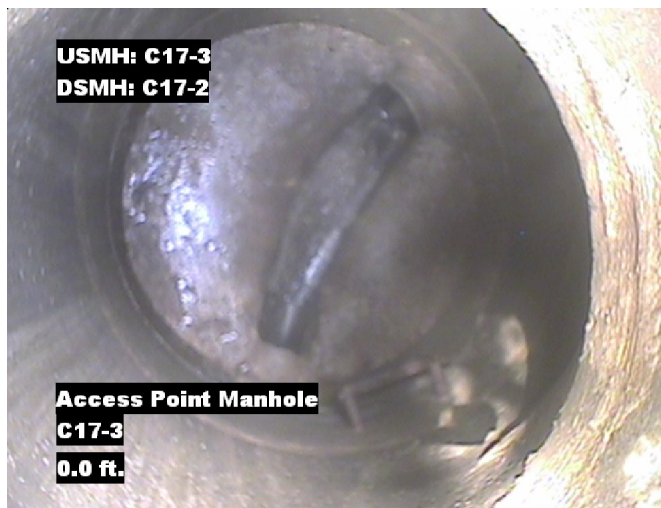
Distance: 0.0 ft. Grade: 0  
Condition: Access Point Manhole  
Remarks: C17-3

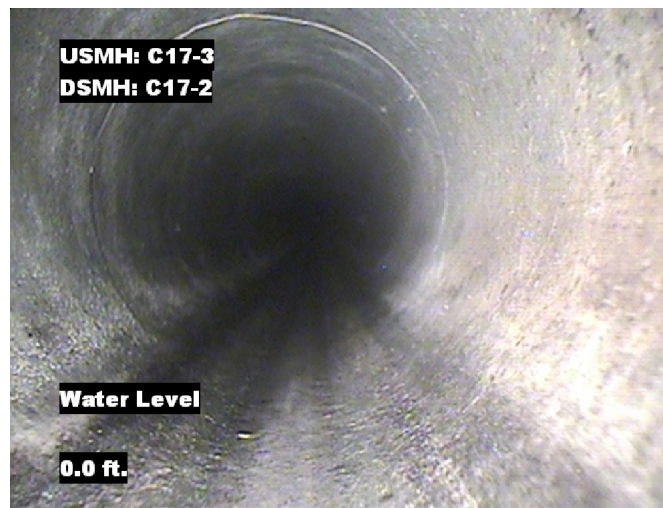
Distance: 0.0 ft. Grade: 0  
Condition: Water Level  
Remarks: N/A

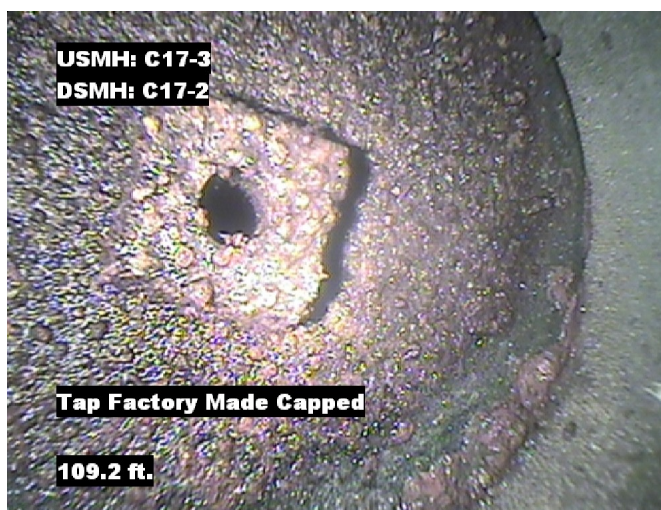
Distance: 109.2 ft. Grade: 0  
Condition: Tap Factory Made Capped  
Remarks: N/A

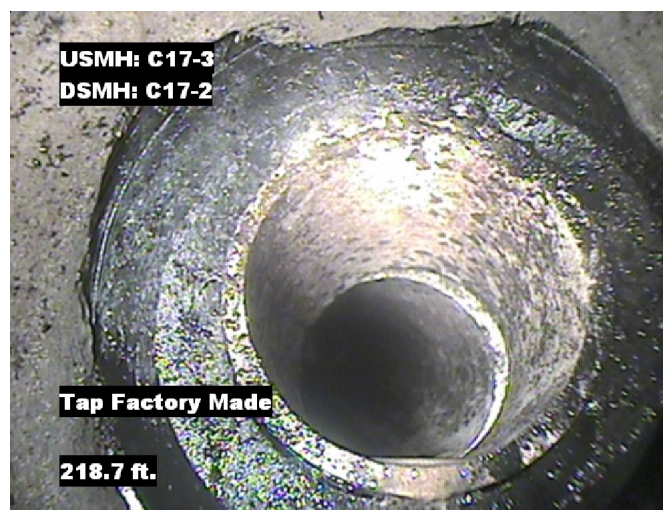
Distance: 218.7 ft. Grade: 0  
Condition: Tap Factory Made  
Remarks: N/A

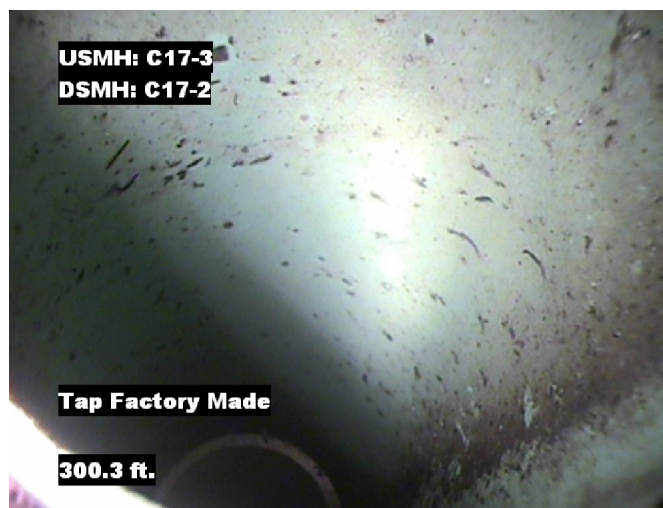
Distance: 300.3 ft. Grade: 0  
Condition: Tap Factory Made  
Remarks: N/A

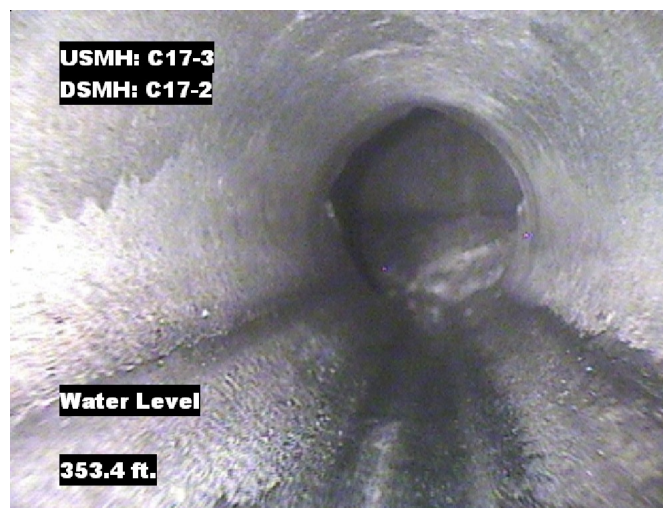
Distance: 353.4 ft. Grade: 0  
Condition: Water Level  
Remarks: N/A

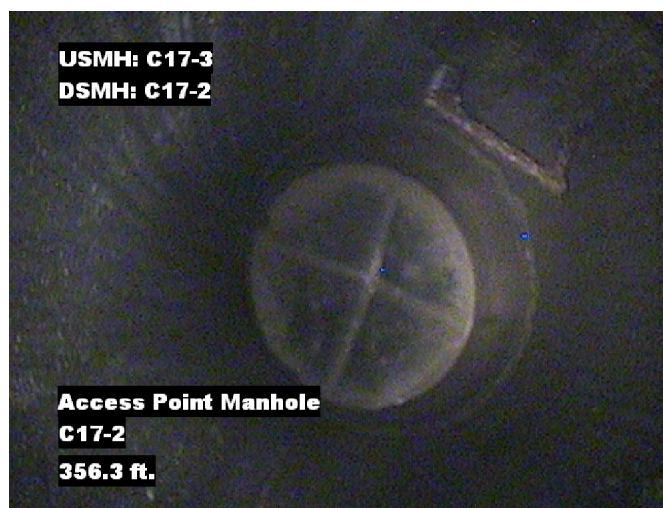
Distance: 356.3 ft. Grade: 0  
Condition: Access Point Manhole  
Remarks: C17-2
