Defect Listing

Pipe Segment Refere... C18-1_C-29	City Oliver Springs	Street Richards Dr	Material Concrete Pipe (non-...	Location C... Light High...	Sewer Use Sanitary
Upstream MH C18-1	Total Length 215.4	Year Laid	Shape Circular	Location Details	
DS Manhole C-29	Length surveyed 215.4	Year Renewed	Height 8	Width 8	Pipe Joint... 4

SPR 1	MPR N/A	PO Number 4397-03	Customer GRW
SPRI 1	MPRI N/A	Work Order 4397-02	Purpose Pre-Rehabilitation Survey
QSR 1100	QMR N/A		
OPR 1	Surveyed By Barry Rogers	Direction Upstream	Date 20150710
OPRI 1	Certificate Number U-1012-16405	Pre-Cleaning Jetting	Time 10:31
	Date Cleaned 20150710	End Time 10:40	Weather Dry
			Media label
			Additional Info

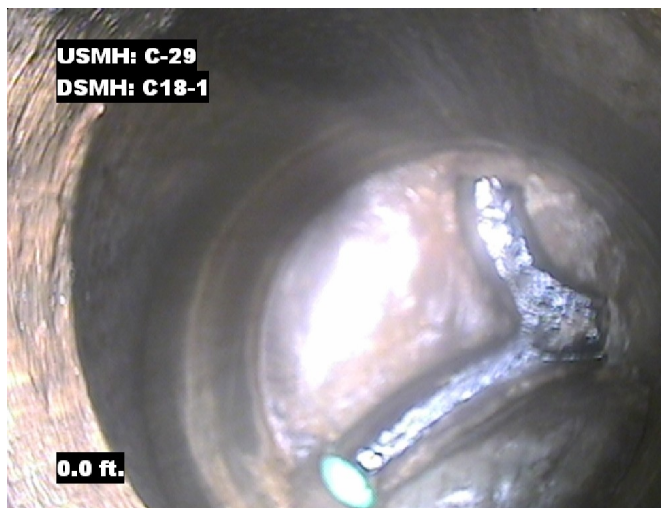
Distance: 0.0 ft. Grade: 0
Condition: Access Point Manhole
Remarks: C18-1

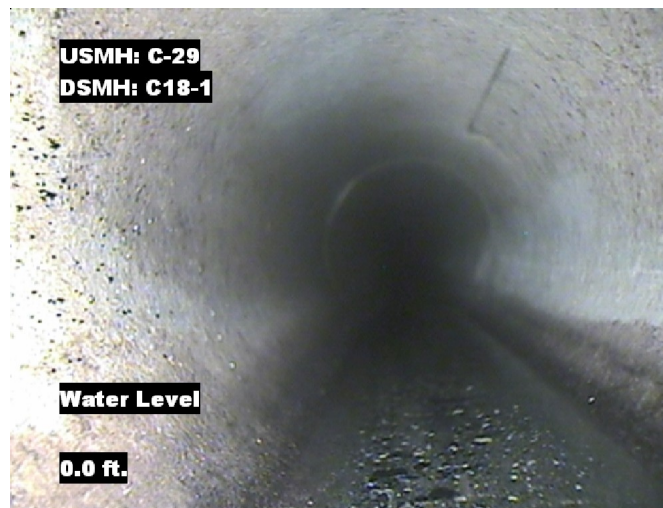
Distance: 0.0 ft. Grade: 0
Condition: Water Level
Remarks: N/A

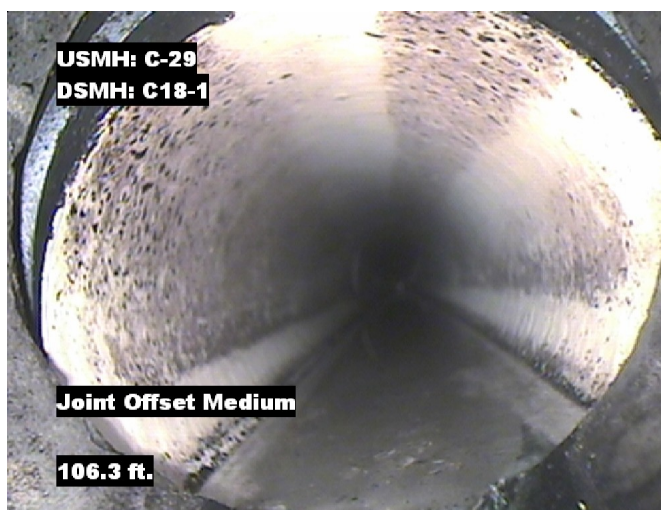
Distance: 106.3 ft. Grade: 1
Condition: Joint Offset Medium
Remarks: N/A

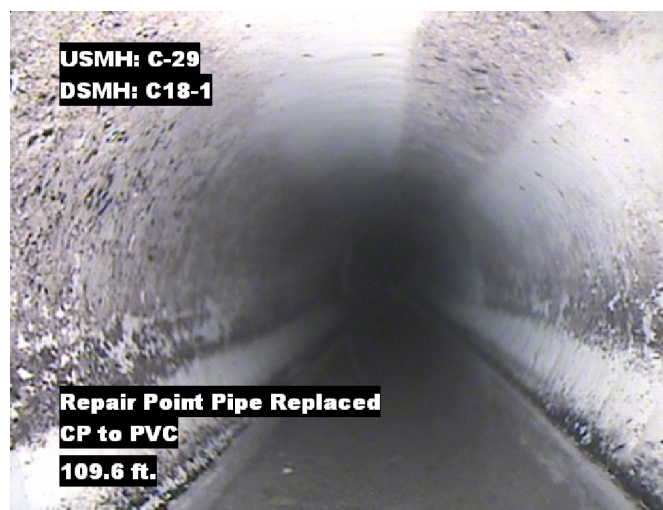
Distance: 109.6 ft. Grade: 0
Condition: Repair Point Pipe Replaced
Remarks: CP to PVC

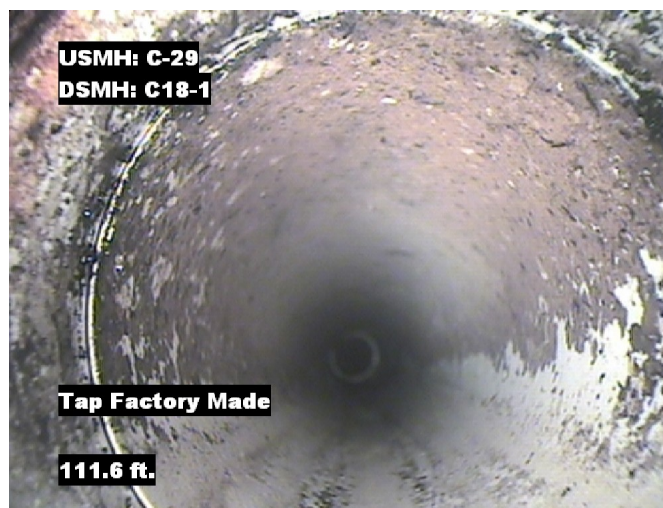
Distance: 111.6 ft. Grade: 0
Condition: Tap Factory Made
Remarks: N/A

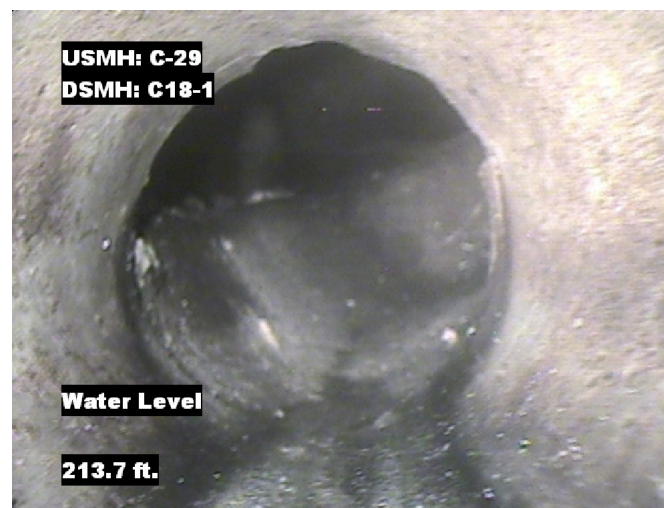
Distance: 213.7 ft. Grade: 0
Condition: Water Level
Remarks: N/A

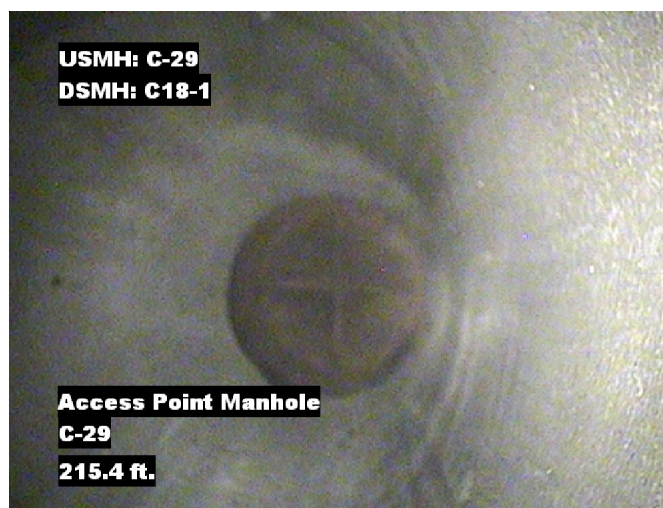
Distance: 215.4 ft. Grade: 0
Condition: Access Point Manhole
Remarks: C-28
