## Defect Listing

Pipe Segment Refere... <b>C2-1_C2-1A</b>	City <b>Oliver Springs</b>	Street <b>Bennett</b>	Material <b>Concrete Pipe (non-...</b>	Location C... <b>Light High...</b>	Sewer Use <b>Sanitary</b>
Upstream MH <b>C2-1</b>	Total Length <b>177.1</b>	Year Laid	Shape <b>Circular</b>	Location Details	
DS Manhole <b>C2-1A</b>	Length surveyed <b>177.1</b>	Year Renewed	Height <b>8</b>	Width <b>8</b>	Pipe Joint... <b>4</b>

SPR <b>N/A</b>	MPR <b>2</b>	PO Number <b>4397-03</b>	Customer <b>GRW</b>
SPRI <b>N/A</b>	MPRI <b>2</b>	Work Order <b>4397-02</b>	Purpose <b>Pre-Rehabilitation Survey</b>
QSR <b>N/A</b>	QMR <b>2100</b>		
OPR <b>2</b>	Surveyed By <b>Barry Rogers</b>	Direction <b>Downstream</b>	Date <b>20150723</b>
OPRI <b>2</b>	Certificate Number <b>U-1012-16405</b>	Pre-Cleaning <b>Jetting</b>	Time <b>10:35</b>
	Date Cleaned <b>20150723</b>	End Time <b>10:42</b>	Weather <b>Heavy Rain</b>
			Media label
			Additional Info

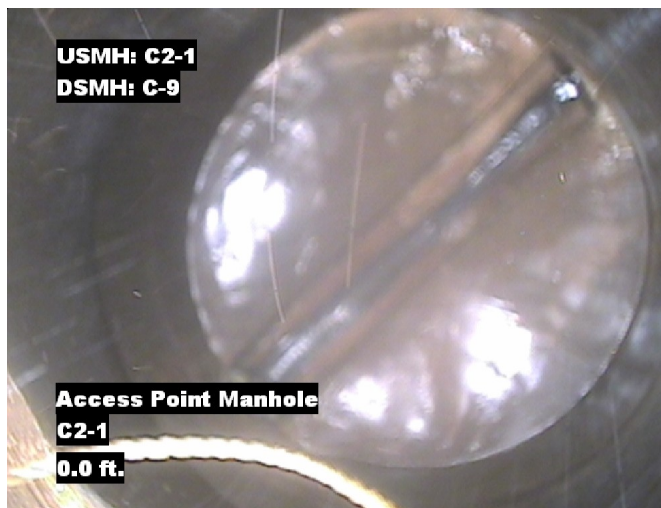
Distance: 0.0 ft. Grade: 0  
Condition: Access Point Manhole  
Remarks: C2-1

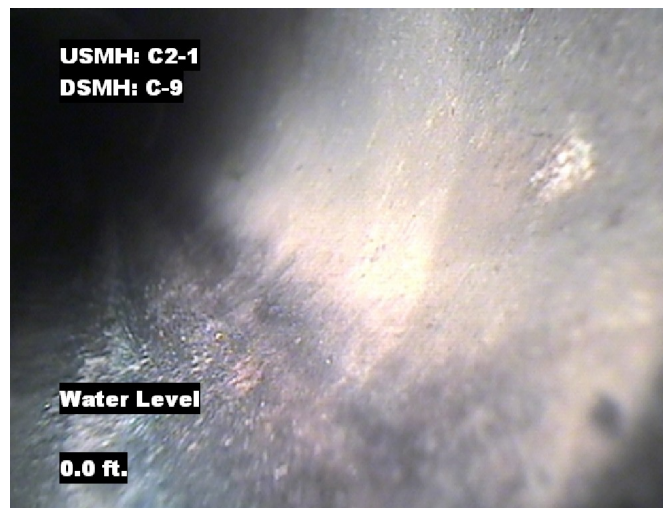
Distance: 0.0 ft. Grade: 0  
Condition: Water Level  
Remarks: N/A

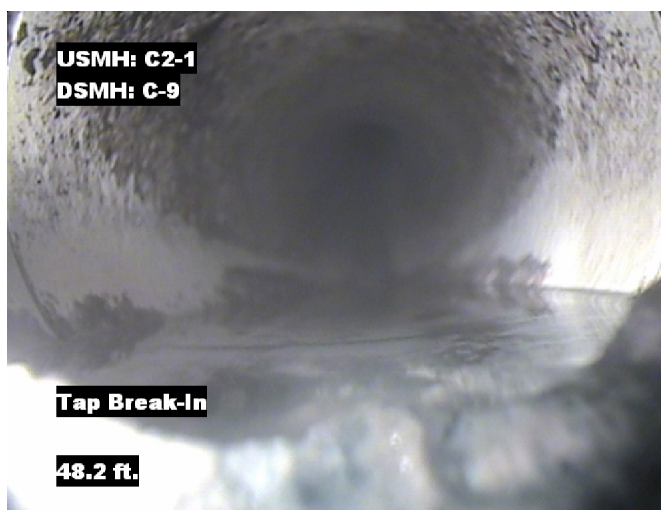
Distance: 48.2 ft. Grade: 0  
Condition: Tap Break-In  
Remarks: N/A

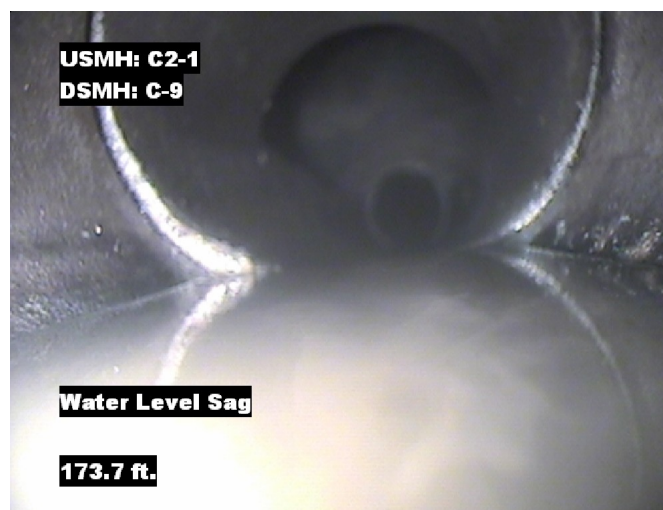
Distance: 173.7 ft. Grade: 2  
Condition: Water Level Sag  
Remarks: N/A

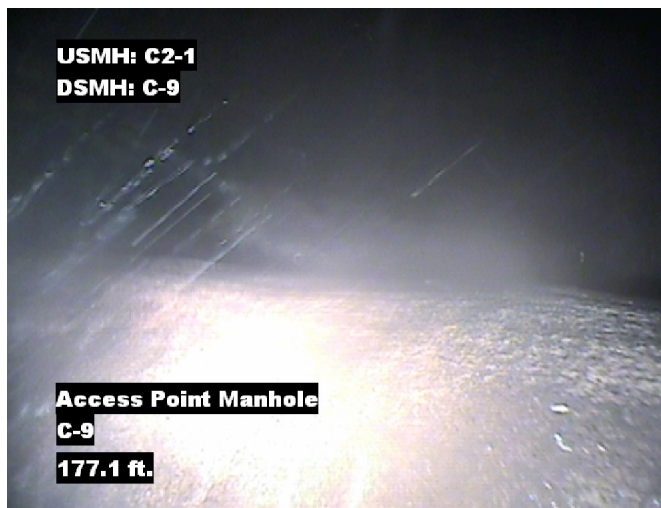
Distance: 177.1 ft. Grade: 0  
Condition: Access Point Manhole  
Remarks: C-9
