Defect Listing

Pipe Segment Refere... C2-1A_C-9	City Oliver Springs	Street Bennett	Material Fibreglass Reinforc...	Location C... Light High...	Sewer Use Sanitary
Upstream MH C2-1A	Total Length 154.7	Year Laid	Shape Circular	Location Details	
DS Manhole C-9	Length surveyed 154.7	Year Renewed	Height 8	Width 8	Pipe Joint... N/A

SPR N/A	MPR 7	PO Number 4397-03	Customer GRW
SPRI N/A	MPRI 3.5	Work Order 4397-02	Purpose Pre-Rehabilitation Survey
QSR N/A	QMR 4131		
OPR 7	Surveyed By Barry Rogers	Direction Downstream	Date 20150723
OPRI 3.5	Certificate Number U-1012-16405	Pre-Cleaning Jetting	Time 10:49
	Date Cleaned 20150723	End Time 10:56	Weather Heavy Rain
			Media label Mh C-9N1 is buried ...

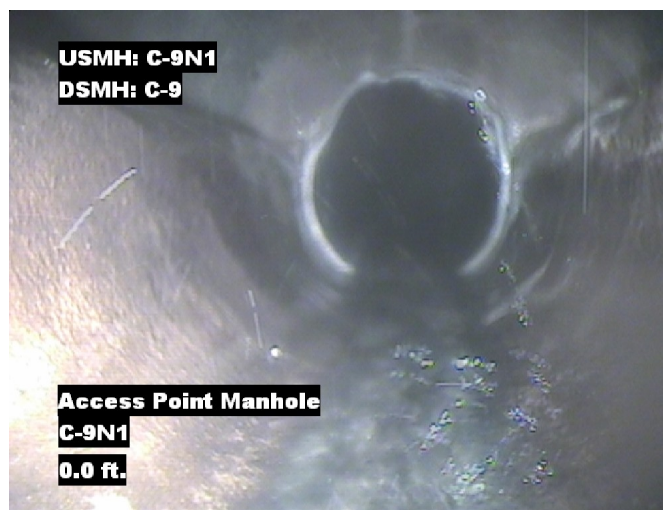
Distance: 0.0 ft. Grade: 0
Condition: Access Point Manhole
Remarks: C-9N1

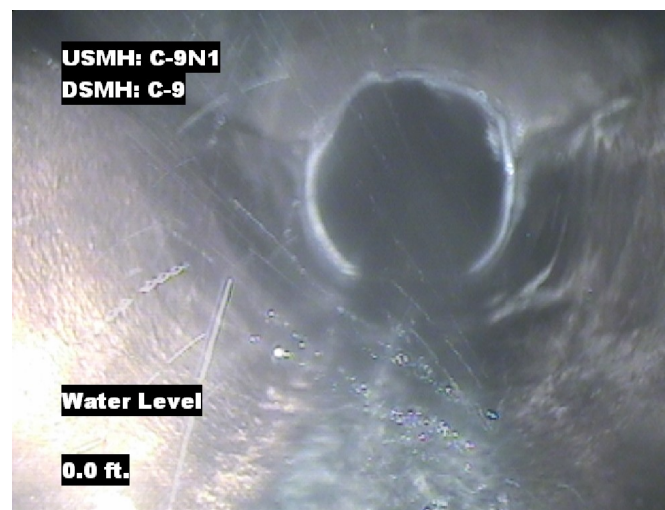
Distance: 0.0 ft. Grade: 0
Condition: Water Level
Remarks: N/A

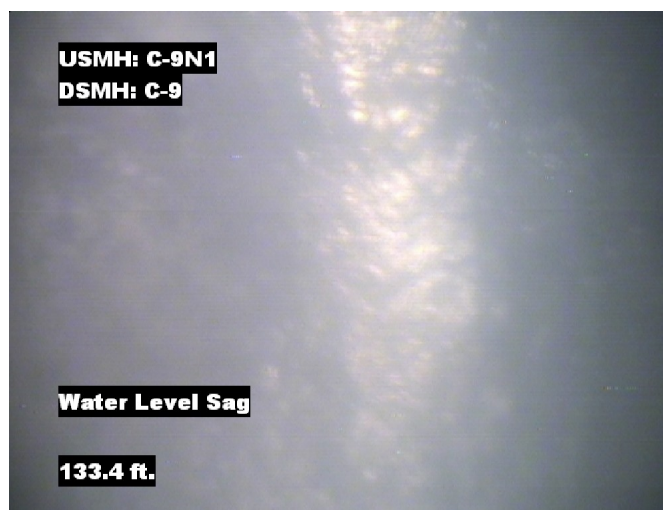
Distance: 133.0 ft. Grade: 3
Condition: Water Level Sag
Remarks: N/A

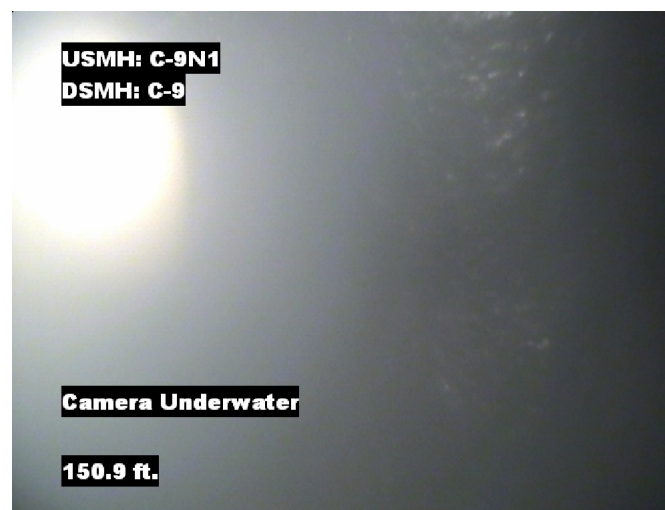
Distance: 151.1 ft. Grade: 4
Condition: Camera Underwater
Remarks: N/A

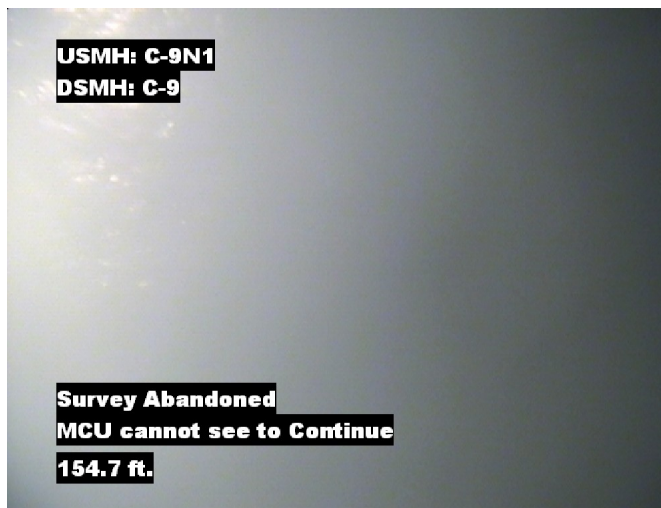
Distance: 154.7 ft. Grade: 0
Condition: Survey Abandoned
Remarks: MCU cannot see to Continue
