Defect Listing

Pipe Segment Refere... C2-2_C2-1	City Oliver Springs	Street Bennett	Material Fibreglass Reinforc...	Location C... Light High...	Sewer Use Sanitary
Upstream MH C2-2	Total Length 235.8	Year Laid	Shape Circular	Location Details	
DS Manhole C2-1	Length surveyed 235.8	Year Renewed	Height 8	Width 8	Pipe Joint... N/A

SPR N/A	MPR N/A	PO Number 4397-03	Customer GRW
SPRI N/A	MPRI N/A	Work Order 4397-02	Purpose Pre-Rehabilitation Survey
QSR N/A	QMR N/A		
OPR N/A	Surveyed By Barry Rogers	Direction Downstream	Date 20150723
OPRI N/A	Certificate Number U-1012-16405	Pre-Cleaning Jetting	Time 10:16
	Date Cleaned 20150723	End Time 10:28	Weather Heavy Rain
			Media label
			Additional Info

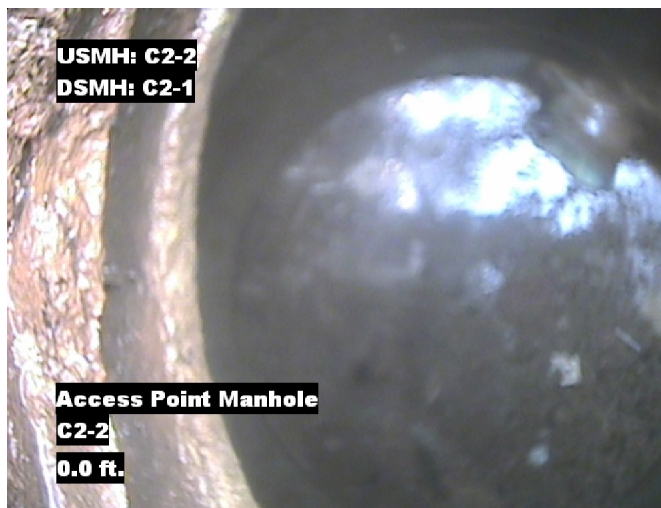
Distance: 0.0 ft. Grade: 0
Condition: Access Point Manhole
Remarks: C2-2

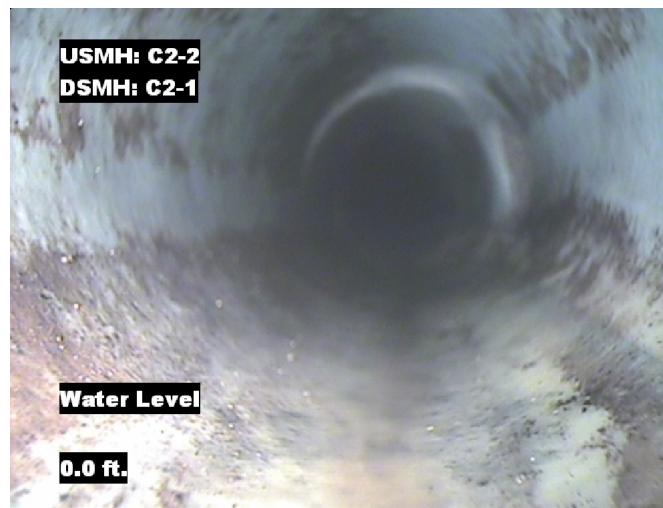
Distance: 0.0 ft. Grade: 0
Condition: Water Level
Remarks: N/A

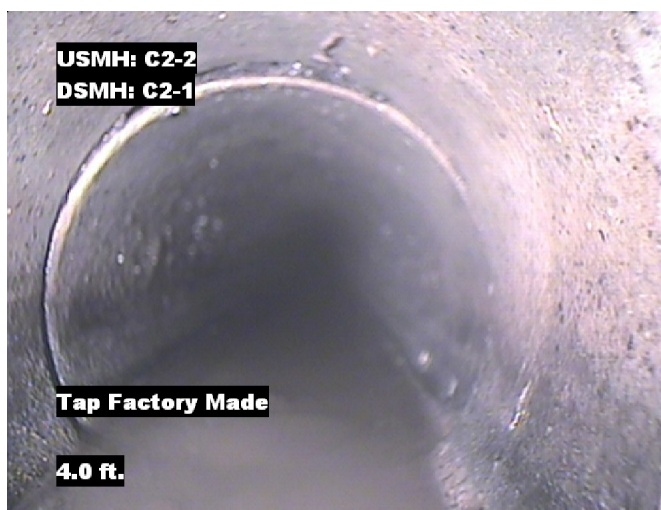
Distance: 4.0 ft. Grade: 0
Condition: Tap Factory Made
Remarks: N/A

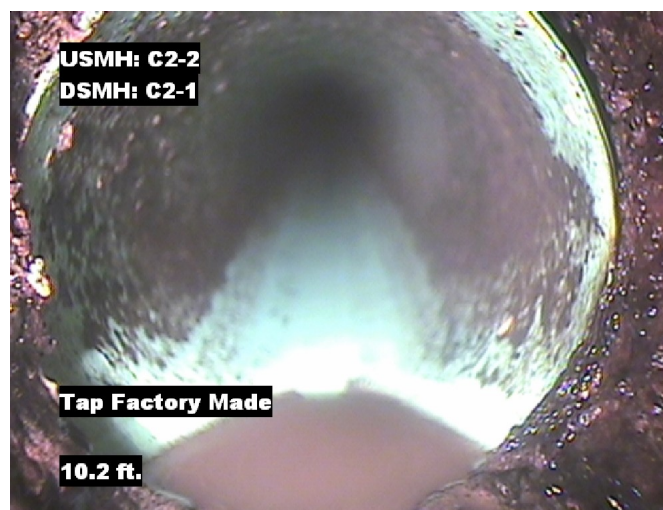
Distance: 10.2 ft. Grade: 0
Condition: Tap Factory Made
Remarks: N/A

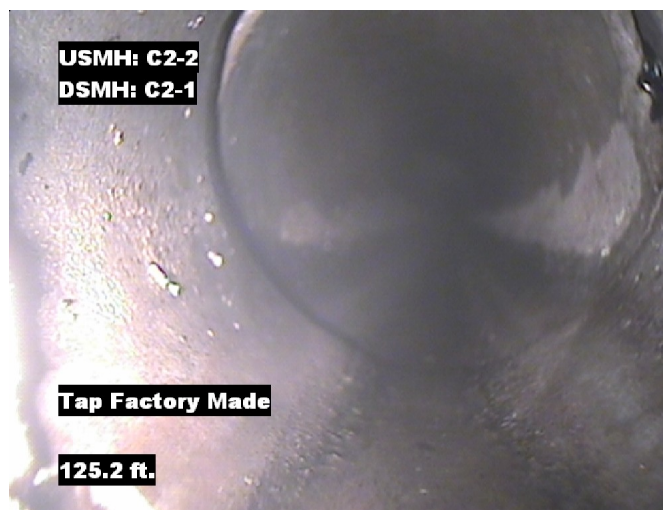
Distance: 125.2 ft. Grade: 0
Condition: Tap Factory Made
Remarks: N/A

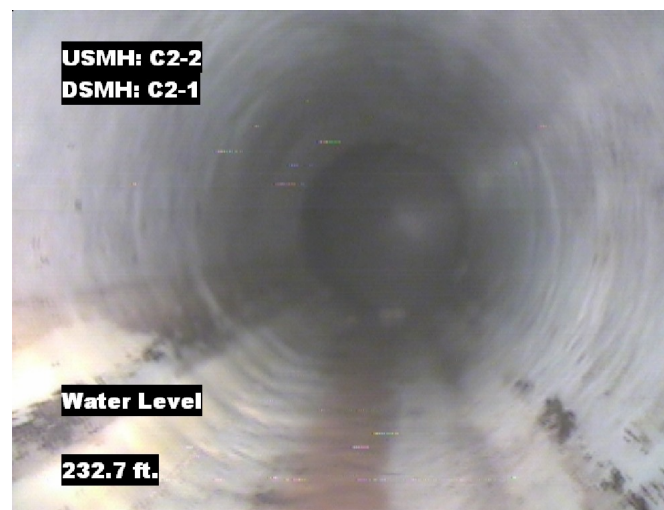
Distance: 232.6 ft. Grade: 0
Condition: Water Level
Remarks: N/A

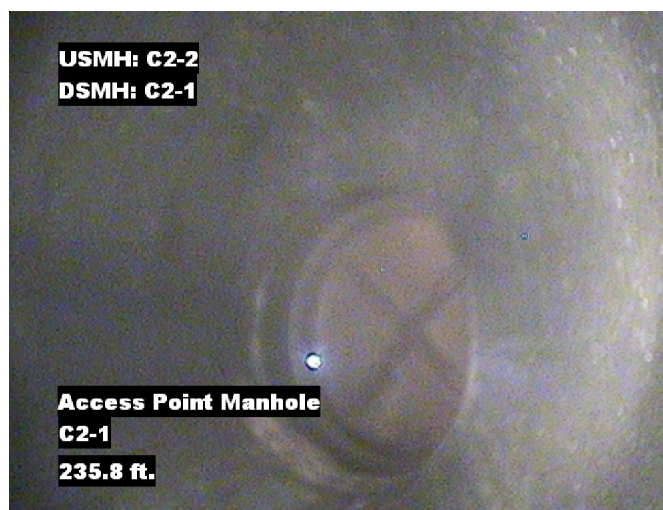
Distance: 235.8 ft. Grade: 0
Condition: Access Point Manhole
Remarks: C2-1
