## Defect Listing

Pipe Segment Refere... <b>C3-1_C-9</b>	City <b>Oliver Springs</b>	Street <b>Heneley Circle</b>	Material <b>Concrete Pipe (non-...</b>	Location C... <b>Light High...</b>	Sewer Use <b>Sanitary</b>
Upstream MH <b>C3-1</b>	Total Length <b>344.4</b>	Year Laid	Shape <b>Circular</b>	Location Details	
DS Manhole <b>C-9</b>	Length surveyed <b>344.4</b>	Year Renewed	Height <b>8</b>	Width <b>8</b>	Pipe Joint... <b>4</b>

SPR <b>N/A</b>	MPR <b>N/A</b>	PO Number <b>4397-03</b>		Customer <b>GRW</b>	
SPRI <b>N/A</b>	MPRI <b>N/A</b>	Work Order <b>4397-02</b>		Purpose <b>Pre-Rehabilitation Survey</b>	
QSR <b>N/A</b>	QMR <b>N/A</b>				
OPR <b>N/A</b>	Surveyed By <b>Barry Rogers</b>	Direction <b>Downstream</b>	Date <b>20150723</b>	Media label	
OPRI <b>N/A</b>	Certificate Number <b>U-1012-16405</b>	Pre-Cleaning <b>Jetting</b>	Time <b>08:57</b>	Weather <b>Saturated</b>	
Date Cleaned <b>20150723</b>			End Time <b>09:10</b>	Additional Info

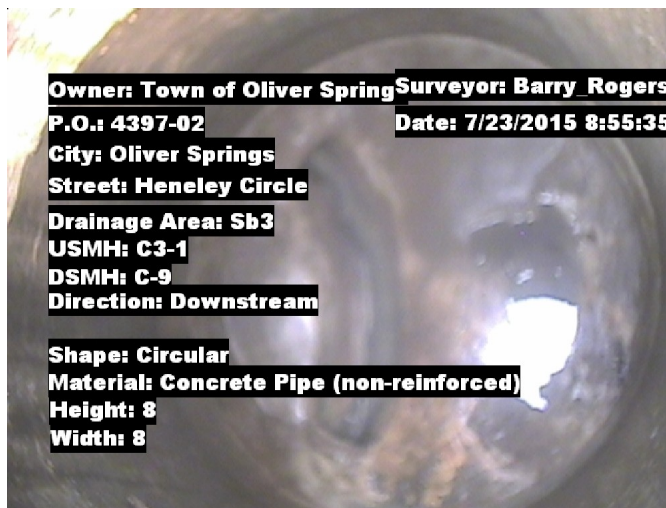
Distance: 0.0 ft. Grade: 0  
Condition: Access Point Manhole  
Remarks: C3-1

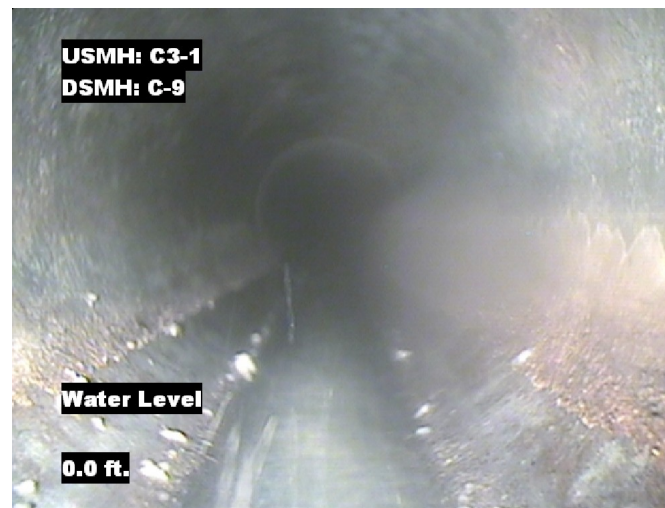
Distance: 0.0 ft. Grade: 0  
Condition: Water Level  
Remarks: N/A

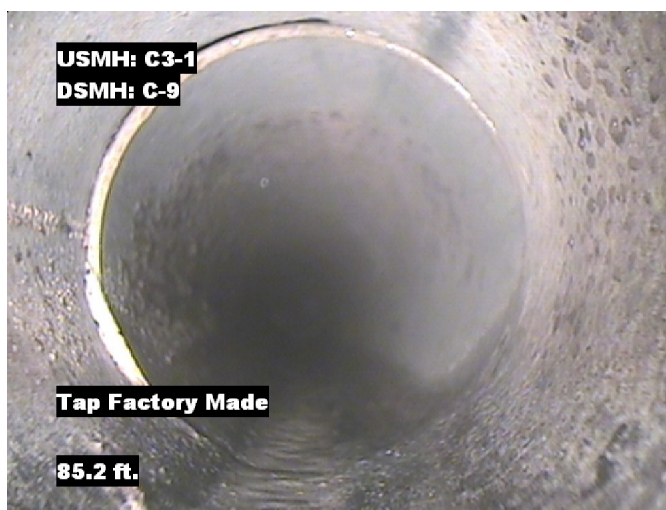
Distance: 85.2 ft. Grade: 0  
Condition: Tap Factory Made  
Remarks: N/A

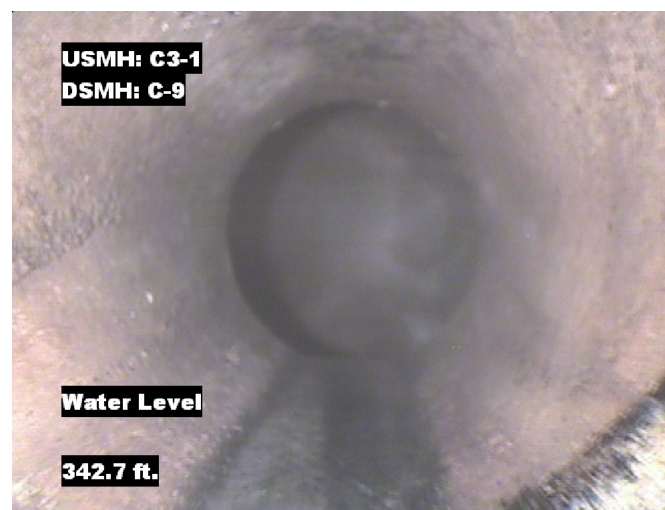
Distance: 342.6 ft. Grade: 0  
Condition: Water Level  
Remarks: N/A

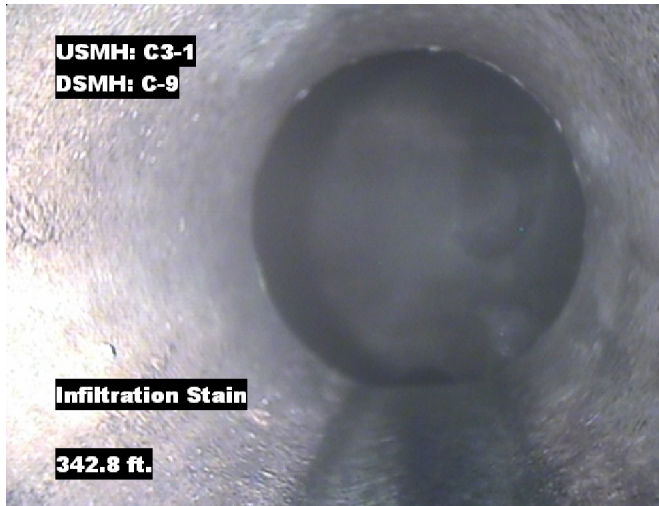
Distance: 342.8 ft. Grade: 0  
Condition: Infiltration Stain  
Remarks: N/A

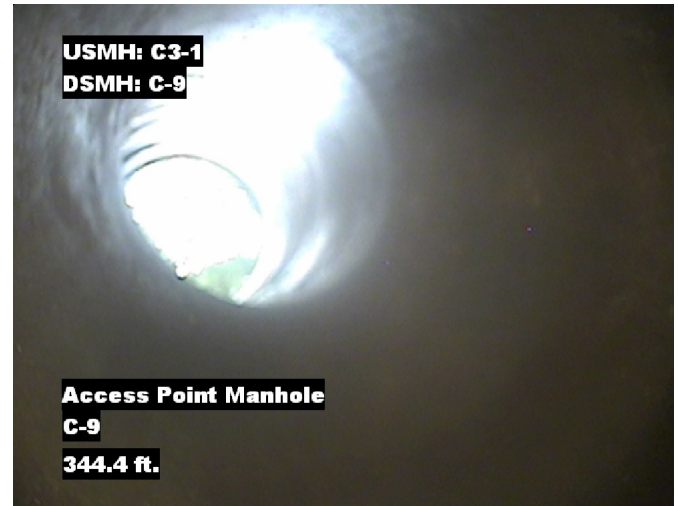
Distance: 344.4 ft. Grade: 0  
Condition: Access Point Manhole  
Remarks: C-9
