Defect Listing

Pipe Segment Refere...	City	Street	Material	Location C...	Sewer Use
C3-2_C3-1	Oliver Springs	Henley Circle	Concrete Pipe (non-...	Light High...	Sanitary
Upstream MH	Total Length	Year Laid	Shape	Location Details	
C3-2	142.6		Circular		
DS Manhole	Length surveyed	Year Renewed	Height	Width	Pipe Joint...
C3-1	142.6		8	8	4

Image Report 4/Page

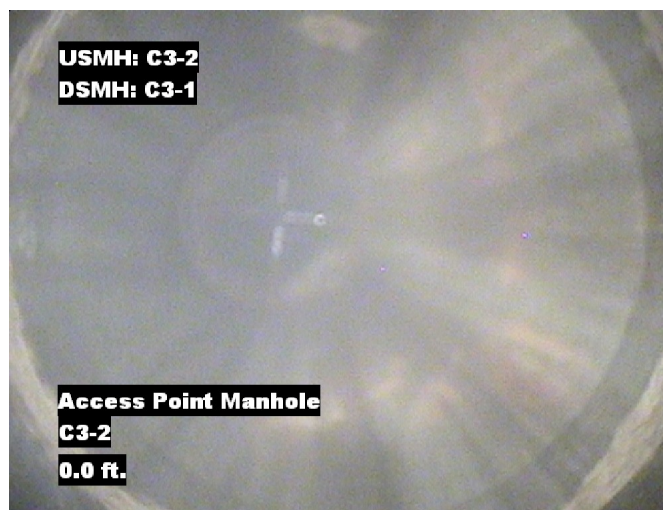
Distance: 0.0 ft. Grade: 0
Condition: Access Point Manhole
Remarks: C3-2

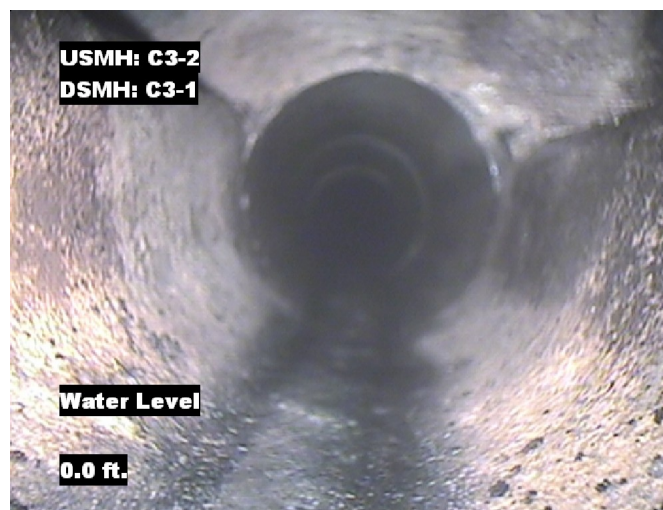
Distance: 0.0 ft. Grade: 0
Condition: Water Level
Remarks: N/A

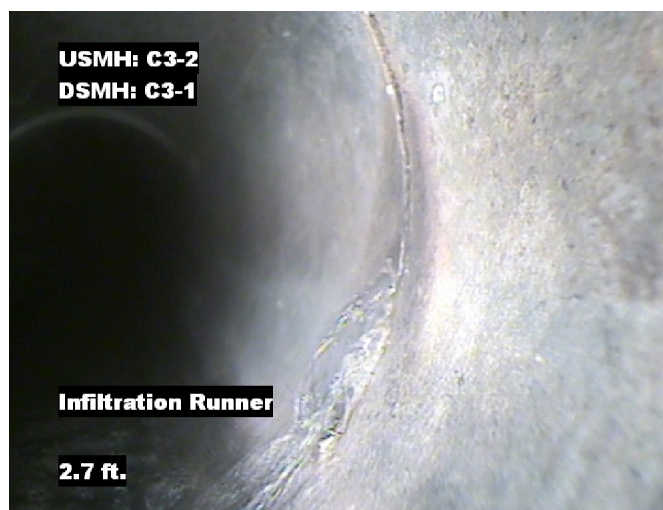
Distance: 2.7 ft. Grade: 4
Condition: Infiltration Runner
Remarks: N/A

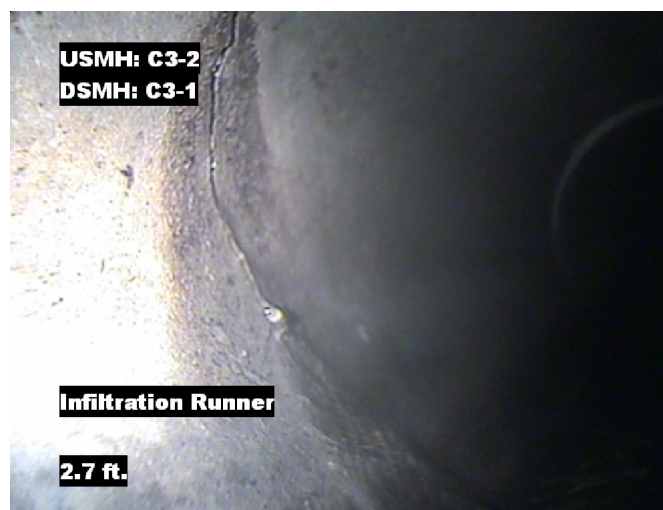
Distance: 2.7 ft. Grade: 4
Condition: Infiltration Runner
Remarks: N/A

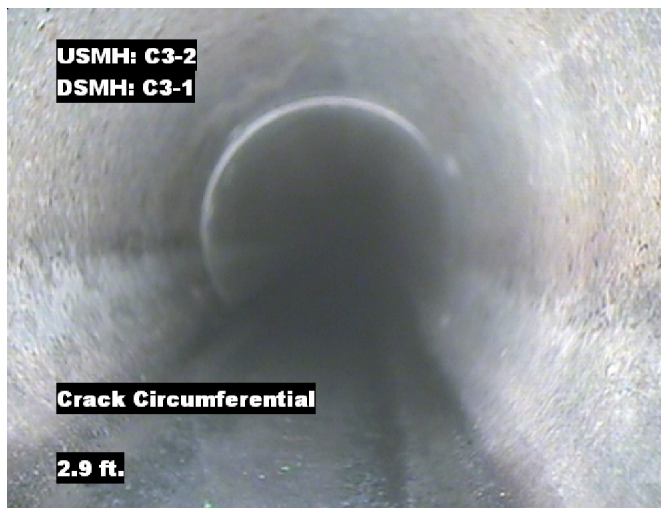
Distance: 2.9 ft. Grade: 1
Condition: Crack Circumferential
Remarks: N/A

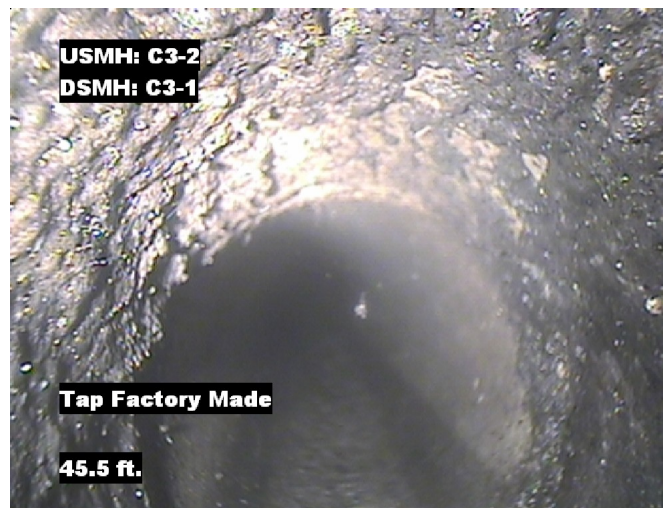
Distance: 45.5 ft. Grade: 0
Condition: Tap Factory Made
Remarks: N/A

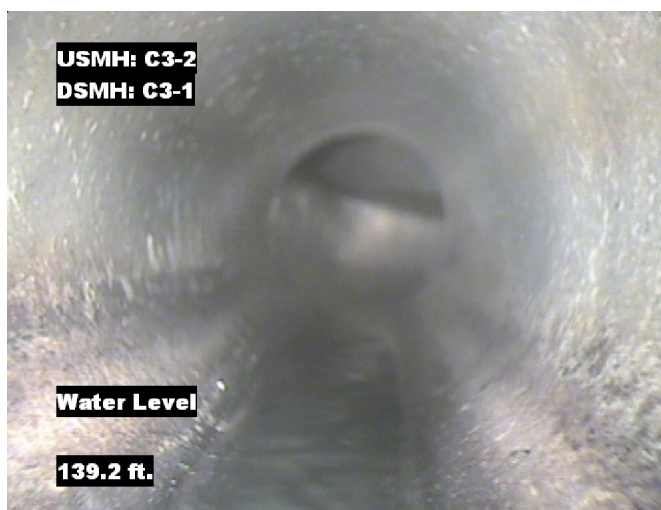
Distance: 139.2 ft. Grade: 0
Condition: Water Level
Remarks: N/A

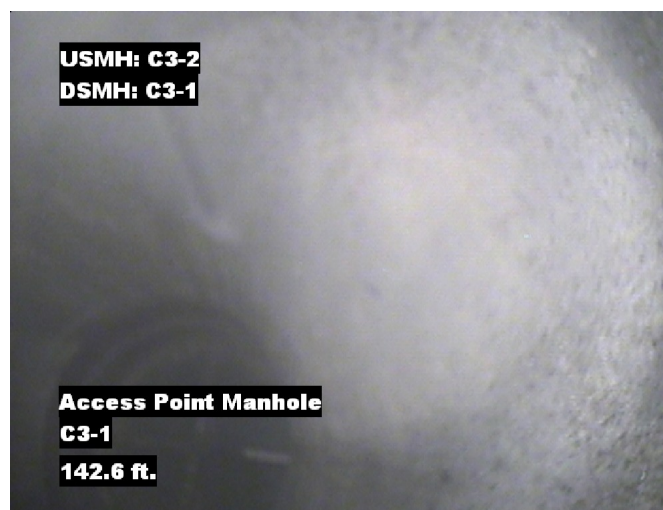
Distance: 142.6 ft. Grade: 0
Condition: Access Point Manhole
Remarks: C3-1
