Defect Listing

Pipe Segment Refere... C3-3_C3-2	City Oliver Springs	Street Henley Circle	Material Fibreglass Reinforc...	Location C... Light High...	Sewer Use Sanitary
Upstream MH C3-3	Total Length 227.9	Year Laid	Shape Circular	Location Details	
DS Manhole C3-2	Length surveyed 227.9	Year Renewed	Height 8	Width 8	Pipe Joint... N/A

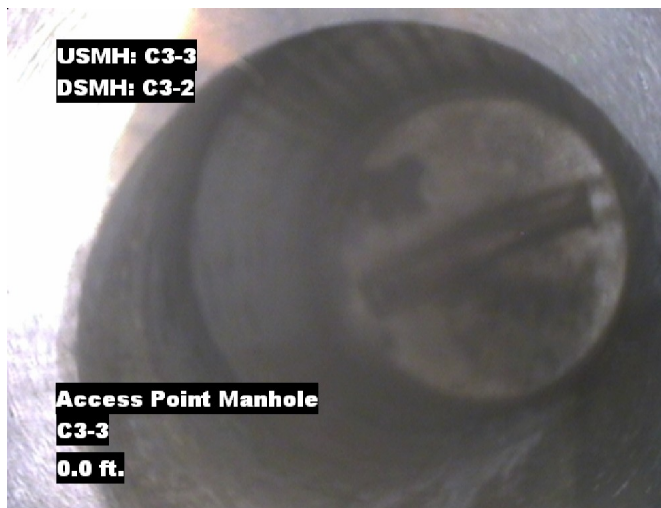
Distance: 0.0 ft. Grade: 0
Condition: Access Point Manhole
Remarks: C3-3

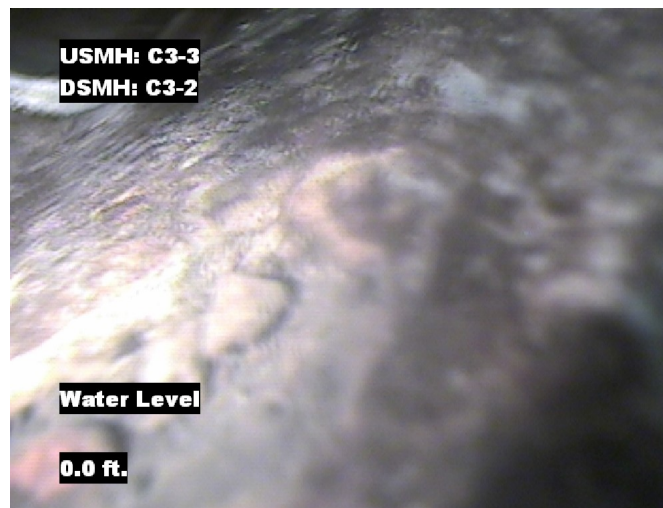
Distance: 0.0 ft. Grade: 0
Condition: Water Level
Remarks: N/A

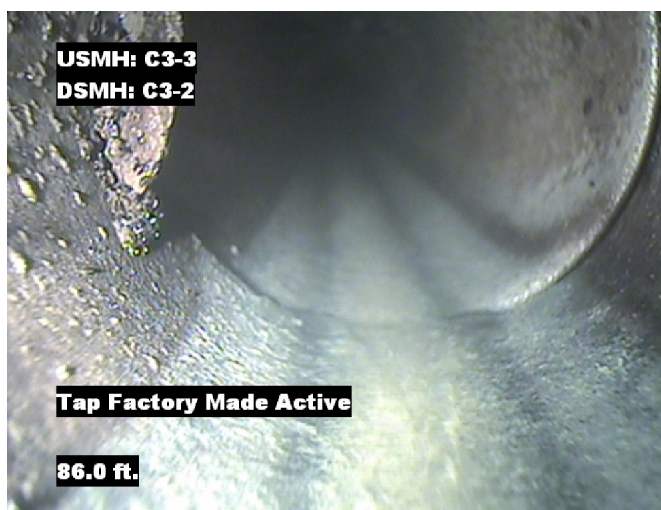
Distance: 86.0 ft. Grade: 0
Condition: Tap Factory Made Active
Remarks: N/A

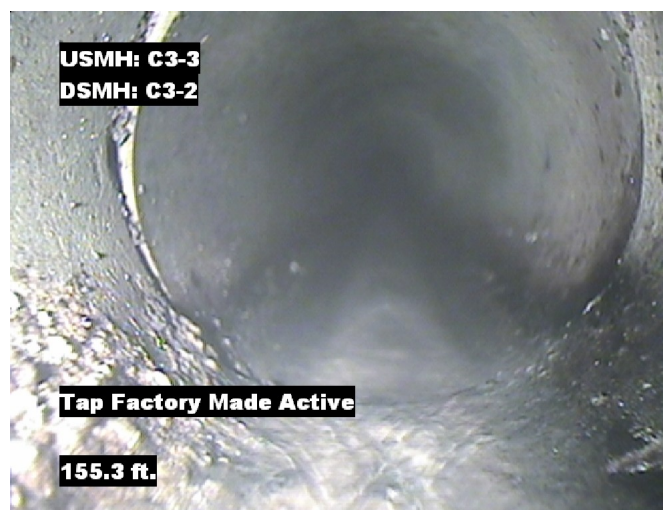
Distance: 155.3 ft. Grade: 0
Condition: Tap Factory Made Active
Remarks: N/A

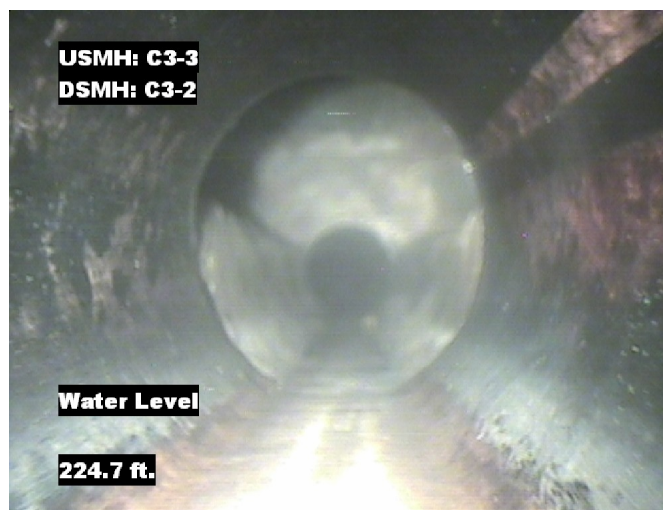
Distance: 224.6 ft. Grade: 0
Condition: Water Level
Remarks: N/A

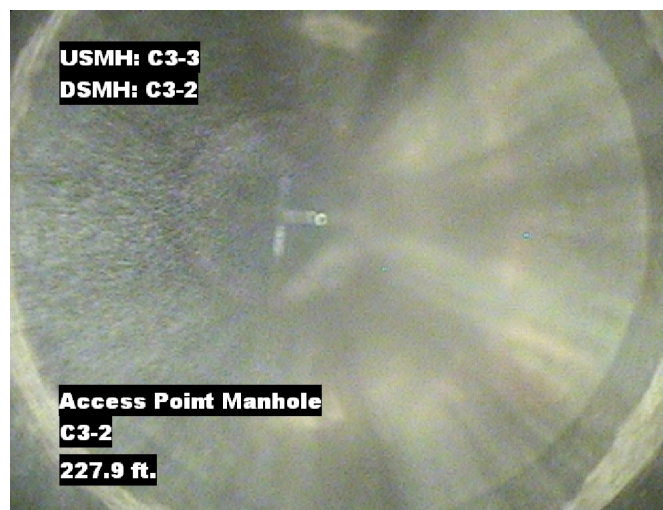
Distance: 227.9 ft. Grade: 0
Condition: Access Point Manhole
Remarks: C3-2
