## Defect Listing

Pipe Segment Refere... <b>C4-3_C4-2</b>	City <b>Oliver Springs</b>	Street <b>Shoopman Ln</b>	Material <b>Concrete Pipe (non-...</b>	Location C... <b>Light High...</b>	Sewer Use <b>Sanitary</b>
Upstream MH <b>C4-3</b>	Total Length <b>165.7</b>	Year Laid	Shape <b>Circular</b>	Location Details	
DS Manhole <b>C4-2</b>	Length surveyed <b>165.7</b>	Year Renewed	Height <b>8</b>	Width <b>8</b>	Pipe Joint... <b>4</b>

## Image Report 4/Page

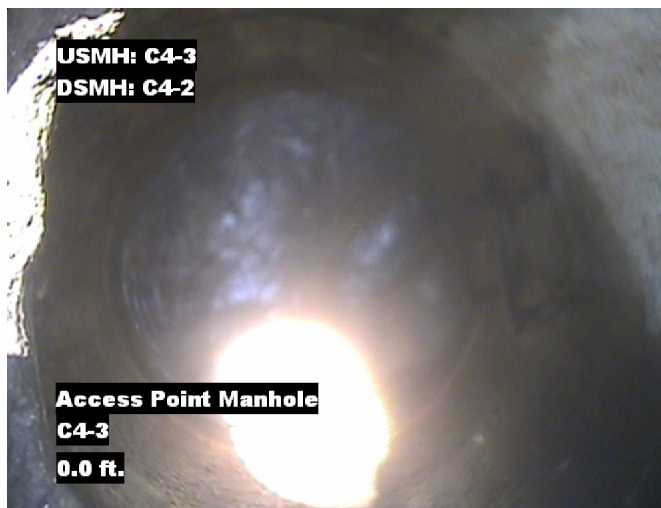
Distance: 0.0 ft. Grade: 0  
Condition: Access Point Manhole  
Remarks: C4-3

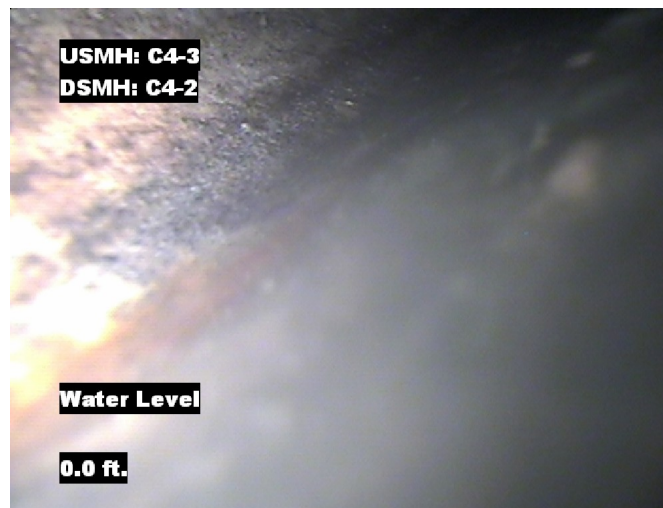
Distance: 0.0 ft. Grade: 0  
Condition: Water Level  
Remarks: N/A

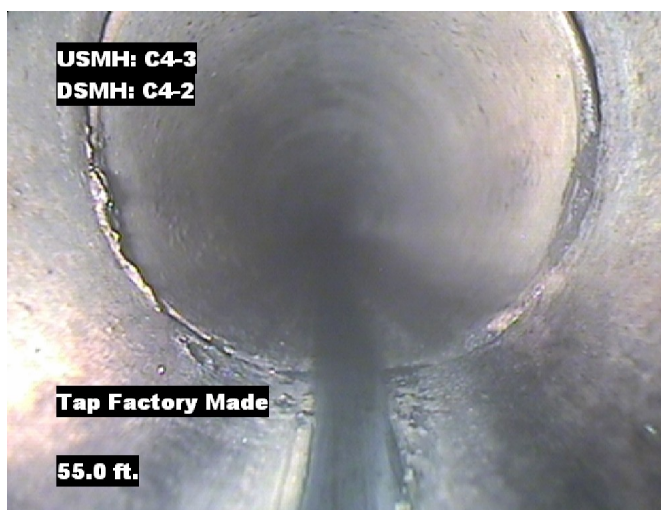
Distance: 55.0 ft. Grade: 0  
Condition: Tap Factory Made  
Remarks: N/A

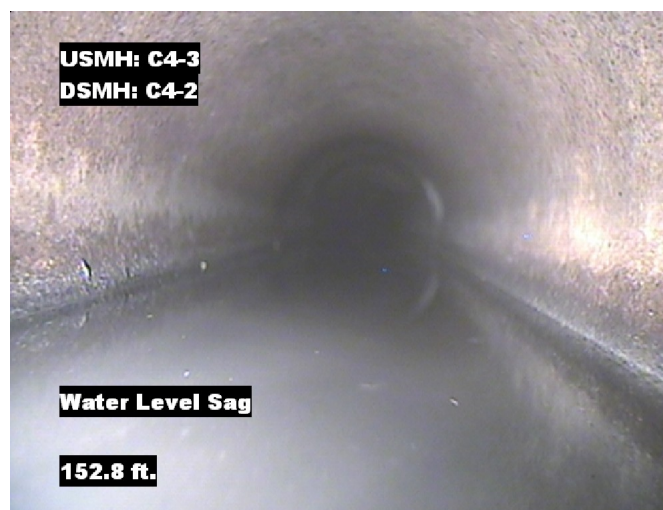
Distance: 152.8 ft. Grade: 2  
Condition: Water Level Sag  
Remarks: N/A

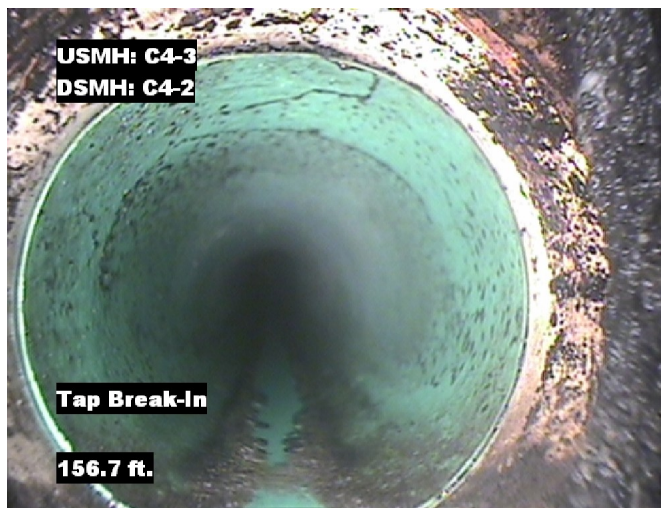
Distance: 156.7 ft. Grade: 0  
Condition: Tap Break-In  
Remarks: N/A

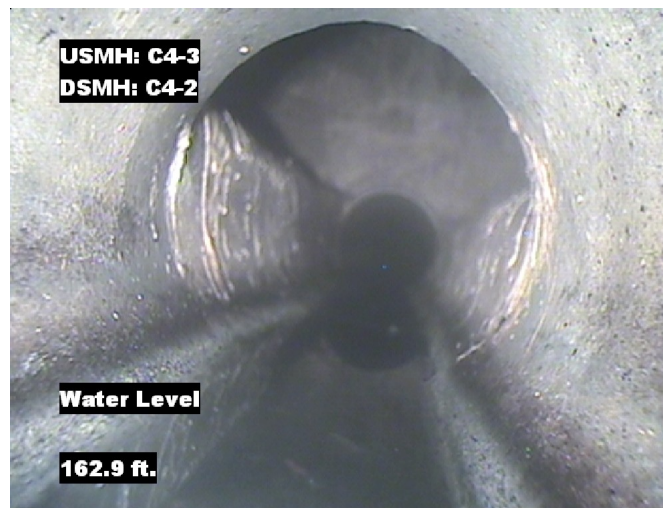
Distance: 162.9 ft. Grade: 0  
Condition: Water Level  
Remarks: N/A

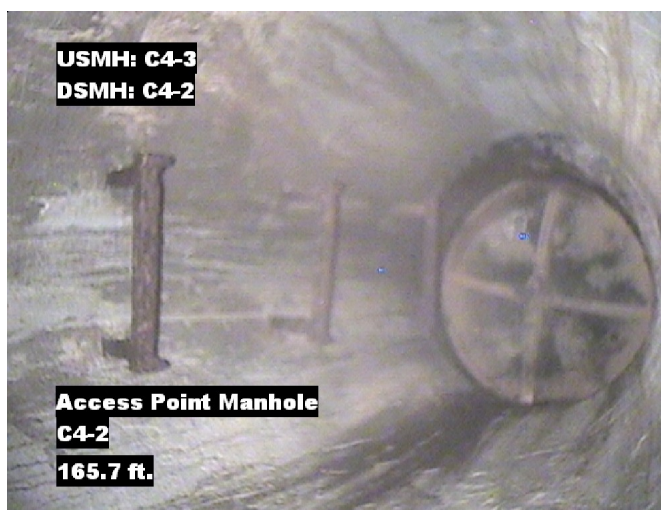
Distance: 165.7 ft. Grade: 0  
Condition: Access Point Manhole  
Remarks: C4-2
