Defect Listing

Pipe Segment Refere... C4-4_C4-3	City Oliver Springs	Street Maple Ave	Material Concrete Pipe (non-...	Location C... Light High...	Sewer Use Sanitary
Upstream MH C4-4	Total Length 355	Year Laid	Shape Circular	Location Details	
DS Manhole C4-3	Length surveyed 355	Year Renewed	Height 8	Width 8	Pipe Joint... 4

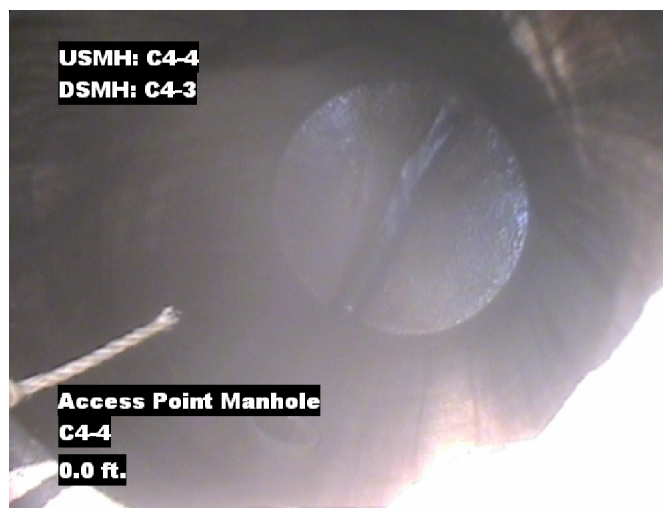
Distance: 0.0 ft. Grade: 0
Condition: Access Point Manhole
Remarks: C4-4

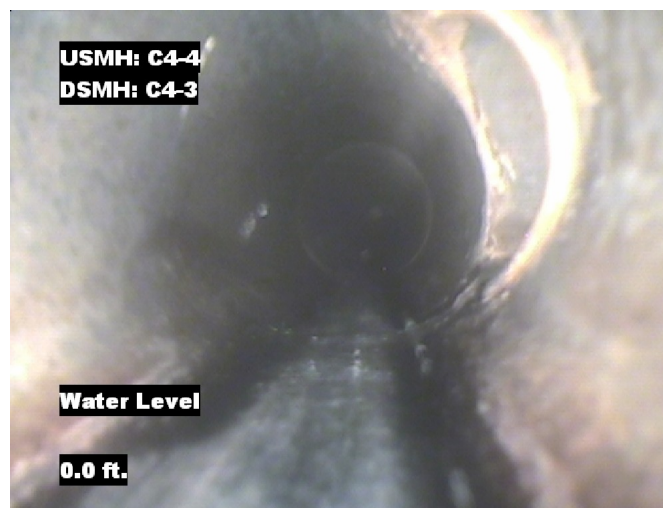
Distance: 0.0 ft. Grade: 0
Condition: Water Level
Remarks: N/A

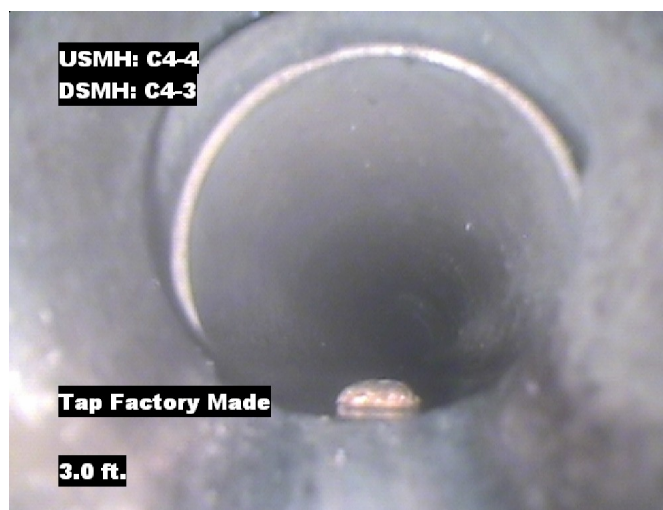
Distance: 3.0 ft. Grade: 0
Condition: Tap Factory Made
Remarks: N/A

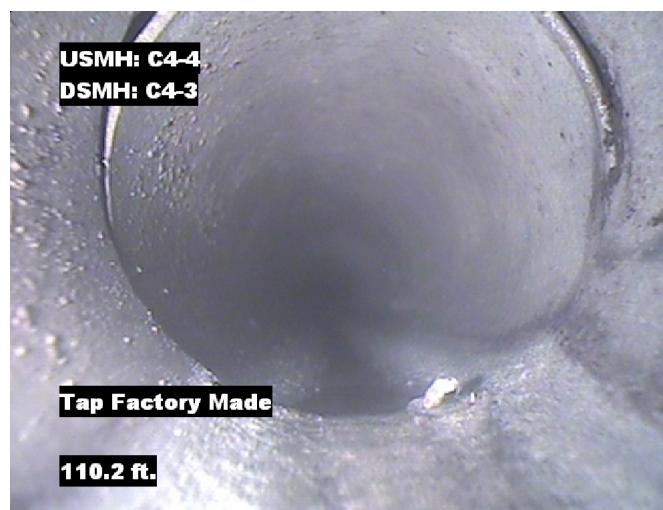
Distance: 110.2 ft. Grade: 0
Condition: Tap Factory Made
Remarks: N/A

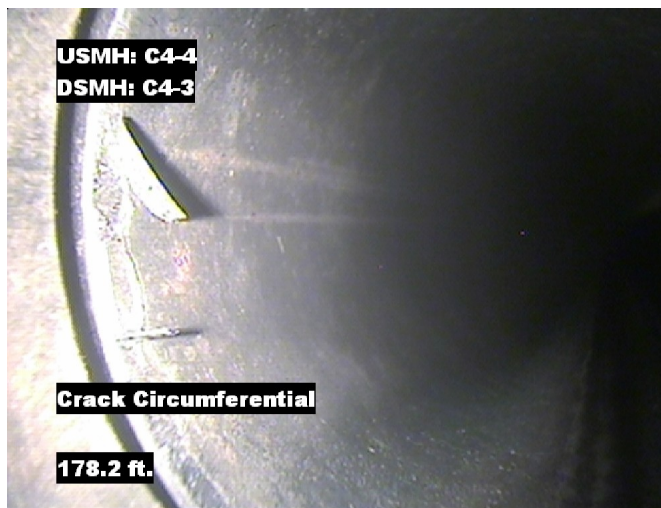
Distance: 178.2 ft. Grade: 1
Condition: Crack Circumferential
Remarks: N/A

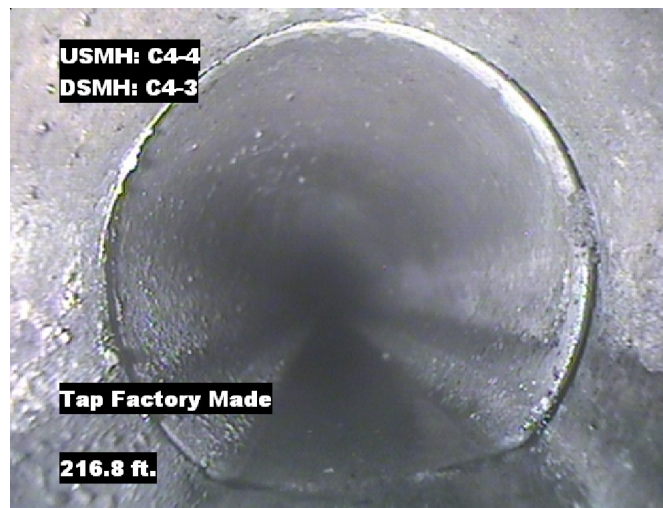
Distance: 216.8 ft. Grade: 0
Condition: Tap Factory Made
Remarks: N/A

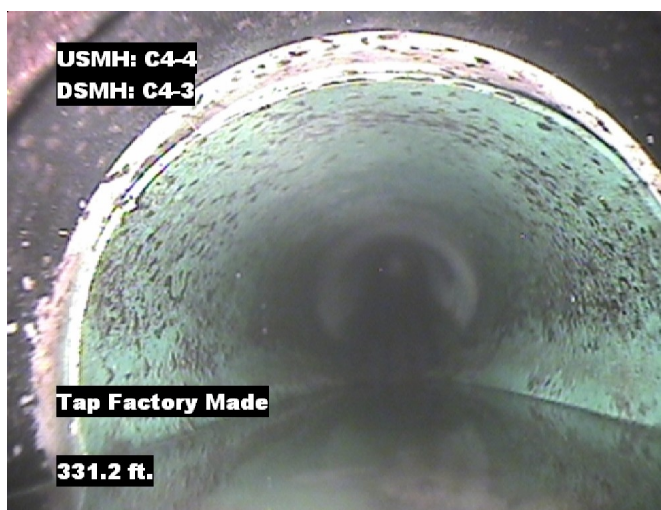
Distance: 331.2 ft. Grade: 0
Condition: Tap Factory Made
Remarks: N/A

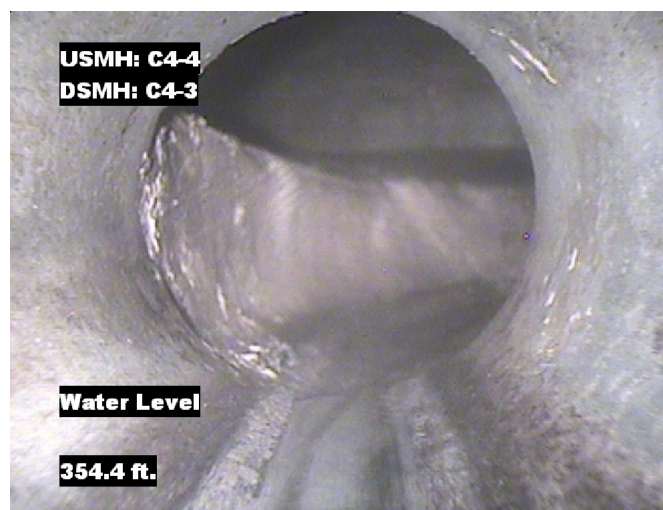
Distance: 354.4 ft. Grade: 0
Condition: Water Level
Remarks: N/A

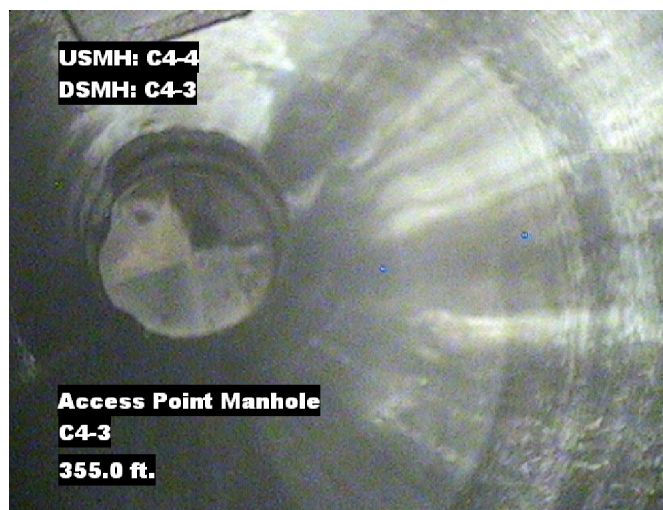
Distance: 355.0 ft. Grade: 0
Condition: Access Point Manhole
Remarks: C4-3
