Defect Listing

Pipe Segment Refere... C4-5_C4-4	City Oliver Springs	Street Maple Ave	Material Concrete Pipe (non-...	Location C... Light High...	Sewer Use Sanitary
Upstream MH C4-5	Total Length 175.9	Year Laid	Shape Circular	Location Details	
DS Manhole C4-4	Length surveyed 118.4	Year Renewed	Height 8	Width 8	Pipe Joint... 4

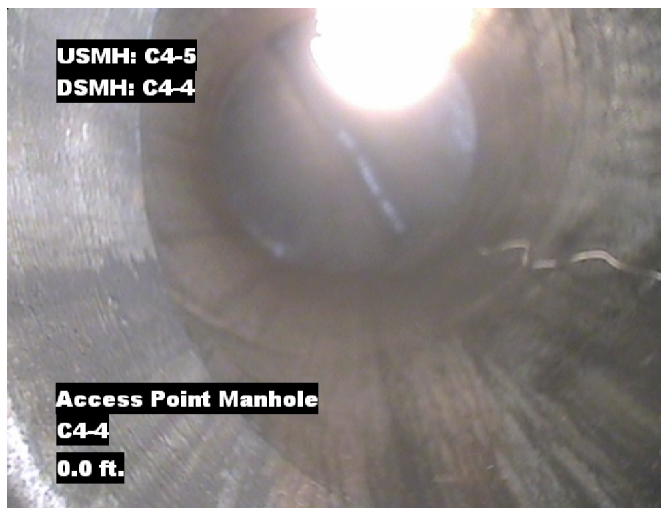
Distance: 0.0 ft. Grade: 0
Condition: Access Point Manhole
Remarks: C4-4

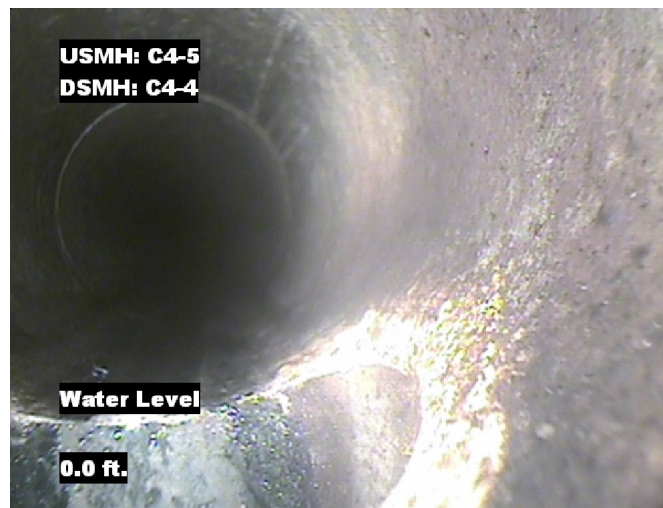
Distance: 0.0 ft. Grade: 0
Condition: Water Level
Remarks: N/A

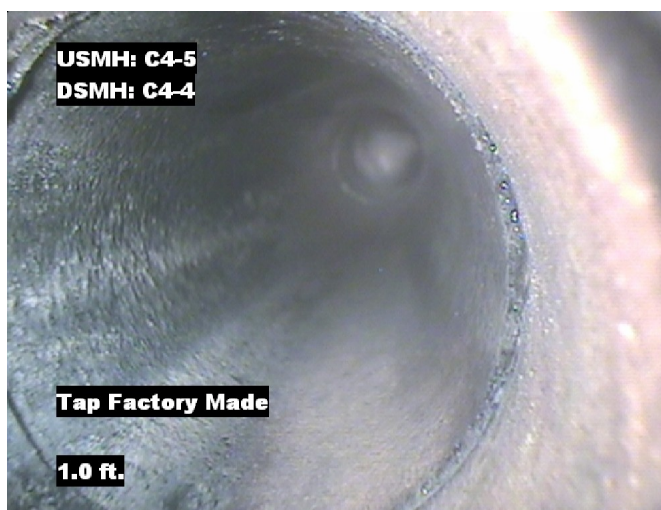
Distance: 1.0 ft. Grade: 0
Condition: Tap Factory Made
Remarks: N/A

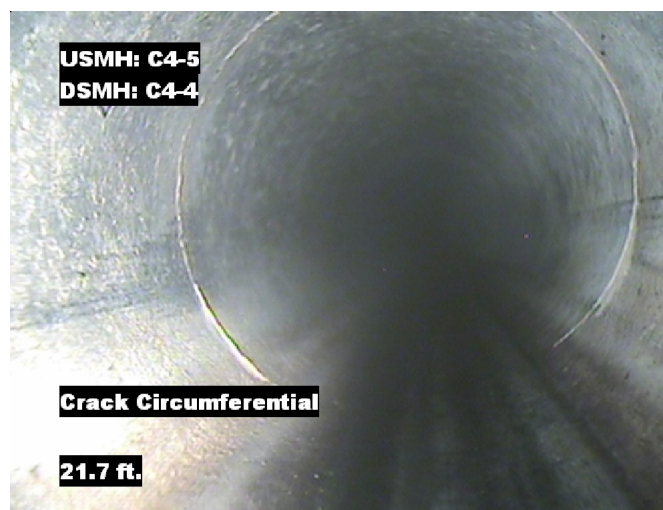
Distance: 21.7 ft. Grade: 1
Condition: Crack Circumferential
Remarks: N/A

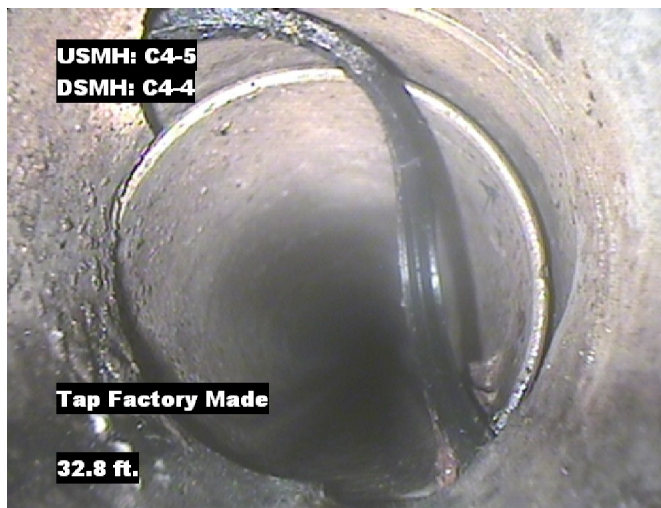
Distance: 32.8 ft. Grade: 0
Condition: Tap Factory Made
Remarks: N/A

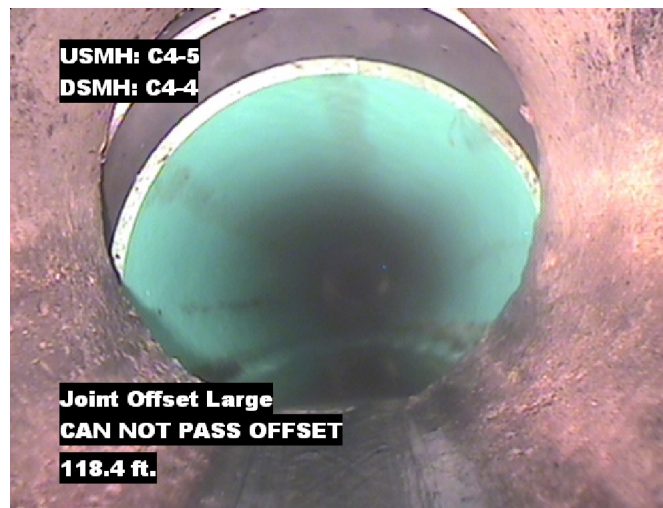
Distance: 118.4 ft. Grade: 2
Condition: Joint Offset Large
Remarks: CAN NOT PASS OFFSET

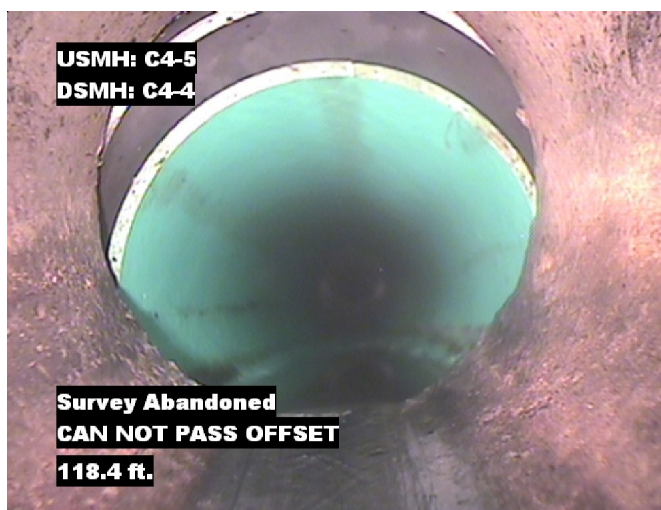
Distance: 118.4 ft. Grade: 0
Condition: Survey Abandoned
Remarks: CAN NOT PASS OFFSET
