Defect Listing

Pipe Segment Refere... C5-11_C5-10	City Oliver Springs	Street Strutt	Material Concrete Pipe (non-...	Location C... Light High...	Sewer Use Sanitary
Upstream MH C5-11	Total Length 225.5	Year Laid	Shape Circular	Location Details 184	
DS Manhole C5-10	Length surveyed 225.5	Year Renewed	Height 8	Width 8	Pipe Joint... 4

Image Report 4/Page

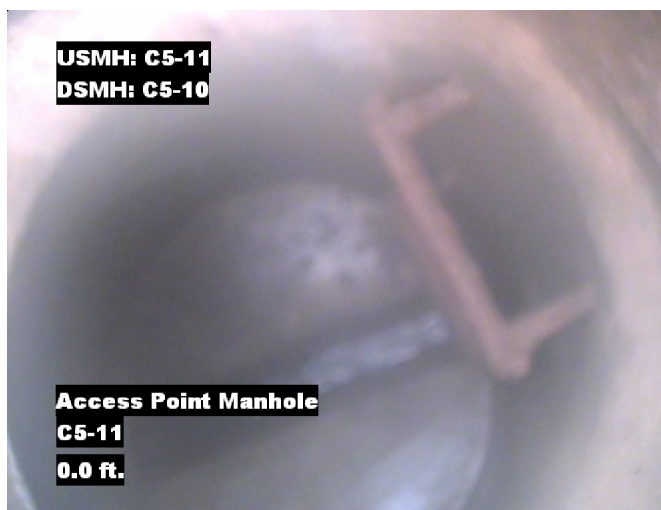
Distance: 0.0 ft. Grade: 0
Condition: Access Point Manhole
Remarks: C5-11

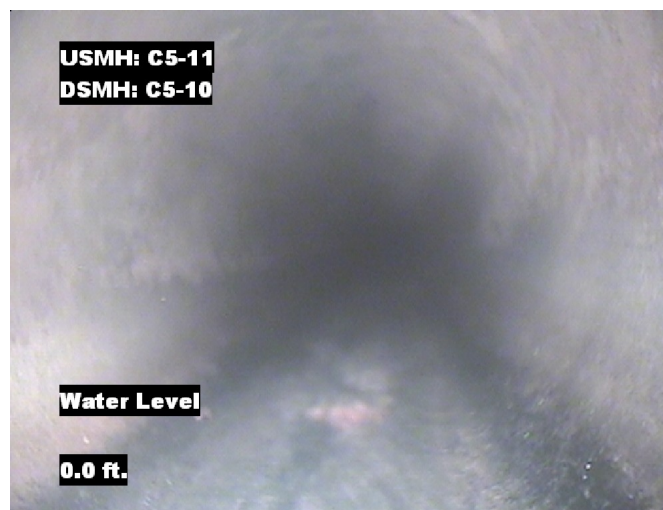
Distance: 0.0 ft. Grade: 0
Condition: Water Level
Remarks: N/A

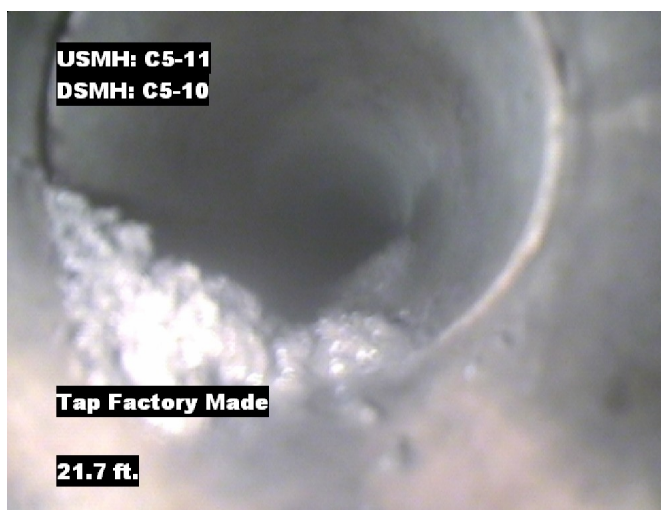
Distance: 21.7 ft. Grade: 0
Condition: Tap Factory Made
Remarks: N/A

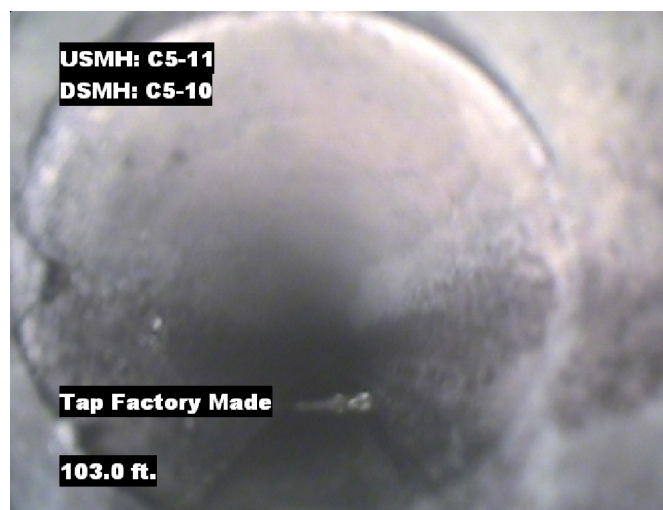
Distance: 103.0 ft. Grade: 0
Condition: Tap Factory Made
Remarks: N/A

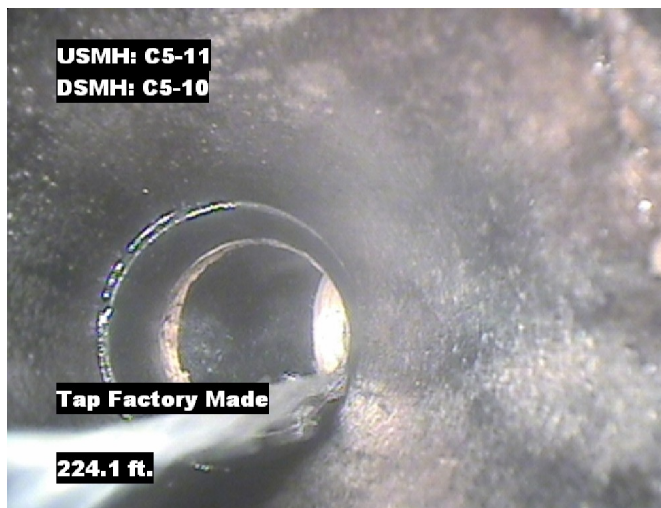
Distance: 224.1 ft. Grade: 0
Condition: Tap Factory Made
Remarks: N/A

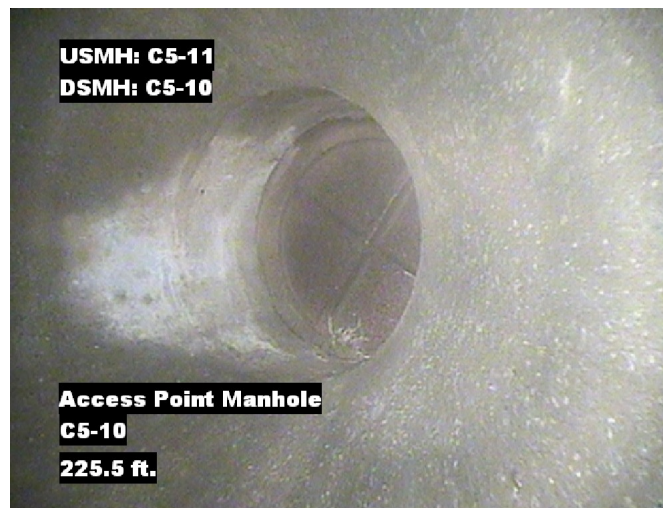
Distance: 225.5 ft. Grade: 0
Condition: Access Point Manhole
Remarks: C5-10
