## Defect Listing

Pipe Segment Refere... <b>C5-12_C5-11</b>	City <b>Oliver Springs</b>	Street <b>Strutt St</b>	Material <b>Concrete Pipe (non-...</b>	Location C... <b>Light High...</b>	Sewer Use <b>Sanitary</b>
Upstream MH <b>C5-12</b>	Total Length <b>209.2</b>	Year Laid	Shape <b>Circular</b>	Location Details	
DS Manhole <b>C5-11</b>	Length surveyed <b>209.2</b>	Year Renewed	Height <b>8</b>	Width <b>8</b>	Pipe Joint... <b>4</b>

SPR <b>N/A</b>	MPR <b>50</b>	PO Number <b>4397-03</b>	Customer <b>GRW</b>
SPRI <b>N/A</b>	MPRI <b>2</b>	Work Order <b>4397-02</b>	Purpose <b>Pre-Rehabilitation Survey</b>
QSR <b>N/A</b>	QMR <b>2D00</b>		
OPR <b>50</b>	Surveyed By <b>Barry Rogers</b>	Direction <b>Downstream</b>	Date <b>20150721</b>
OPRI <b>2</b>	Certificate Number <b>U-1012-16405</b>	Pre-Cleaning <b>Jetting</b>	Time <b>12:36</b>
	Date Cleaned <b>20150721</b>	End Time <b>12:48</b>	Weather <b>Dry</b>
			Additional Info

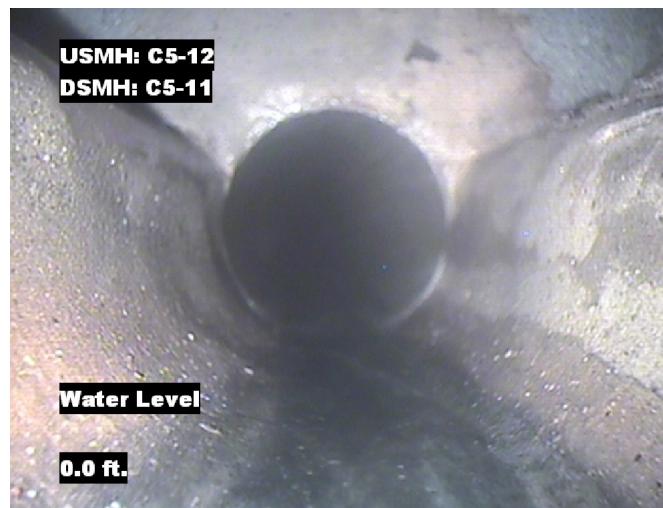
Distance: 0.0 ft. Grade: 0  
Condition: Water Level  
Remarks: N/A

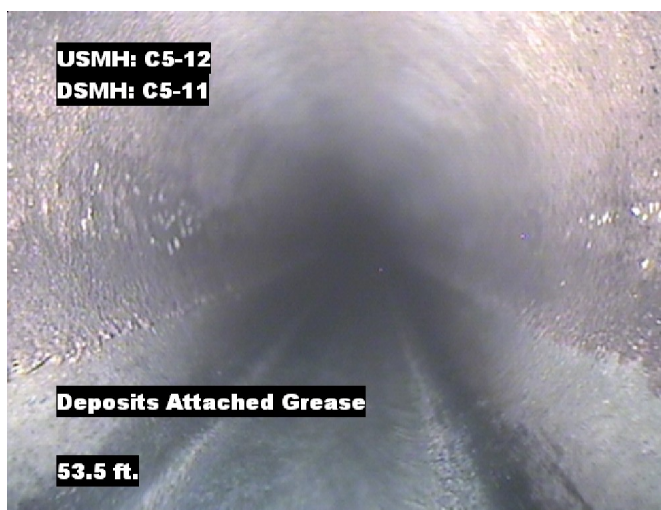
Distance: 53.5 ft. Grade: 2  
Condition: Deposits Attached Grease  
Remarks: N/A

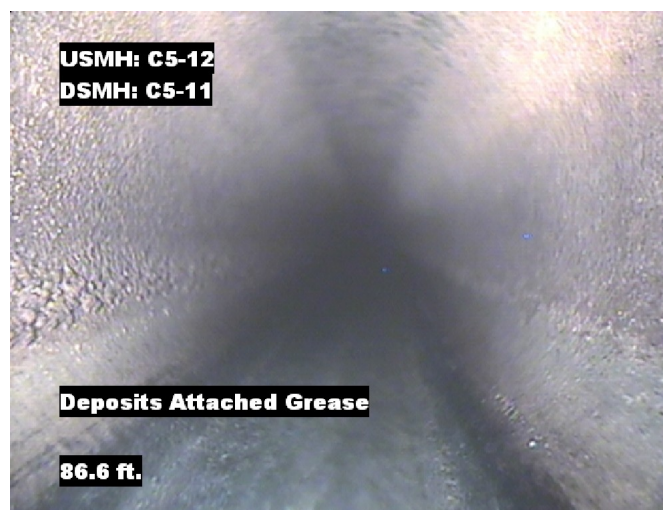
Distance: 86.6 ft. Grade: 2  
Condition: Deposits Attached Grease  
Remarks: N/A

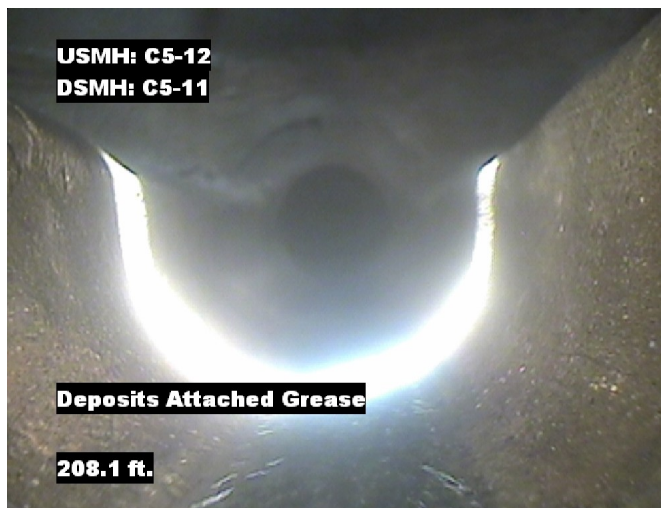
Distance: 208.1 ft. Grade: 2  
Condition: Deposits Attached Grease  
Remarks: N/A

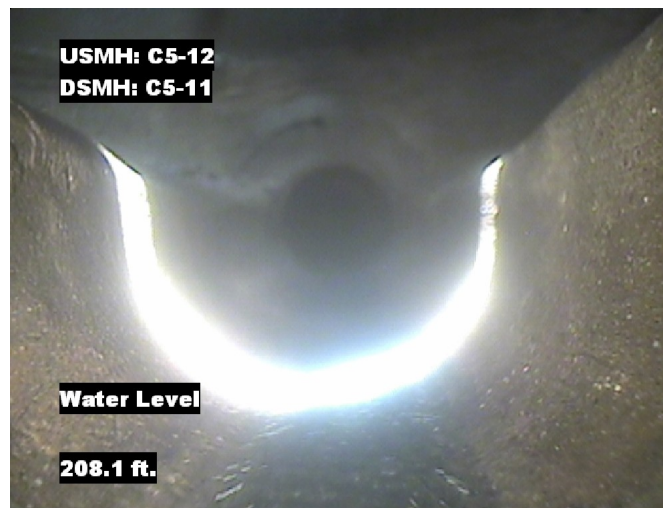
Distance: 208.1 ft. Grade: 0  
Condition: Water Level  
Remarks: N/A
