Defect Listing

Pipe Segment Refere... C5-13_C5-12	City Oliver Springs	Street Strutt St	Material Concrete Pipe (non-...	Location C... Light High...	Sewer Use Sanitary
Upstream MH C5-13	Total Length 237.7	Year Laid	Shape Circular	Location Details	
DS Manhole C5-12	Length surveyed 237.7	Year Renewed	Height 8	Width 8	Pipe Joint... 4

SPR N/A	MPR N/A	PO Number 4397-03		Customer GRW	
SPRI N/A	MPRI N/A	Work Order 4397-02		Purpose Pre-Rehabilitation Survey	
QSR N/A	QMR N/A				
OPR N/A	Surveyed By Barry Rogers	Direction Downstream	Date 20150721	Media label	
OPRI N/A	Certificate Number U-1012-16405	Pre-Cleaning Jetting	Time 12:20	Weather Dry	
Date Cleaned 20150721			End Time 12:35	Additional Info

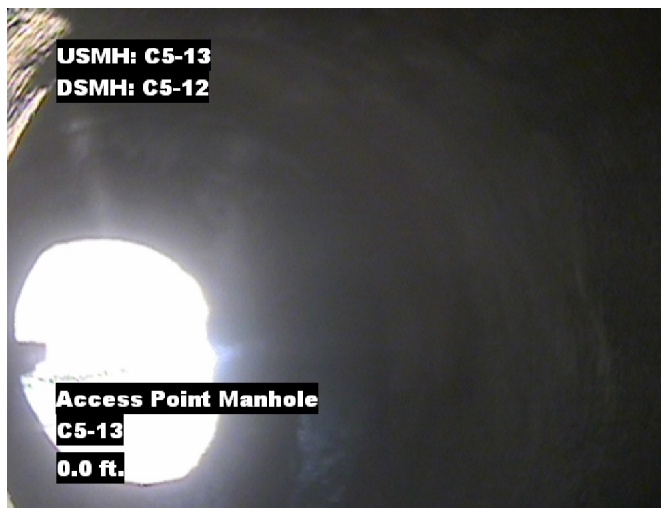
Distance: 0.0 ft. Grade: 0
Condition: Access Point Manhole
Remarks: C5-13

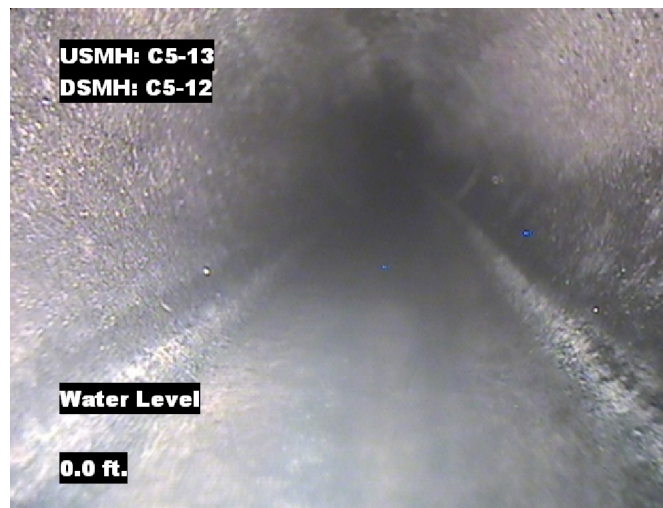
Distance: 0.0 ft. Grade: 0
Condition: Water Level
Remarks: N/A

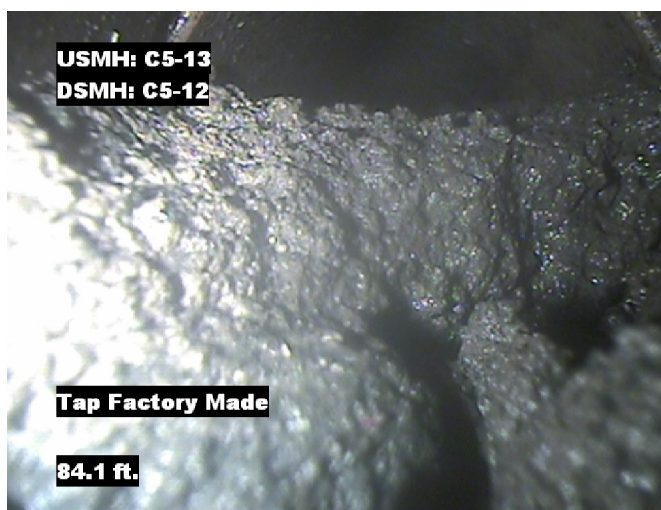
Distance: 84.1 ft. Grade: 0
Condition: Tap Factory Made
Remarks: N/A

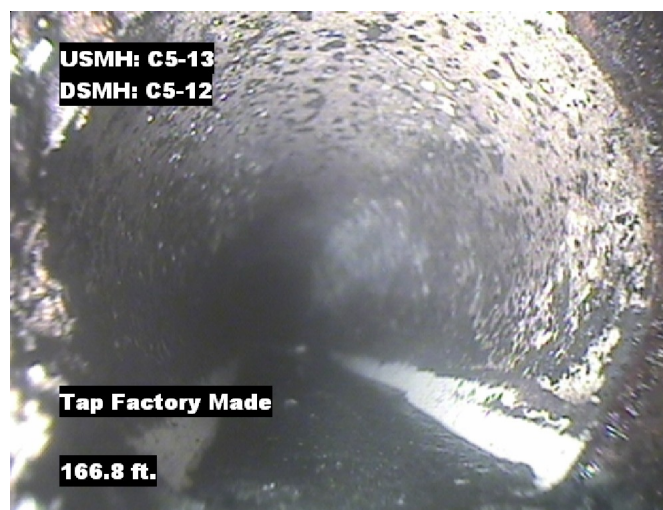
Distance: 166.8 ft. Grade: 0
Condition: Tap Factory Made
Remarks: N/A

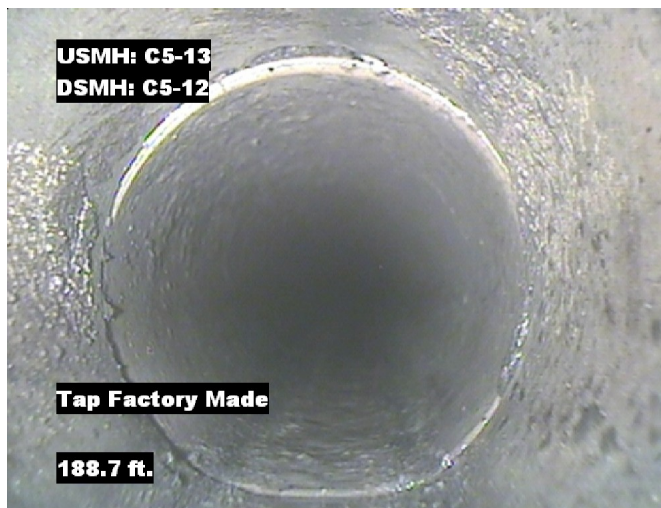
Distance: 188.7 ft. Grade: 0
Condition: Tap Factory Made
Remarks: N/A

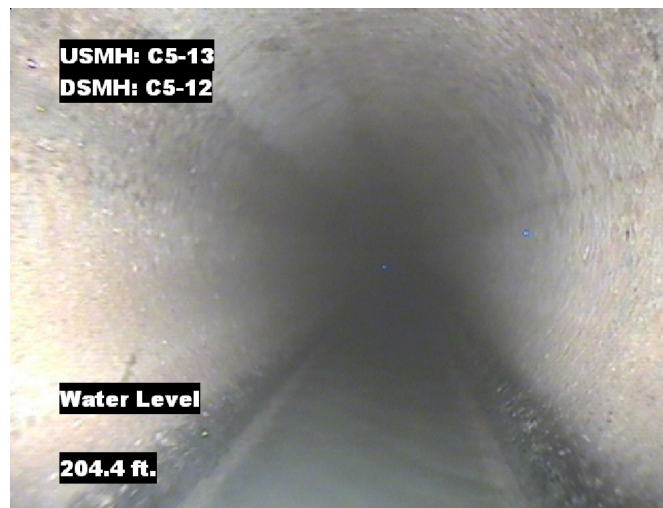
Distance: 204.4 ft. Grade: 0
Condition: Water Level
Remarks: N/A

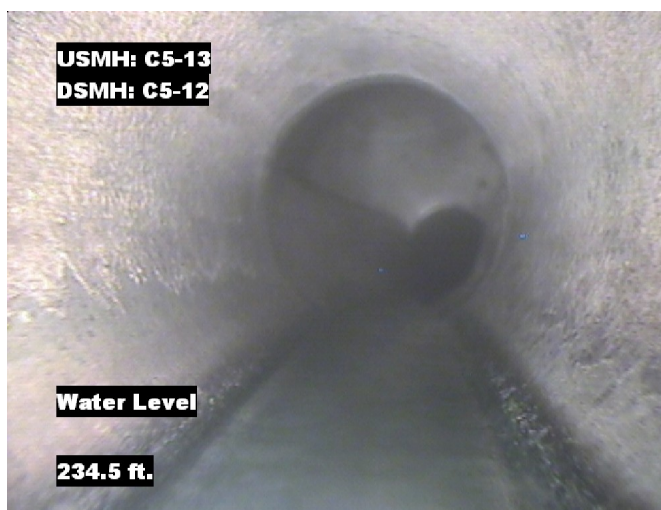
Distance: 234.4 ft. Grade: 0
Condition: Water Level
Remarks: N/A

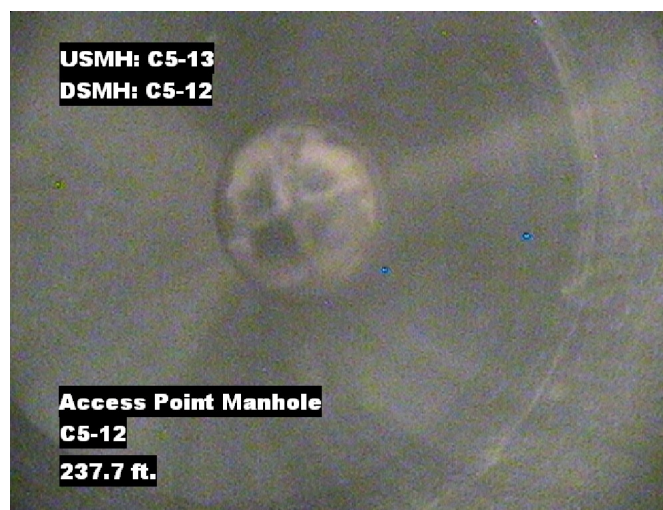
Distance: 237.7 ft. Grade: 0
Condition: Access Point Manhole
Remarks: C5-12
