Defect Listing

Pipe Segment Refere... C5-15_C5-14	City Oliver Springs	Street Cherokee Place	Material PolyVinyl Chloride	Location C... Light High...	Sewer Use Sanitary
Upstream MH C5-15	Total Length 151	Year Laid	Shape Circular	Location Details Apartment Complex	
DS Manhole C5-14	Length surveyed 151	Year Renewed	Height 8	Width 8	Pipe Joint... 13

SPR 2	MPR N/A	PO Number 4397-03		Customer GRW	
SPRI 2	MPRI N/A	Work Order 4397-02		Purpose Pre-Rehabilitation Survey	
QSR 2100	QMR N/A				
OPR 2	Surveyed By Barry Rogers	Direction Downstream	Date 20150721	Media label	
OPRI 2	Certificate Number U-1012-16405	Pre-Cleaning Jetting	Time 09:52	Weather Damp	
Date Cleaned 20150721			End Time 09:59	Additional Info

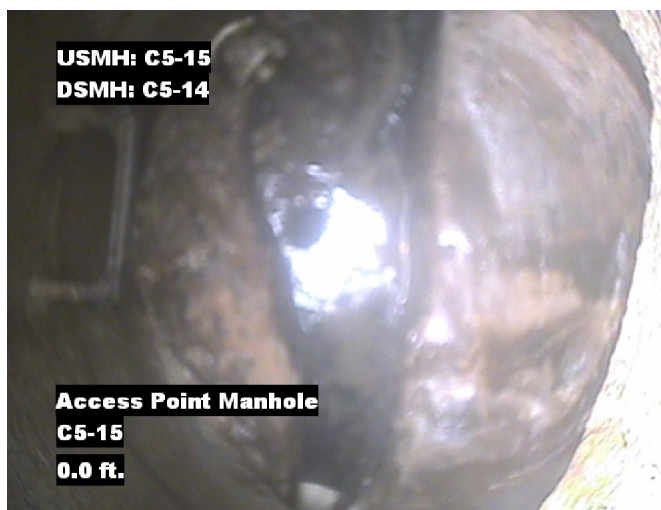
Distance: 0.0 ft. Grade: 0
Condition: Access Point Manhole
Remarks: C5-15

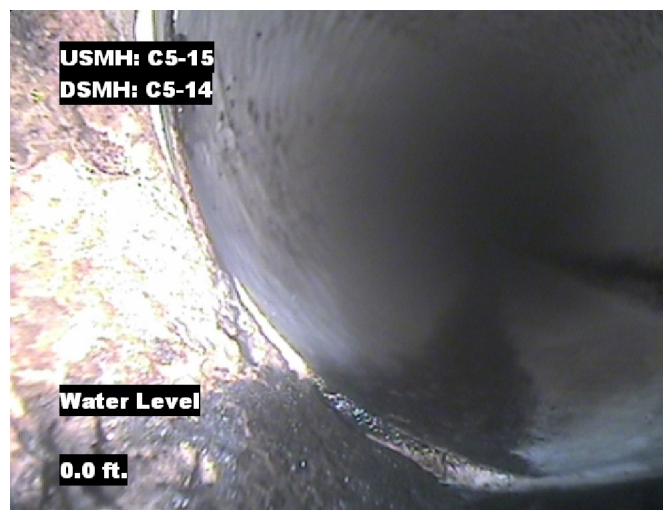
Distance: 0.0 ft. Grade: 0
Condition: Water Level
Remarks: N/A

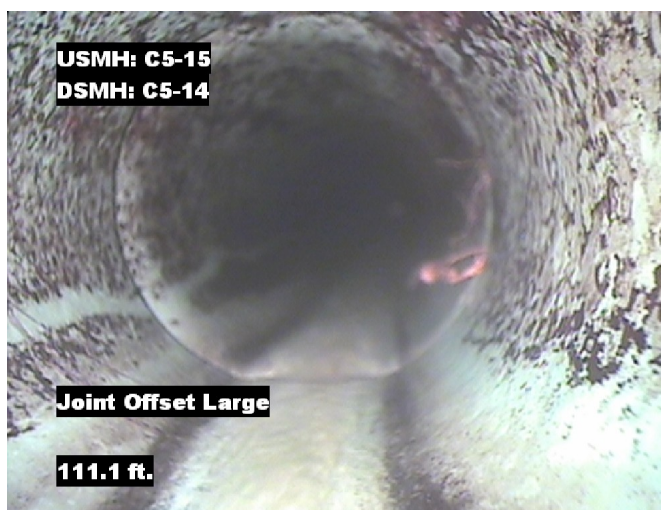
Distance: 111.1 ft. Grade: 2
Condition: Joint Offset Large
Remarks: N/A

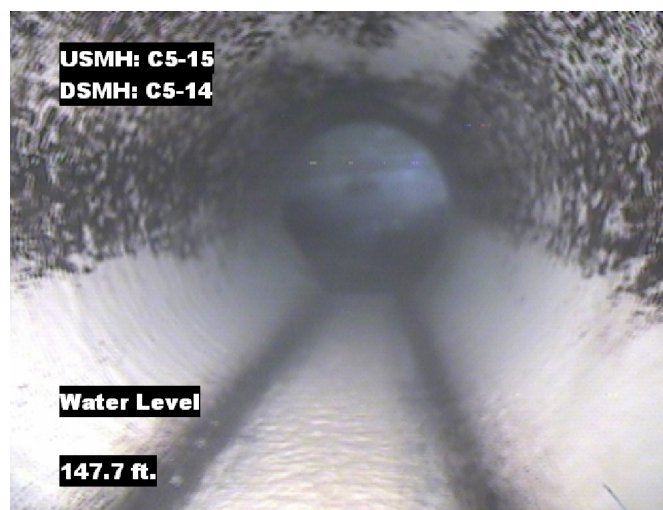
Distance: 147.7 ft. Grade: 0
Condition: Water Level
Remarks: N/A

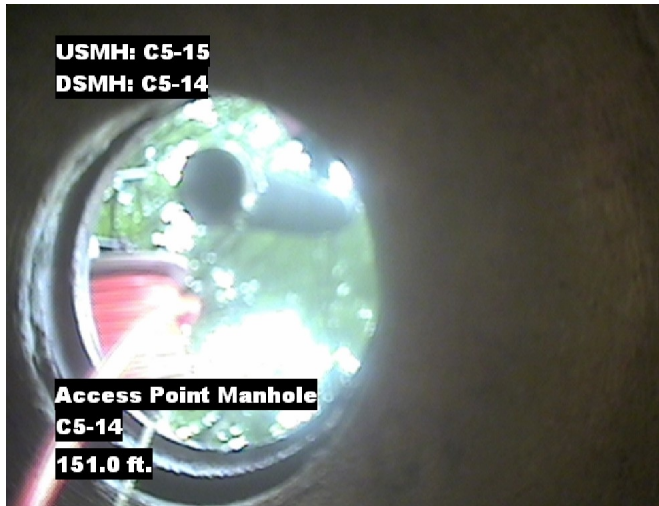
Distance: 151.0 ft. Grade: 0
Condition: Access Point Manhole
Remarks: C5-14
