## Defect Listing

Pipe Segment Refere... <b>C5-16_C5-15</b>	<b>City</b> <b>Oliver Springs</b>	<b>Street</b> <b>Cherokee Place</b>	<b>Material</b> <b>PolyVinyl Chloride</b>		<b>Location C...</b> <b>Light High...</b>	<b>Sewer Use</b> <b>Sanitary</b>
<b>Upstream MH</b> <b>C5-16</b>	Total Length <b>358.1</b>	Year Laid	<b>Shape</b> <b>Circular</b>		Location Details <b>Apartment Complex</b>	
<b>DS Manhole</b> <b>C5-15</b>	<b>Length surveyed</b> <b>358.1</b>	Year Renewed	<b>Height</b> <b>8</b>	Width <b>8</b>	Pipe Joint... <b>13</b>

## Image Report 4/Page

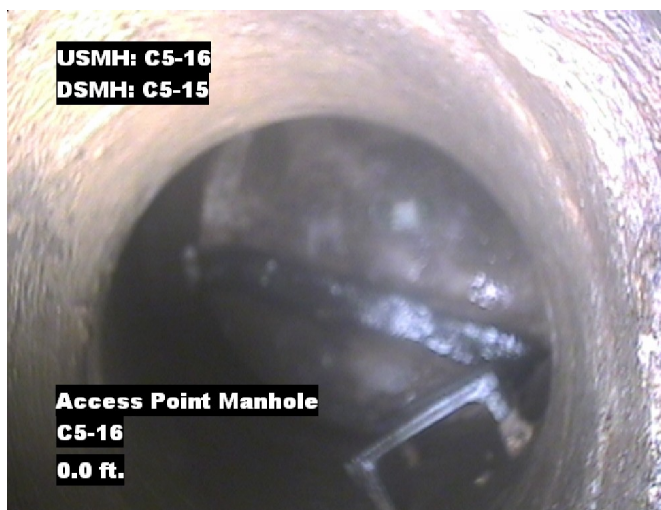
Distance: 0.0 ft. Grade: 0  
Condition: Access Point Manhole  
Remarks: C5-16

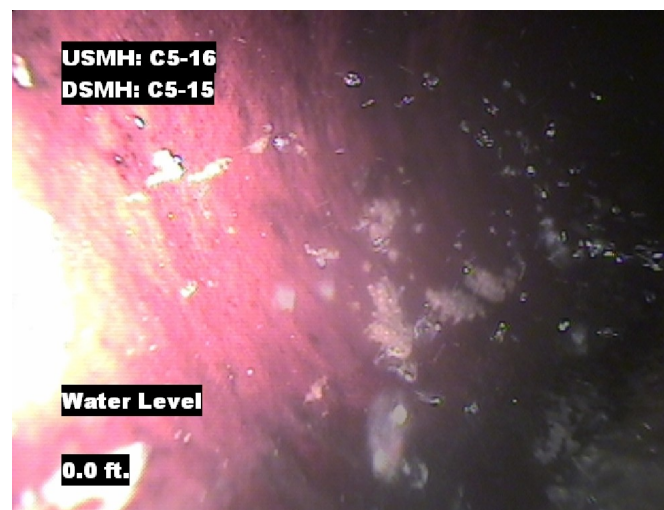
Distance: 0.0 ft. Grade: 0  
Condition: Water Level  
Remarks: N/A

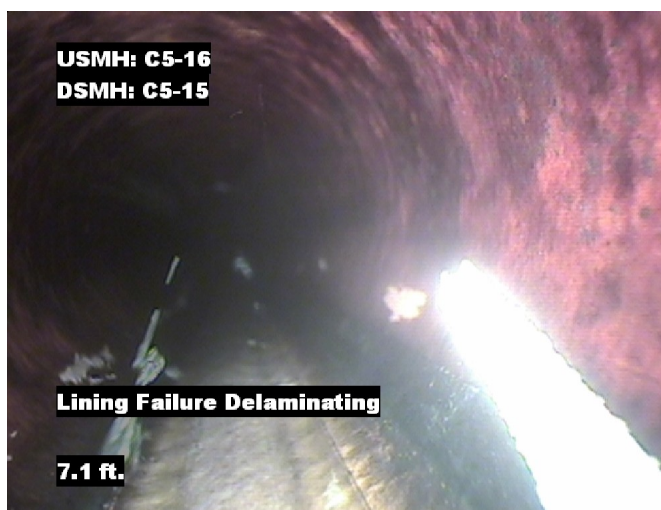
Distance: 7.1 ft. Grade: 3  
Condition: Lining Failure Delaminating  
Remarks: N/A

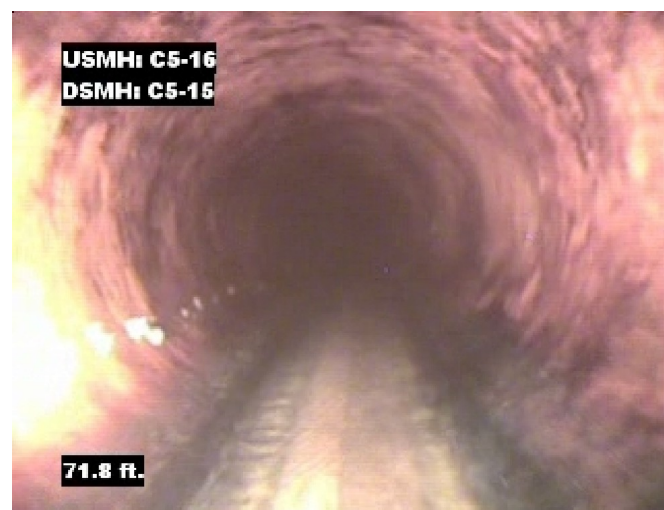
Distance: 71.8 ft. Grade: 2  
Condition: Deposits Attached Grease  
Remarks: N/A

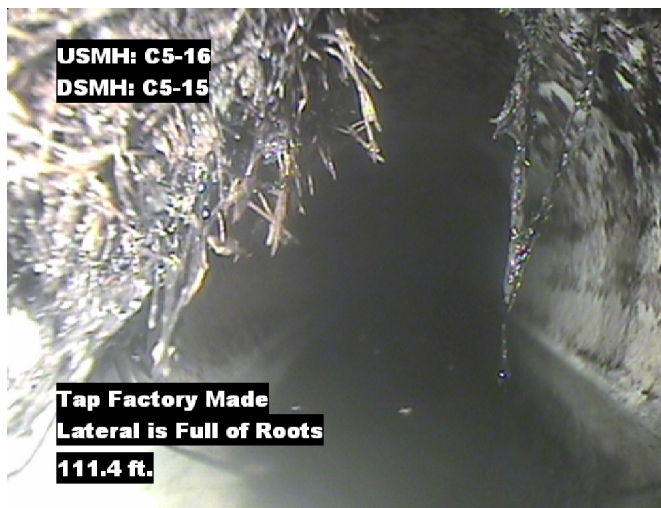
Distance: 111.4 ft. Grade: 0  
Condition: Tap Factory Made  
Remarks: Lateral is Full of Roots

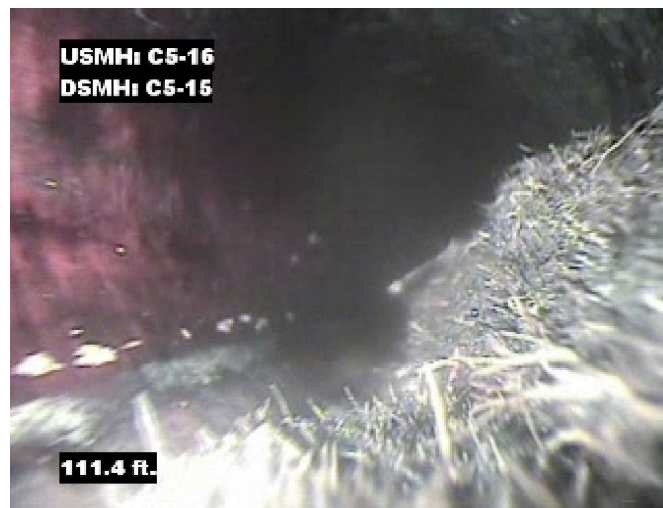
Distance: 111.5 ft. Grade: 4  
Condition: Roots Medium Barrel  
Remarks: N/A

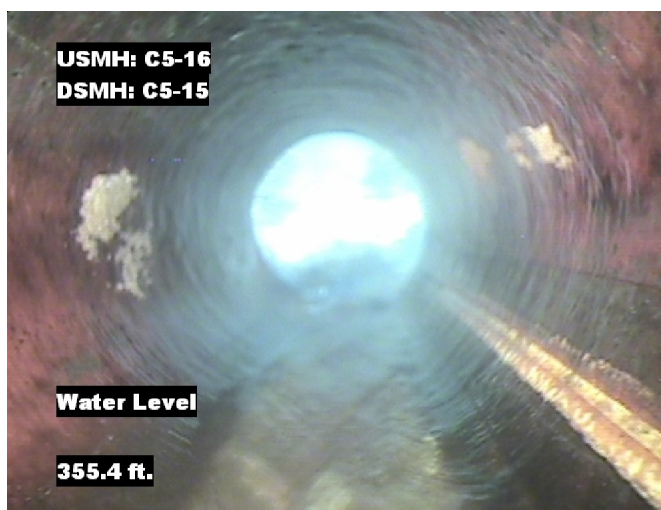
Distance: 355.4 ft. Grade: 0  
Condition: Water Level  
Remarks: N/A

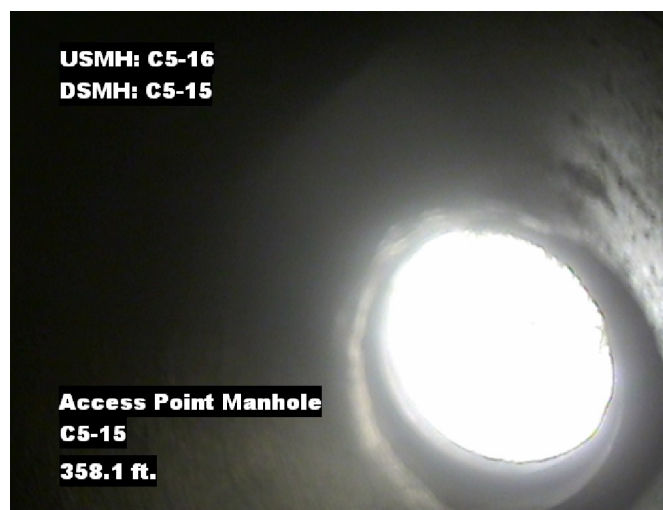
Distance: 358.1 ft. Grade: 0  
Condition: Access Point Manhole  
Remarks: C5-15
