Defect Listing

Pipe Segment Refere		City		Street	Mat	Material		Sewer Use	
C5-4A_C5-4		Oliver Springs		McGhee St	Concrete F	Concrete Pipe (non		Sanitary	
Upstream MH		Total Length		Year Laid	Sha	ape	Location Details		
C5-	C5-4A 174.1			Circ	ular				
DS Ma	anhole	Length s	urveyed	Year Renewed	Height	Width	idth Pipe Joint		
C5-4		174.1			8	8	4		
SPR	N/A	MPR	N/A	PO Number			Customer		
0001				4397-03		GRW			
SPRI	N/A	MPRI	N/A	Work Order					
QSR	N/A	QMR	N/A	4397-02		Pre-l	e-Rehabilitation Survey		
O	PR	Surveyed By		Direction	Date		Media label		
N.	/A	Barry_Rogers		Downstream	20150812				
OF	PRI	Certificate Number		Pre-Cleaning	Time		Weather		
N/A		U-1012-16405		No Pre-Cleaning	14:36		Dry		
		Date C	leaned		End Time		Additional Info		
					14	:52

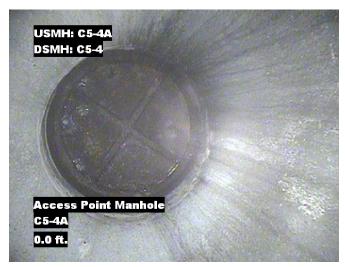
Distance: 0.0 ft. Grade: 0

Condition: Access Point Manhole

Remarks: C5-4A

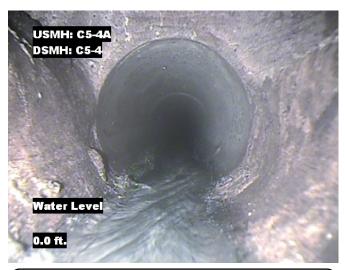
Distance: 0.0 ft. Grade: 0

Condition: Water Level

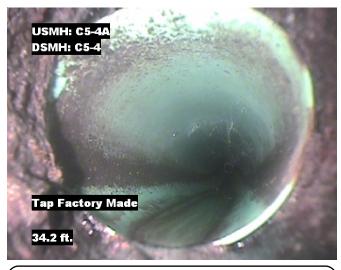
Distance: 34.2 ft. Grade: 0

Condition: Tap Factory Made

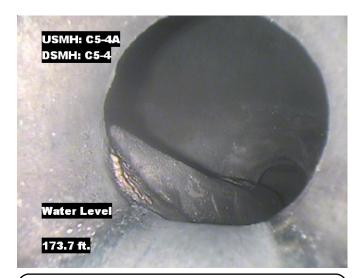
Distance: 173.7 ft. Grade: 0

Condition: Water Level

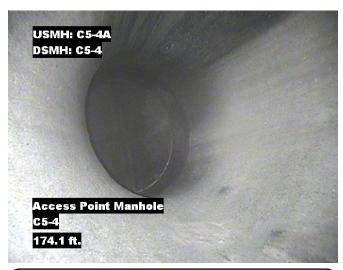
Distance: 174.1 ft. Grade: 0

Condition: Access Point Manhole

Remarks: C5-4
