Defect Listing

Pipe Segment Refere... C5-5_C5-4A	City Oliver Springs	Street Mcghee St	Material Fibreglass Reinforc...	Location C... Woods	Sewer Use Sanitary
Upstream MH C5-5	Total Length 76.3	Year Laid	Shape Circular	Location Details	
DS Manhole C5-4A	Length surveyed 76.3	Year Renewed	Height 8	Width 8	Pipe Joint... N/A

SPR N/A	MPR 4	PO Number 4397-03	Customer GRW
SPRI N/A	MPRI 2	Work Order 4397-02	Purpose Pre-Rehabilitation Survey
QSR N/A	QMR 2200		
OPR 4	Surveyed By Barry Rogers	Direction Downstream	Date 20150812
OPRI 2	Certificate Number U-1012-16405	Pre-Cleaning No Pre-Cleaning	Time 14:28
	Date Cleaned	End Time 14:30	Additional Info

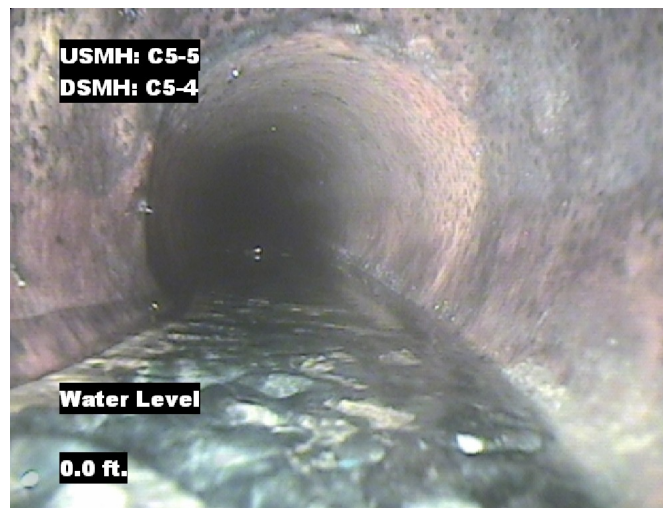
Distance: 0.0 ft. Grade: 0
Condition: Water Level
Remarks: N/A

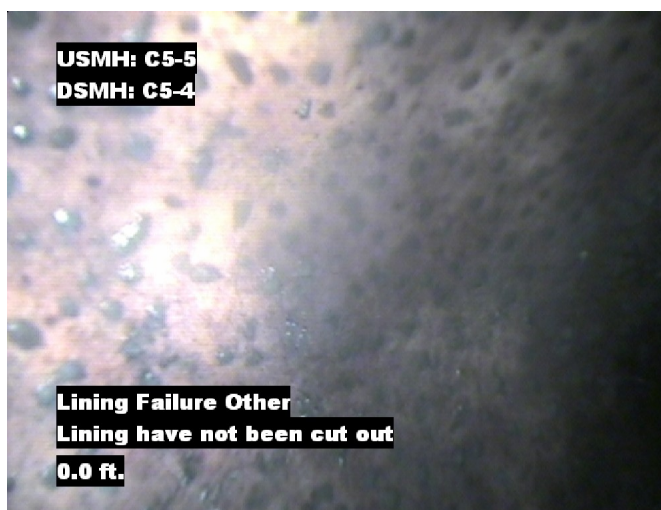
Distance: 0.0 ft. Grade: 0
Condition: Lining Failure Other
Remarks: Lining have not been cut out

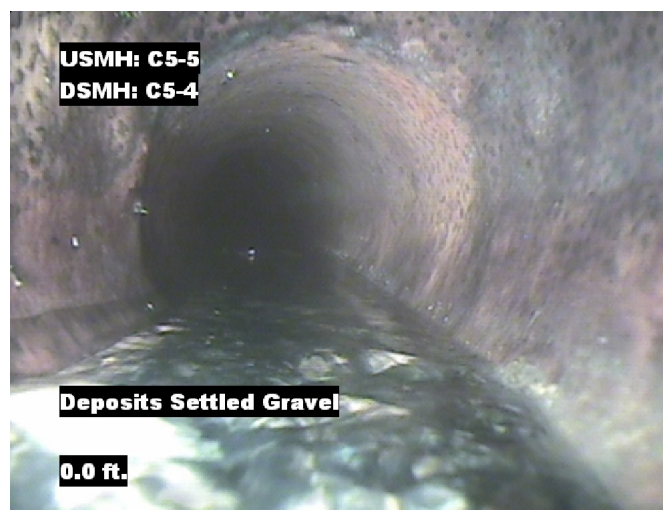
Distance: 0.0 ft. Grade: 2
Condition: Deposits Settled Gravel
Remarks: N/A

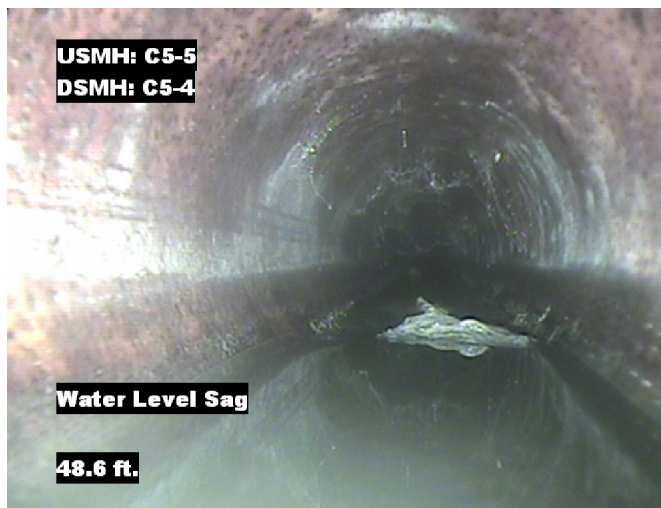
Distance: 48.5 ft. Grade: 2
Condition: Water Level Sag
Remarks: N/A

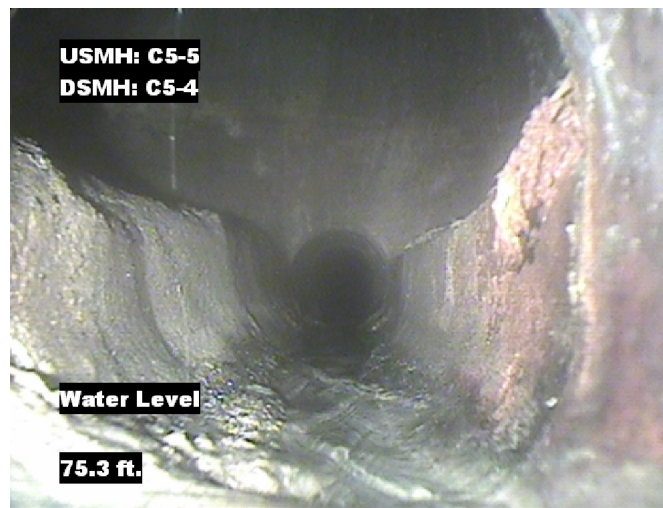
Distance: 75.3 ft. Grade: 0
Condition: Water Level
Remarks: N/A
