Defect Listing

Pipe Segment Refere... C5-6_C5-5	City Oliver Springs	Street Mcghee St	Material Fibreglass Reinforc...	Location C... Woods	Sewer Use Sanitary
Upstream MH C5-6	Total Length 265.3	Year Laid	Shape Circular	Location Details	
DS Manhole C5-5	Length surveyed 265.3	Year Renewed	Height 8	Width 8	Pipe Joint... N/A

Image Report 4/Page

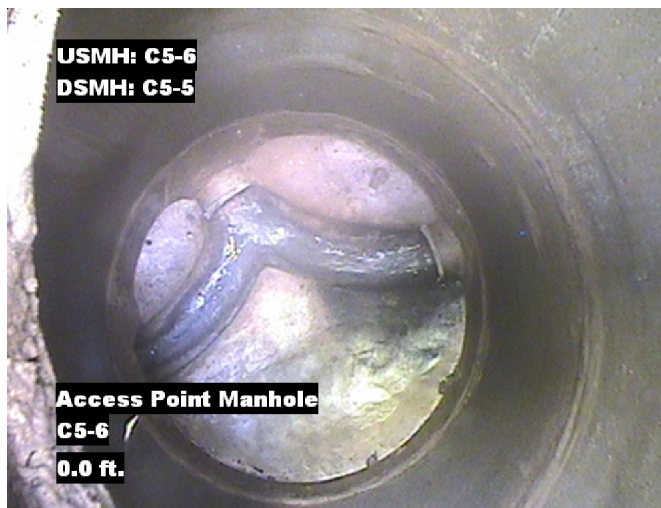
Distance: 0.0 ft. Grade: 0
Condition: Access Point Manhole
Remarks: C5-6

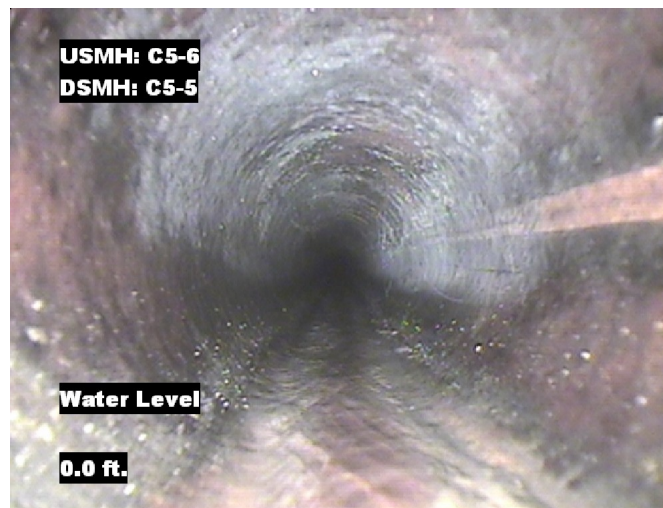
Distance: 0.0 ft. Grade: 0
Condition: Water Level
Remarks: N/A

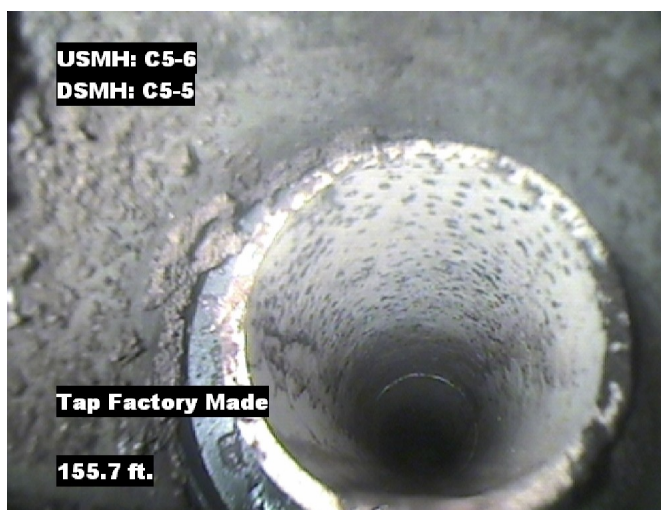
Distance: 155.7 ft. Grade: 0
Condition: Tap Factory Made
Remarks: N/A

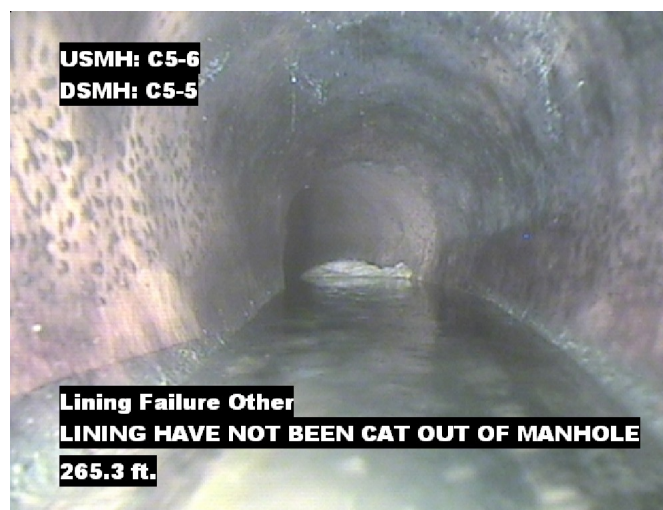
Distance: 265.3 ft. Grade: 0
Condition: Lining Failure Other
Remarks: LINING HAVE NOT BEEN CAT OUT OF MANHOLE

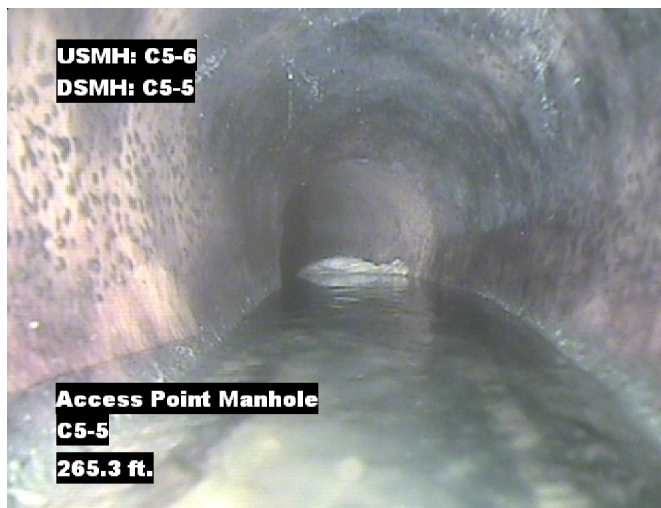
Distance: 265.3 ft. Grade: 0
Condition: Access Point Manhole
Remarks: C5-5
