Defect Listing

Pipe Segment Refere... C5-7_C5-6	City Oliver Springs	Street Mcghee St	Material Fibreglass Reinforc...	Location C... Light High...	Sewer Use Sanitary
Upstream MH C5-7	Total Length 187.2	Year Laid	Shape Circular	Location Details	
DS Manhole C5-6	Length surveyed 187.2	Year Renewed	Height 8	Width 8	Pipe Joint... N/A

SPR N/A	MPR N/A	PO Number 4397-03		Customer GRW	
SPRI N/A	MPRI N/A	Work Order 4397-02		Purpose Pre-Rehabilitation Survey	
QSR N/A	QMR N/A				
OPR N/A	Surveyed By Barry Rogers	Direction Downstream	Date 20150722	Media label	
OPRI N/A	Certificate Number U-1012-16405	Pre-Cleaning Jetting	Time 08:27	Weather Dry	
Date Cleaned 20150722			End Time 08:32	Additional Info

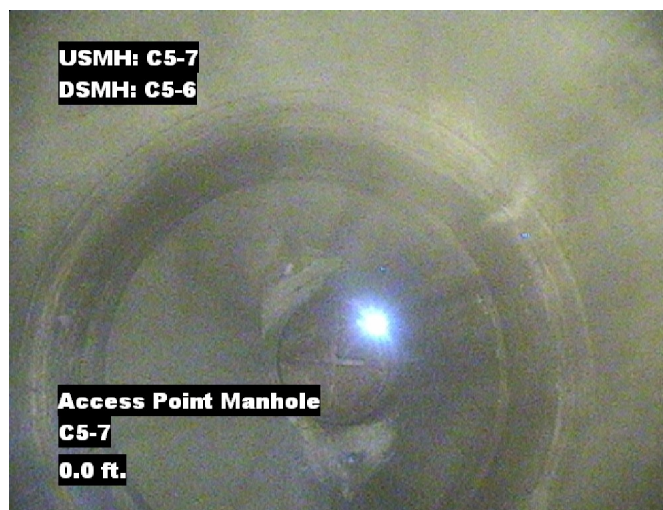
Distance: 0.0 ft. Grade: 0
Condition: Access Point Manhole
Remarks: C5-7

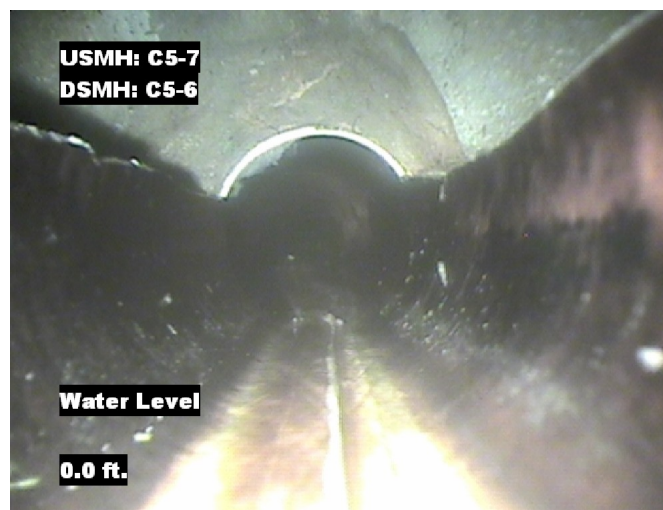
Distance: 0.0 ft. Grade: 0
Condition: Water Level
Remarks: N/A

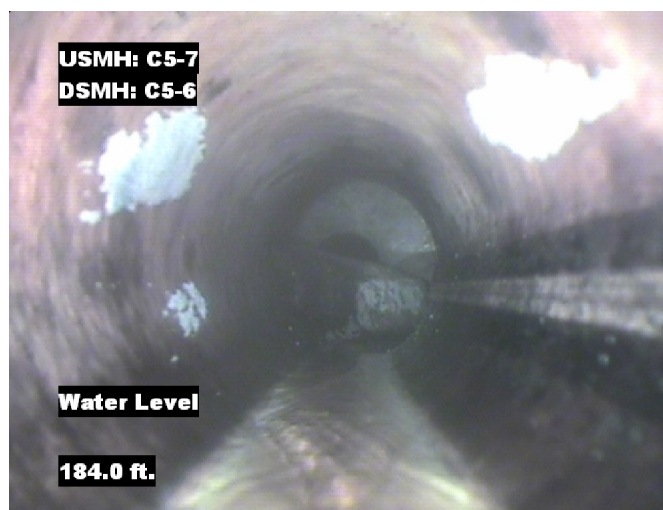
Distance: 184.0 ft. Grade: 0
Condition: Water Level
Remarks: N/A

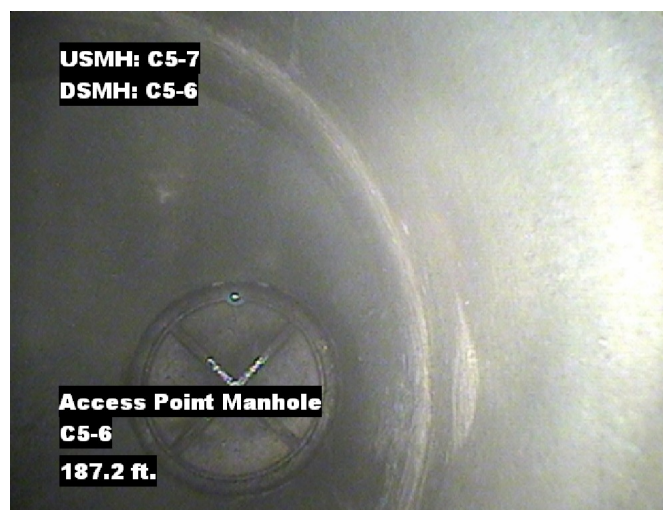
Distance: 187.2 ft. Grade: 0
Condition: Access Point Manhole
Remarks: C5-6
