Defect Listing

Pipe Segment Refere... C5-8_C5-7	City Oliver Springs	Street Mcghee	Material Fibreglass Reinforc...	Location C... Light High...	Sewer Use Sanitary
Upstream MH C5-8	Total Length 188.8	Year Laid	Shape Circular	Location Details	
DS Manhole C5-7	Length surveyed 188.8	Year Renewed	Height 8	Width 8	Pipe Joint... N/A

SPR N/A	MPR N/A	PO Number 4397-03	Customer GRW
SPRI N/A	MPRI N/A	Work Order 4397-02	Purpose Pre-Rehabilitation Survey
QSR N/A	QMR N/A		
OPR N/A	Surveyed By Barry Rogers	Direction Downstream	Date 20150722
OPRI N/A	Certificate Number U-1012-16405	Pre-Cleaning Jetting	Time 08:14
	Date Cleaned 20150722	End Time 08:24	Weather Dry
			Additional Info

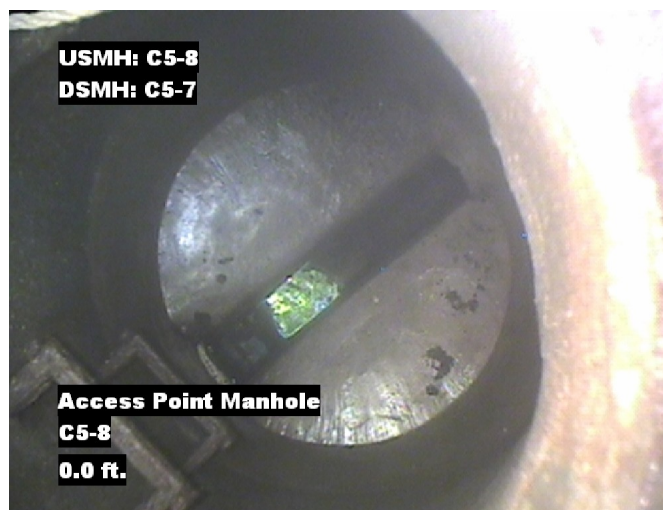
Distance: 0.0 ft. Grade: 0
Condition: Access Point Manhole
Remarks: C5-8

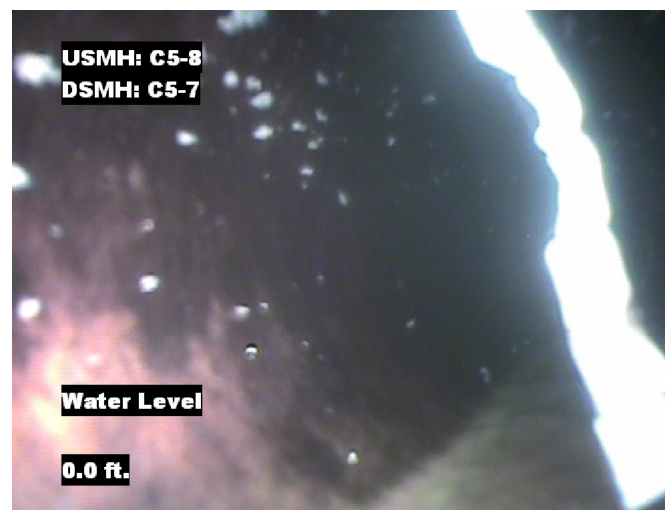
Distance: 0.0 ft. Grade: 0
Condition: Water Level
Remarks: N/A

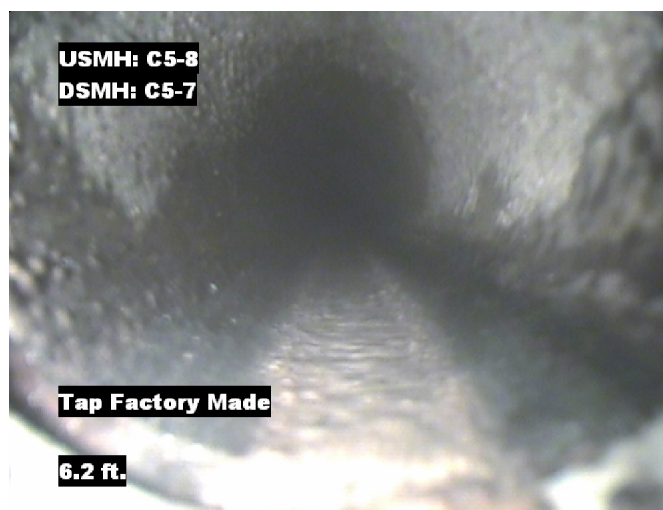
Distance: 6.2 ft. Grade: 0
Condition: Tap Factory Made
Remarks: N/A

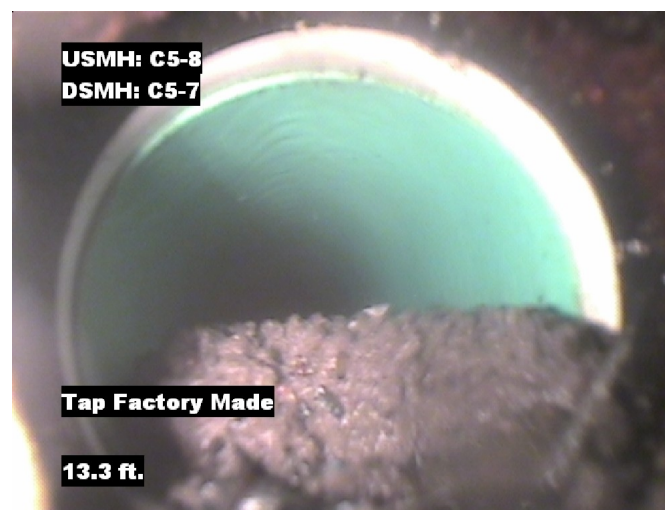
Distance: 13.3 ft. Grade: 0
Condition: Tap Factory Made
Remarks: N/A

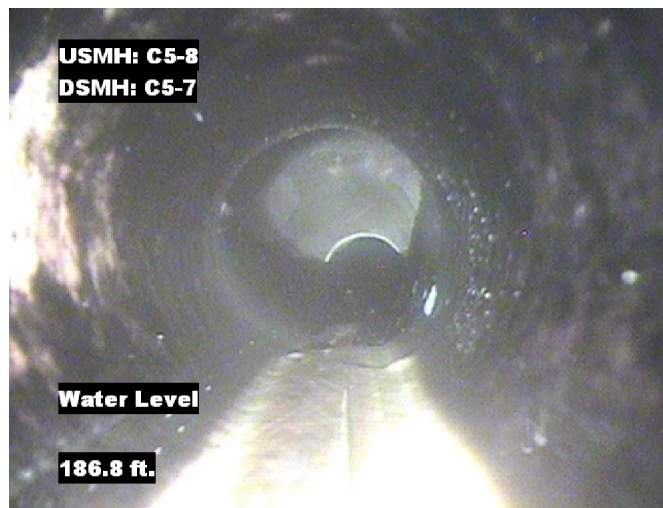
Distance: 186.8 ft. Grade: 0
Condition: Water Level
Remarks: N/A

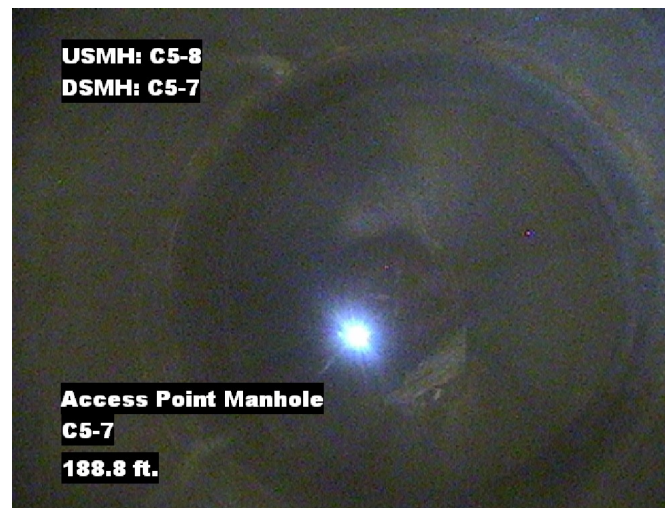
Distance: 188.8 ft. Grade: 0
Condition: Access Point Manhole
Remarks: C5-7
