Defect Listing

Pipe Segment Refere... C5-9_C5-8	City Oliver Springs	Street Strutt St	Material Concrete Pipe (non-...	Location C... Light High...	Sewer Use Sanitary
Upstream MH C5-9	Total Length 215.6	Year Laid	Shape Circular	Location Details	
DS Manhole C5-8	Length surveyed 215.6	Year Renewed	Height 8	Width 8	Pipe Joint... 4

SPR N/A	MPR N/A	PO Number 4397-03		Customer GRW	
SPRI N/A	MPRI N/A	Work Order 4397-02		Purpose Pre-Rehabilitation Survey	
QSR N/A	QMR N/A				
OPR N/A	Surveyed By Barry Rogers	Direction Upstream	Date 20150722	Media label	
OPRI N/A	Certificate Number U-1012-16405	Pre-Cleaning Jetting	Time 07:18	Weather Dry	
Date Cleaned 20150722			End Time 08:08	Additional Info

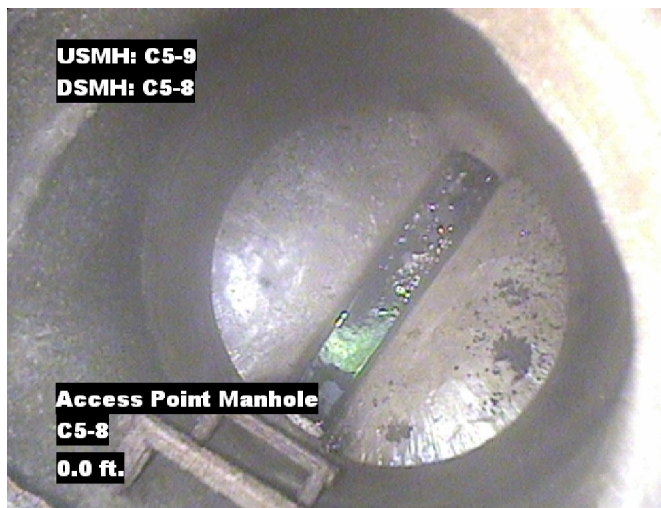
Distance: 0.0 ft. Grade: 0
Condition: Access Point Manhole
Remarks: C5-8

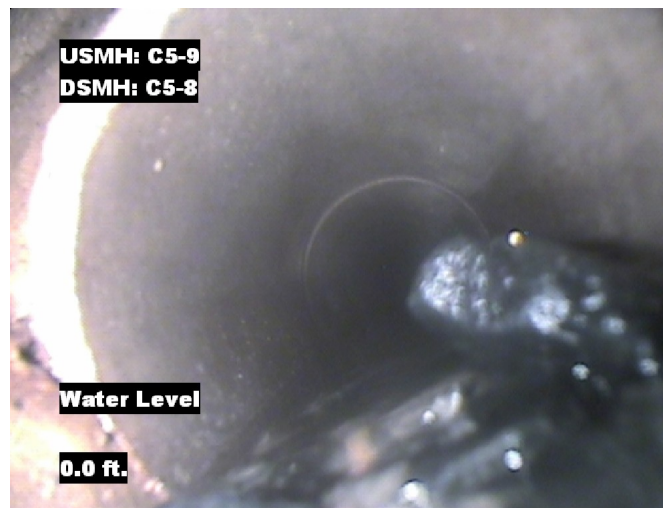
Distance: 0.0 ft. Grade: 0
Condition: Water Level
Remarks: N/A

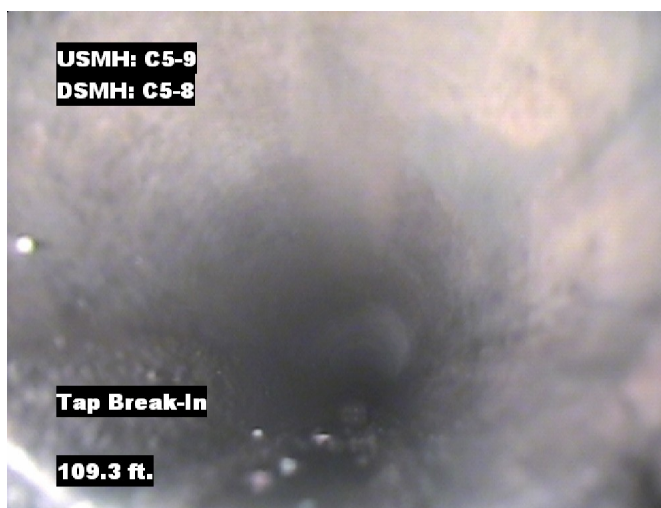
Distance: 109.3 ft. Grade: 0
Condition: Tap Break-In
Remarks: N/A

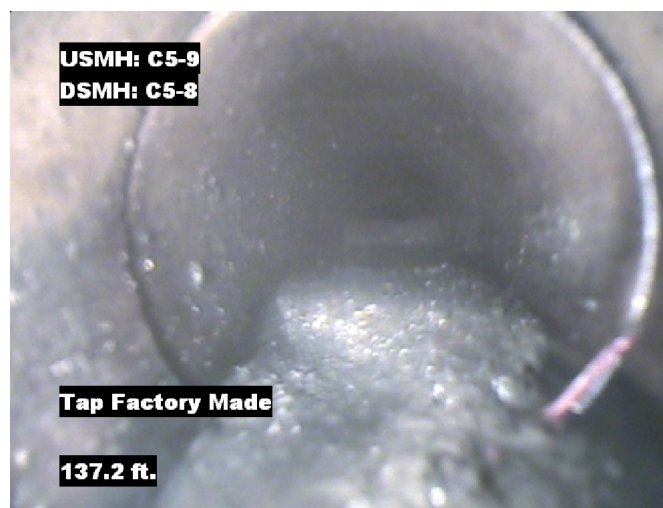
Distance: 137.2 ft. Grade: 0
Condition: Tap Factory Made
Remarks: N/A

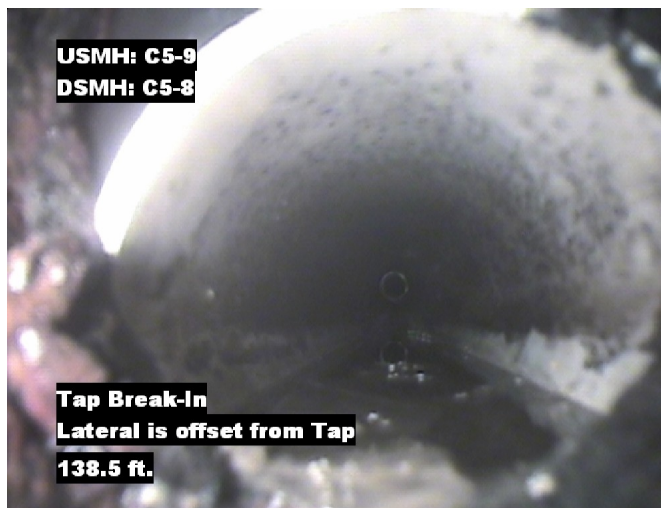
Distance: 138.5 ft. Grade: 0
Condition: Tap Break-In
Remarks: Lateral is offset from Tap

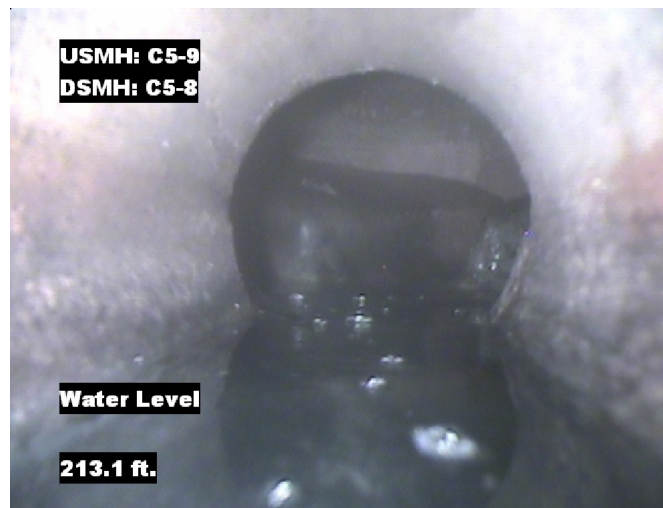
Distance: 213.1 ft. Grade: 0
Condition: Water Level
Remarks: N/A

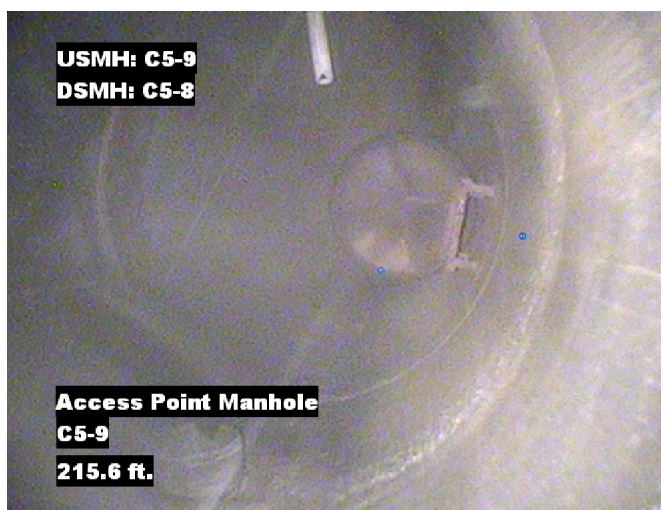
Distance: 215.6 ft. Grade: 0
Condition: Access Point Manhole
Remarks: C5-9
