Defect Listing

Pipe Segment Refere... C6-1_C5-14	City Oliver Springs	Street Cherokee Place	Material PolyVinyl Chloride		Location C... Easement/R...	Sewer Use Sanitary
Upstream MH C6-1	Total Length 303.5	Year Laid	Shape Circular		Location Details Apartment Complex	
DS Manhole C5-14	Length surveyed 303.5	Year Renewed	Height 8	Width 8	Pipe Joint... 13

Image Report 4/Page

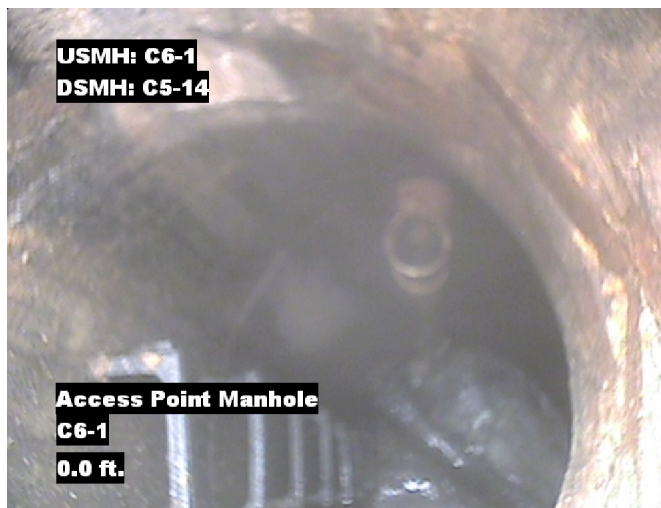
Distance: 0.0 ft. Grade: 0
Condition: Access Point Manhole
Remarks: C6-1

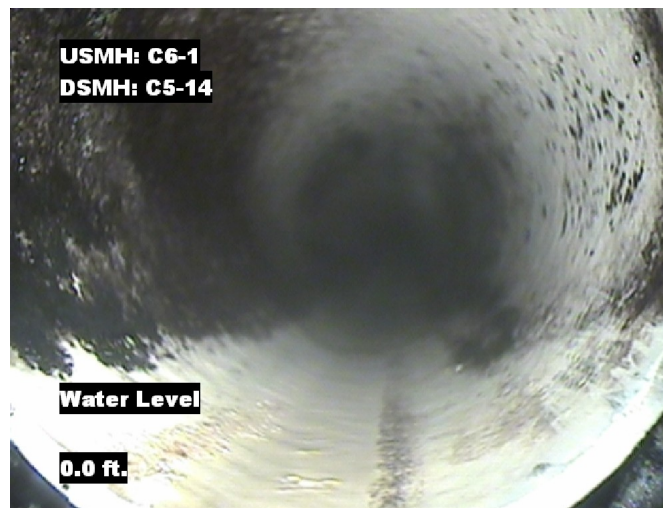
Distance: 0.0 ft. Grade: 0
Condition: Water Level
Remarks: N/A

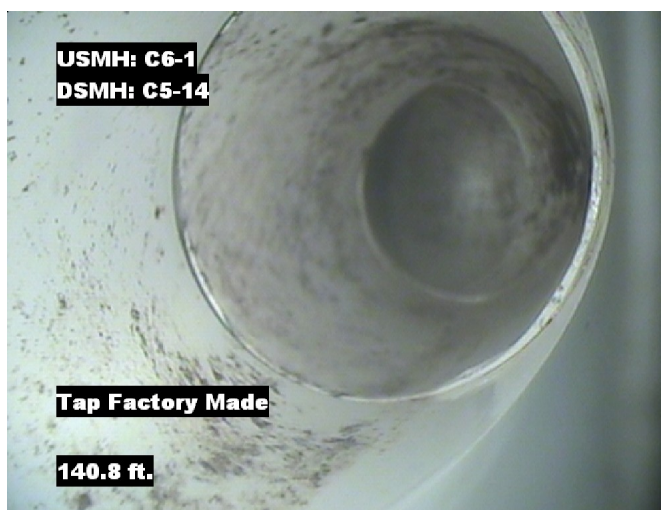
Distance: 140.8 ft. Grade: 0
Condition: Tap Factory Made
Remarks: N/A

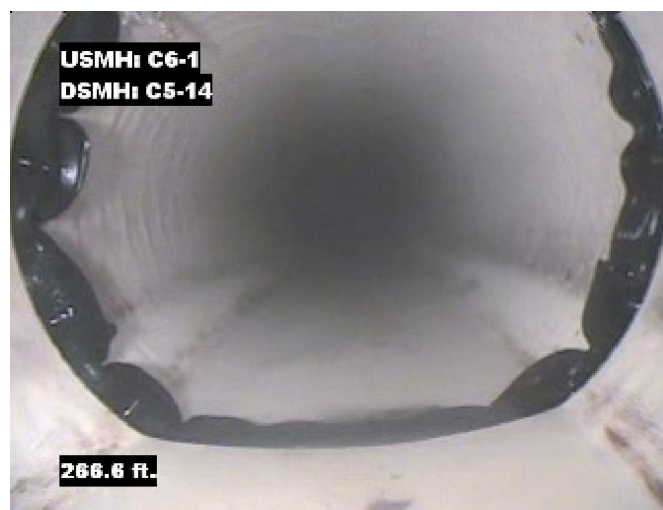
Distance: 266.7 ft. Grade: 2
Condition: Intruding Sealing Ring Loose/Poorly Fitting
Remarks: N/A

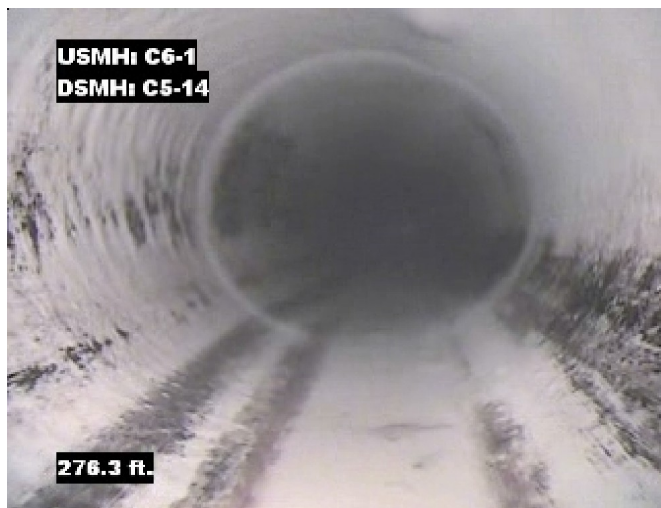
Distance: 276.5 ft. Grade: 3
Condition: Lining Failure Buckled
Remarks: N/A

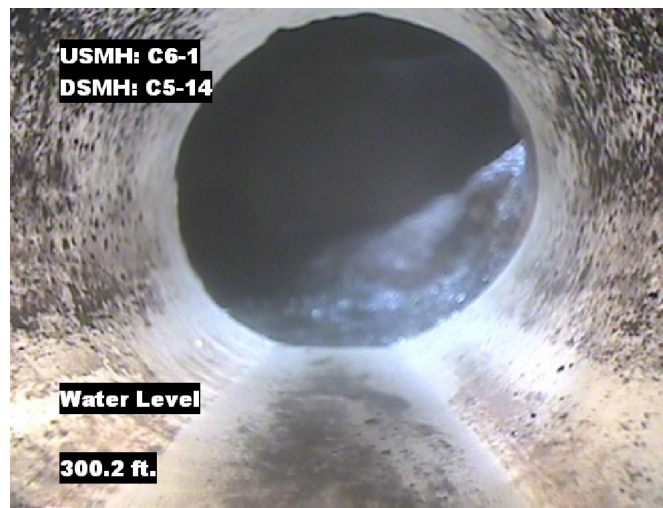
Distance: 300.2 ft. Grade: 0
Condition: Water Level
Remarks: N/A

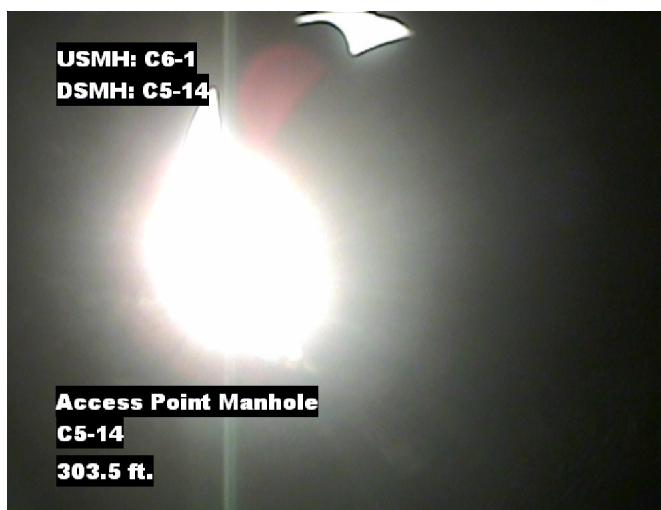
Distance: 303.5 ft. Grade: 0
Condition: Access Point Manhole
Remarks: C5-14
