## Defect Listing

Pipe Segment Refere... <b>C7-1_C5-6</b>	City <b>Oliver Springs</b>	Street <b>Mcghee St</b>	Material <b>Concrete Pipe (non-...</b>	Location C... <b>Light High...</b>	Sewer Use <b>Sanitary</b>
Upstream MH <b>C7-1</b>	Total Length <b>325.6</b>	Year Laid	Shape <b>Circular</b>	Location Details	
DS Manhole <b>C5-6</b>	Length surveyed <b>325.6</b>	Year Renewed	Height <b>8</b>	Width <b>8</b>	Pipe Joint... <b>4</b>

SPR <b>N/A</b>	MPR <b>N/A</b>	PO Number <b>4397-03</b>	Customer <b>GRW</b>
SPRI <b>N/A</b>	MPRI <b>N/A</b>	Work Order <b>4397-02</b>	Purpose <b>Pre-Rehabilitation Survey</b>
QSR <b>N/A</b>	QMR <b>N/A</b>		
OPR <b>N/A</b>	Surveyed By <b>Barry Rogers</b>	Direction <b>Downstream</b>	Date <b>20150722</b>
OPRI <b>N/A</b>	Certificate Number <b>U-1012-16405</b>	Pre-Cleaning <b>Jetting</b>	Time <b>09:29</b>
	Date Cleaned <b>20150722</b>	End Time <b>09:42</b>	Weather <b>Dry</b>
			Additional Info

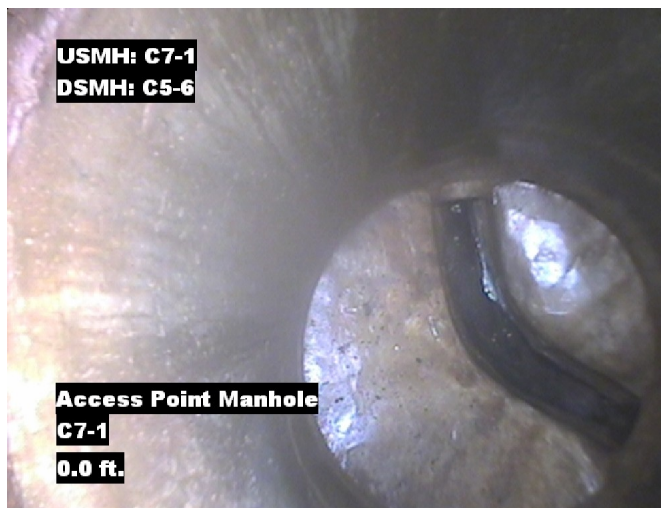
Distance: 0.0 ft. Grade: 0  
Condition: Access Point Manhole  
Remarks: C7-1

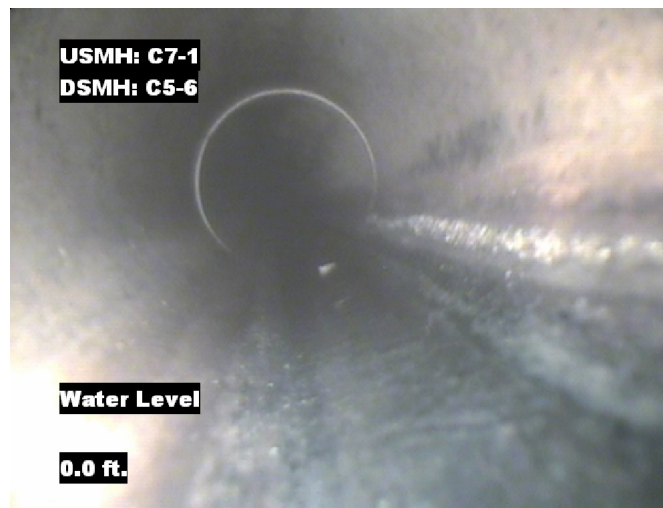
Distance: 0.0 ft. Grade: 0  
Condition: Water Level  
Remarks: N/A

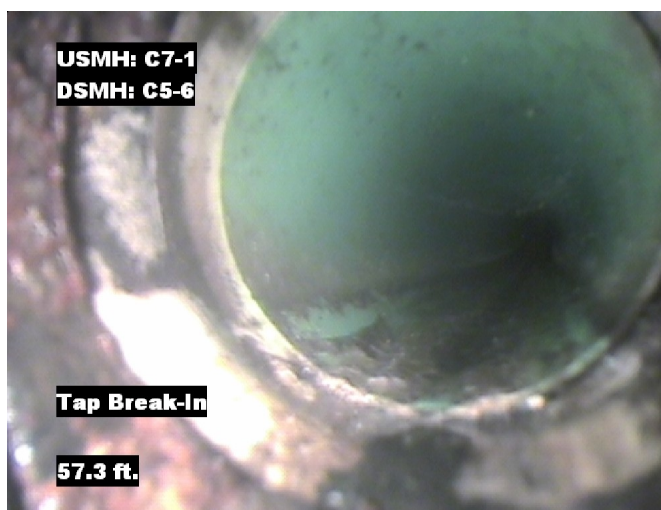
Distance: 57.3 ft. Grade: 0  
Condition: Tap Break-In  
Remarks: N/A

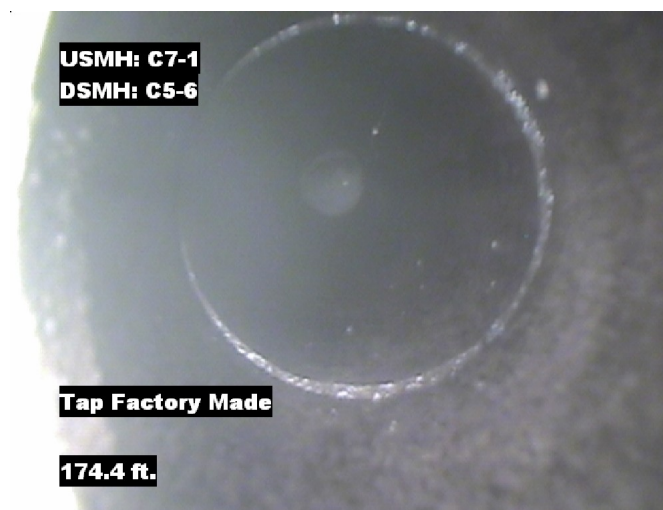
Distance: 174.4 ft. Grade: 0  
Condition: Tap Factory Made  
Remarks: N/A

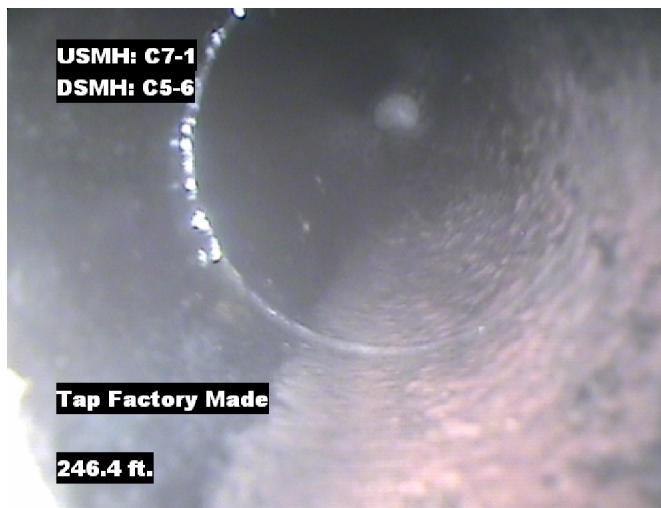
Distance: 246.4 ft. Grade: 0  
Condition: Tap Factory Made  
Remarks: N/A

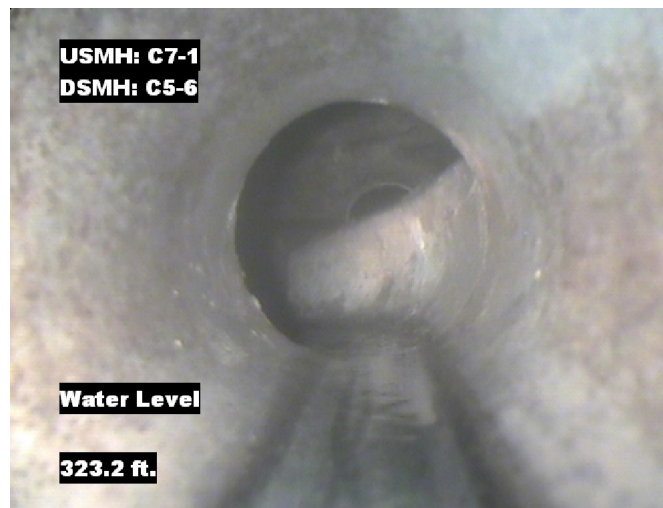
Distance: 323.2 ft. Grade: 0  
Condition: Water Level  
Remarks: N/A

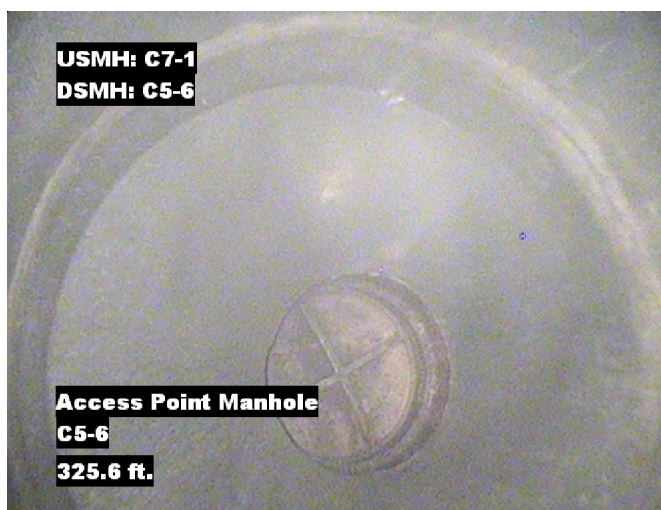
Distance: 325.6 ft. Grade: 0  
Condition: Access Point Manhole  
Remarks: C5-6
