## Defect Listing

Pipe Segment Refere... <b>C7-2_C7-1</b>	City <b>Oliver Springs</b>	Street <b>Mcghee St</b>	Material <b>Concrete Pipe (non-...</b>	Location C... <b>Light High...</b>	Sewer Use <b>Sanitary</b>
Upstream MH <b>C7-2</b>	Total Length <b>114.8</b>	Year Laid	Shape <b>Circular</b>	Location Details	
DS Manhole <b>C7-1</b>	Length surveyed <b>114.8</b>	Year Renewed	Height <b>8</b>	Width <b>8</b>	Pipe Joint... <b>4</b>

SPR <b>N/A</b>	MPR <b>4</b>	PO Number <b>4397-03</b>	Customer <b>GRW</b>
SPRI <b>N/A</b>	MPRI <b>4</b>	Work Order <b>4397-02</b>	Purpose <b>Pre-Rehabilitation Survey</b>
QSR <b>N/A</b>	QMR <b>4100</b>		
OPR <b>4</b>	Surveyed By <b>Barry Rogers</b>	Direction <b>Upstream</b>	Date <b>20150722</b>
OPRI <b>4</b>	Certificate Number <b>U-1012-16405</b>	Pre-Cleaning <b>Jetting</b>	Time <b>09:18</b>
	Date Cleaned <b>20150722</b>	End Time <b>09:25</b>	Weather <b>Dry</b>
			Media label
			Additional Info

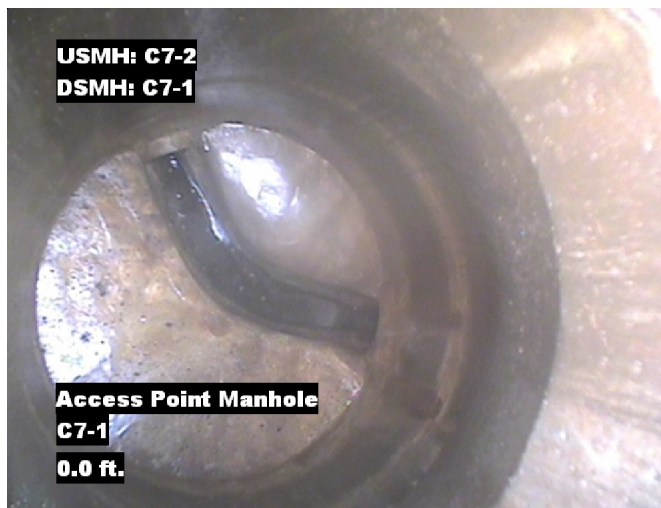
Distance: 0.0 ft. Grade: 0  
Condition: Access Point Manhole  
Remarks: C7-1

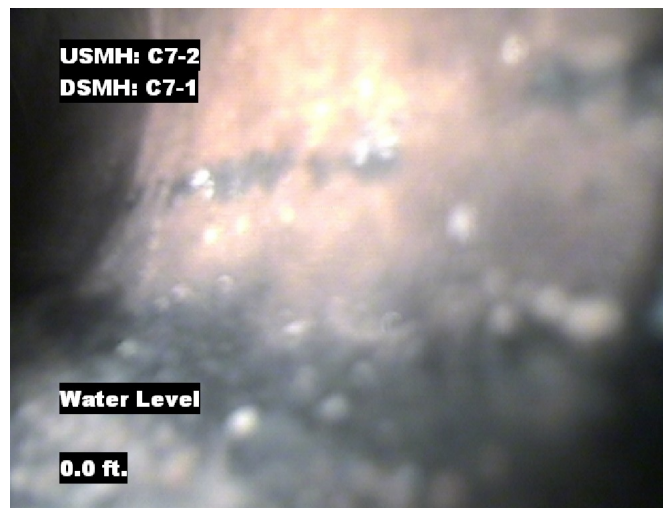
Distance: 0.0 ft. Grade: 0  
Condition: Water Level  
Remarks: N/A

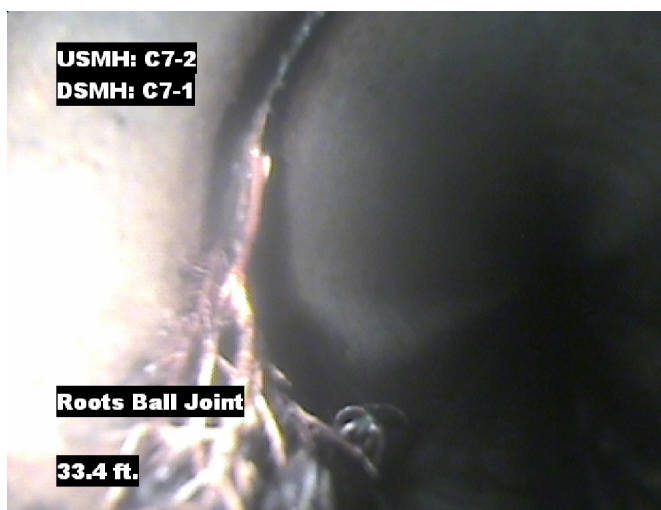
Distance: 33.4 ft. Grade: 4  
Condition: Roots Ball Joint  
Remarks: N/A

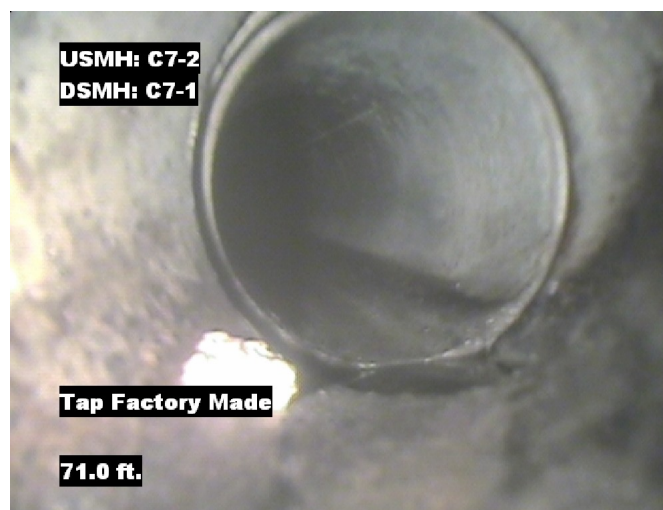
Distance: 71.0 ft. Grade: 0  
Condition: Tap Factory Made  
Remarks: N/A

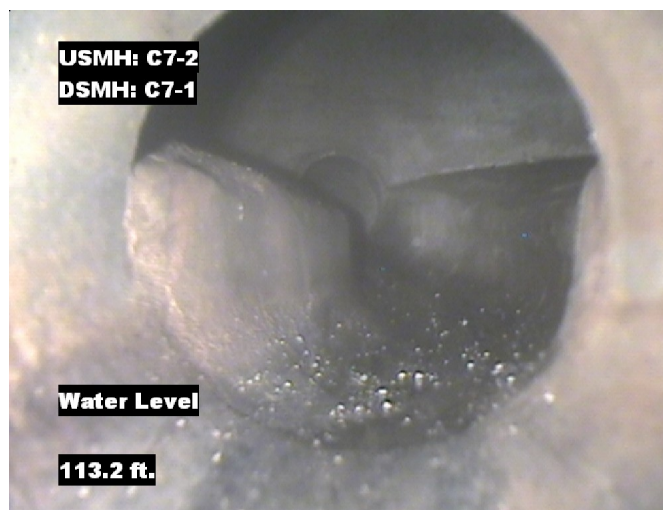
Distance: 113.2 ft.      Grade: 0  
Condition: Water Level  
Remarks: N/A

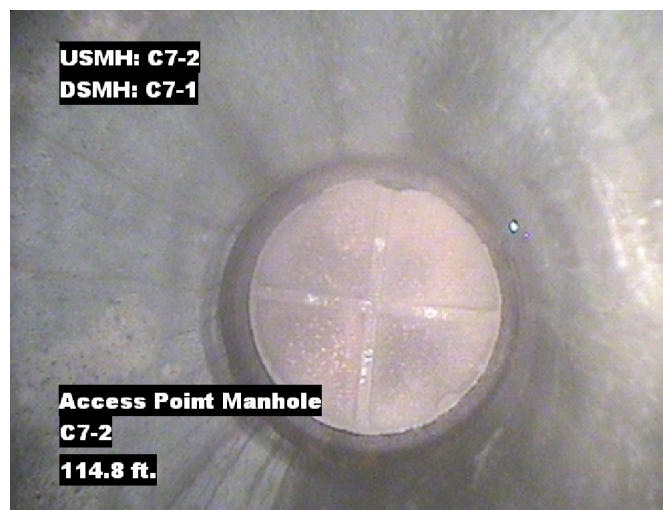
Distance: 114.8 ft.      Grade: 0  
Condition: Access Point Manhole  
Remarks: C7-2
