Defect Listing

Pipe Segment Refere... C7-3_C7-2	City Oliver Springs	Street Mcghee st	Material Concrete Pipe (non-...	Location C... Light High...	Sewer Use Sanitary
Upstream MH C7-3	Total Length 161.6	Year Laid	Shape Circular	Location Details	
DS Manhole C7-2	Length surveyed 161.6	Year Renewed	Height 8	Width 8	Pipe Joint... 4

Image Report 4/Page

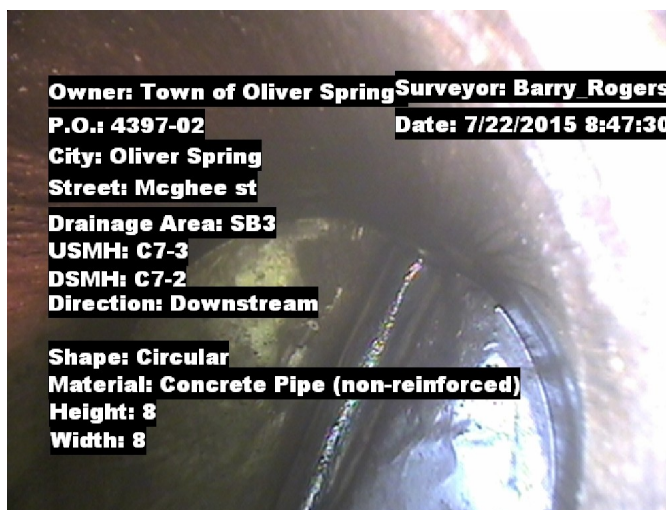
Distance: 0.0 ft. Grade: 0
Condition: Access Point Manhole
Remarks: C7-3

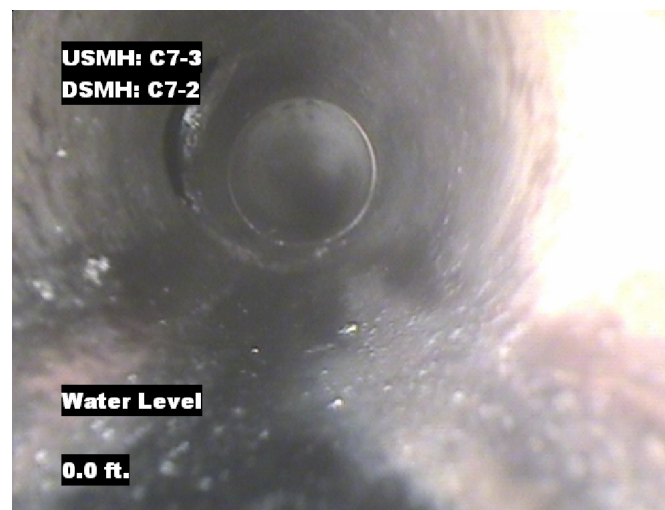
Distance: 0.0 ft. Grade: 0
Condition: Water Level
Remarks: N/A

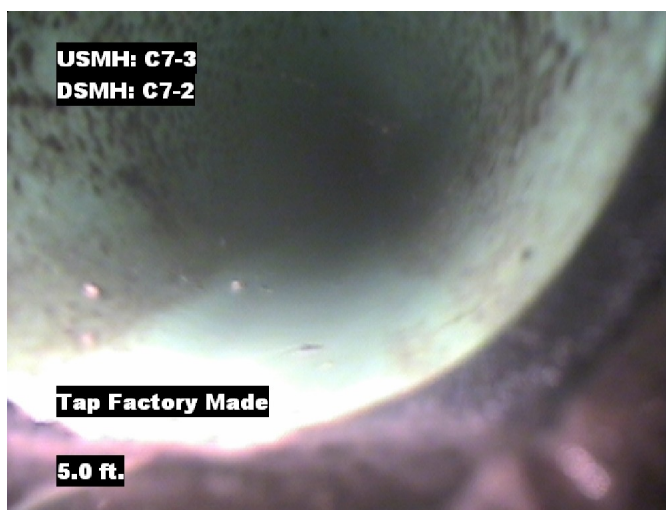
Distance: 5.0 ft. Grade: 0
Condition: Tap Factory Made
Remarks: N/A

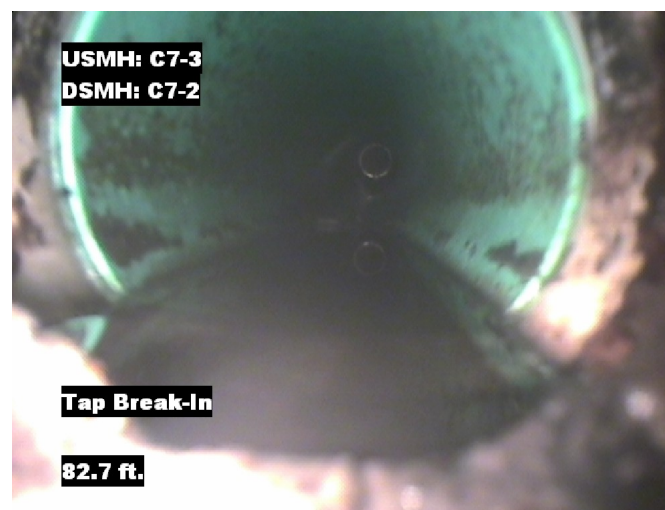
Distance: 82.7 ft. Grade: 0
Condition: Tap Break-In
Remarks: N/A

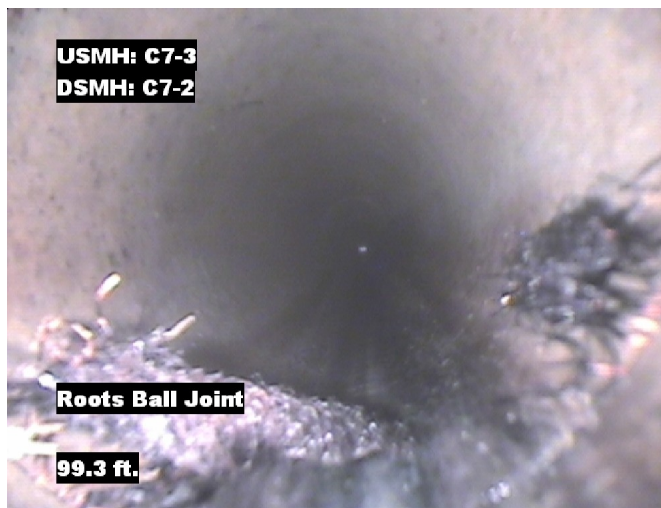
Distance: 99.3 ft. Grade: 4
Condition: Roots Ball Joint
Remarks: N/A

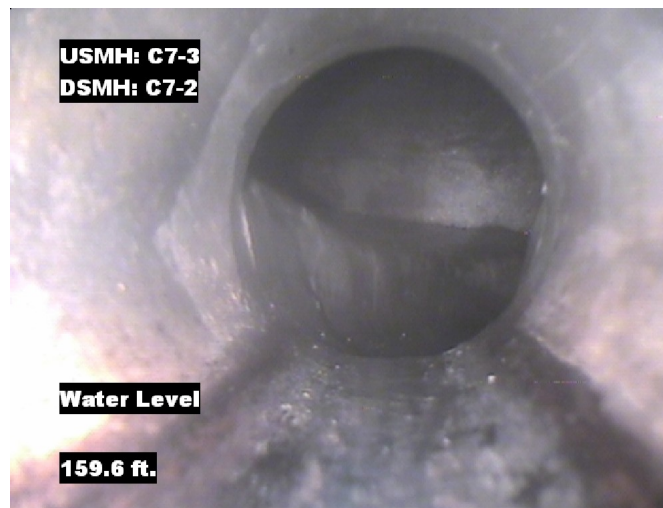
Distance: 159.5 ft. Grade: 0
Condition: Water Level
Remarks: N/A

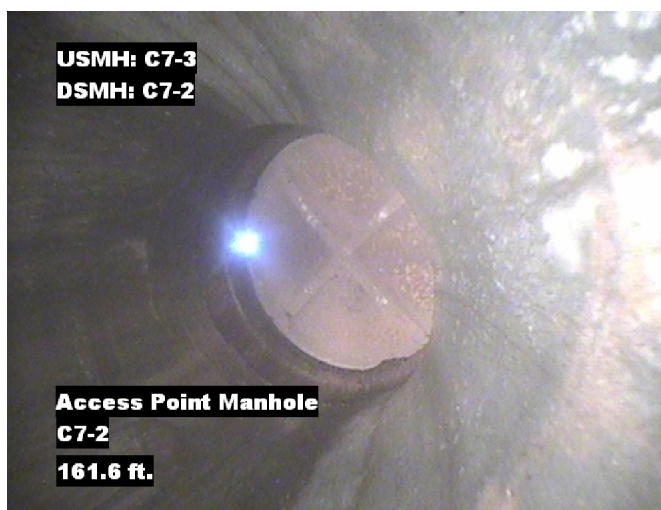
Distance: 161.6 ft. Grade: 0
Condition: Access Point Manhole
Remarks: C7-2
