Defect Listing

Pipe Segment Refere... C8-1_C-15	City Oliver Springs	Street Steward LN	Material Concrete Pipe (non-...	Location C... Yard	Sewer Use Sanitary
Upstream MH C8-1	Total Length 165.3	Year Laid	Shape Circular	Location Details	
DS Manhole C-15	Length surveyed 165.3	Year Renewed	Height 8	Width 8	Pipe Joint... 4

SPR N/A	MPR 1	PO Number 4397-03	Customer GRW
SPRI N/A	MPRI 1	Work Order 4397-02	Purpose Pre-Rehabilitation Survey
QSR N/A	QMR 1100		
OPR 1	Surveyed By Barry Rogers	Direction Upstream	Date 20150720
OPRI 1	Certificate Number U-1012-16405	Pre-Cleaning Jetting	Time 08:46
	Date Cleaned 20150720	End Time 09:03	Weather Dry
			Media label
			Additional Info

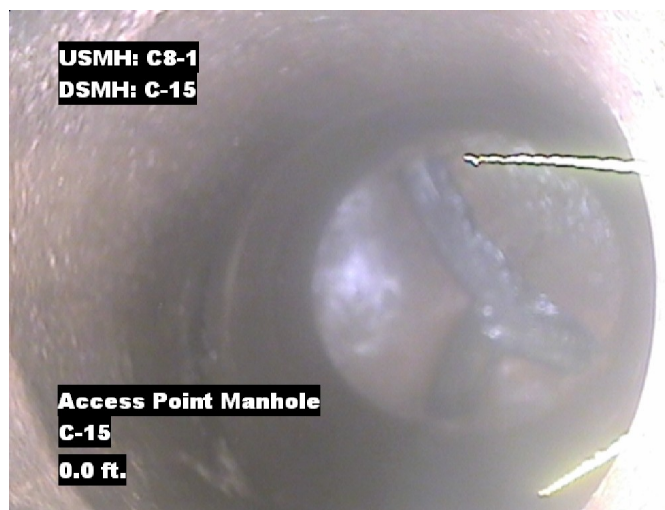
Distance: 0.0 ft. Grade: 0
Condition: Access Point Manhole
Remarks: C-15

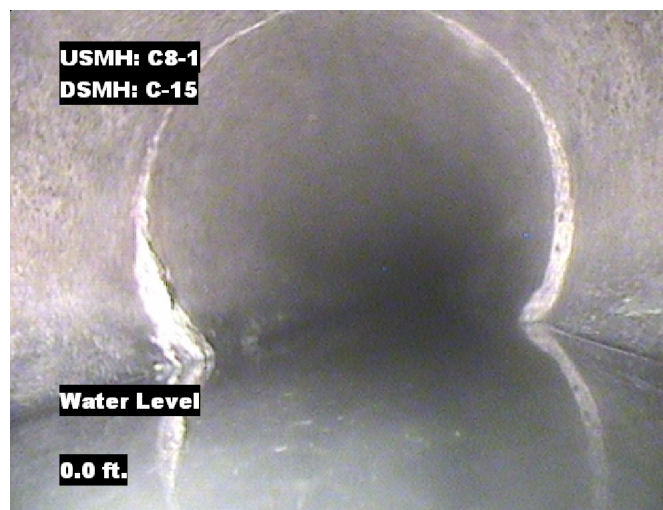
Distance: 0.0 ft. Grade: 0
Condition: Water Level
Remarks: N/A

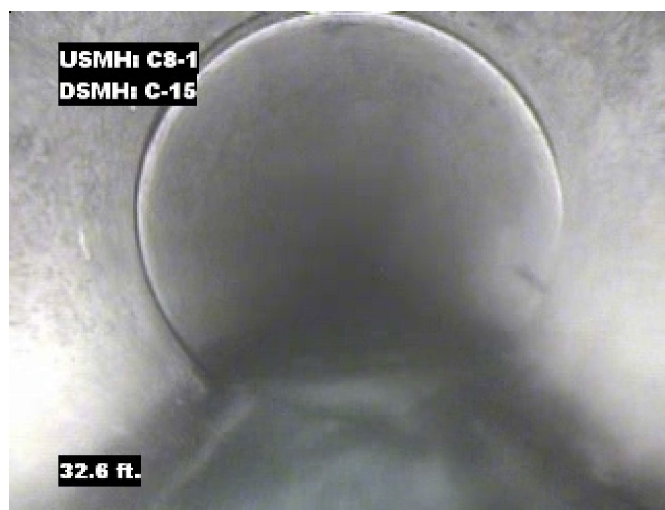
Distance: 32.8 ft. Grade: 1
Condition: Roots Fine Joint
Remarks: N/A

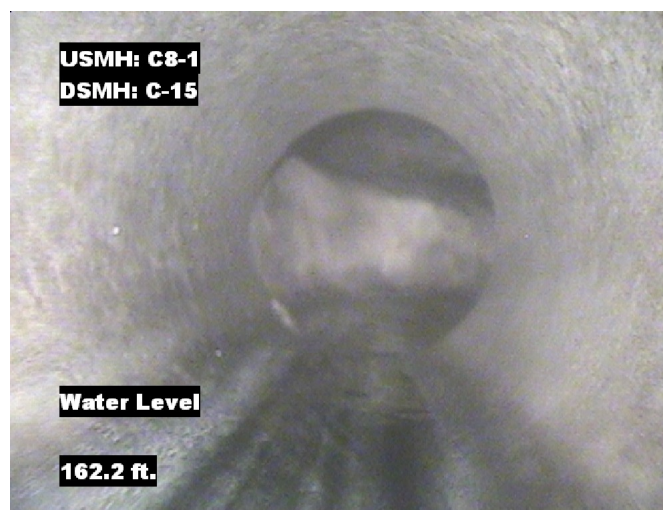
Distance: 162.1 ft. Grade: 0
Condition: Water Level
Remarks: N/A

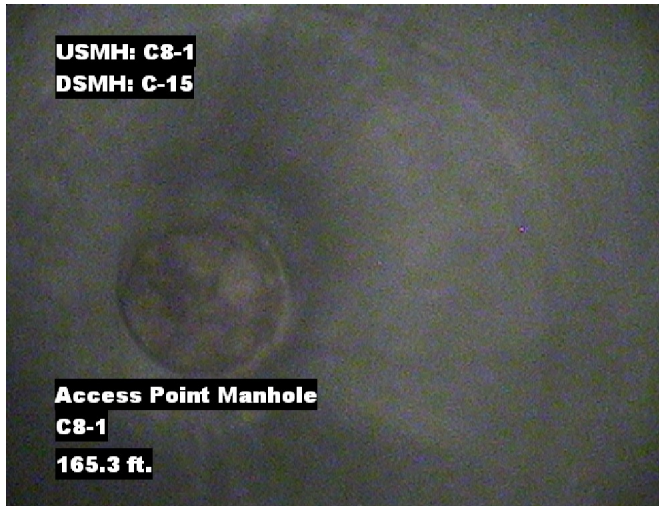
Distance: 165.3 ft. Grade: 0
Condition: Access Point Manhole
Remarks: C8-1
