Defect Listing

Pipe Segment Refere... C8-10_C8-9	City Oliver Springs	Street Dellwood DR	Material Concrete Pipe (non-...	Location C... Light High...	Sewer Use Sanitary
Upstream MH C8-10	Total Length 277.1	Year Laid	Shape Circular	Location Details	
DS Manhole C8-9	Length surveyed 277.1	Year Renewed	Height 8	Width 8	Pipe Joint... 4

SPR N/A	MPR N/A	PO Number 4397-03	Customer GRW
SPRI N/A	MPRI N/A	Work Order 4397-02	Purpose Pre-Rehabilitation Survey
QSR N/A	QMR N/A		
OPR N/A	Surveyed By Barry Rogers	Direction Downstream	Date 20150720
OPRI N/A	Certificate Number U-1012-16405	Pre-Cleaning Jetting	Time 10:27
	Date Cleaned 20150720	End Time 10:47	Weather Dry
			Additional Info

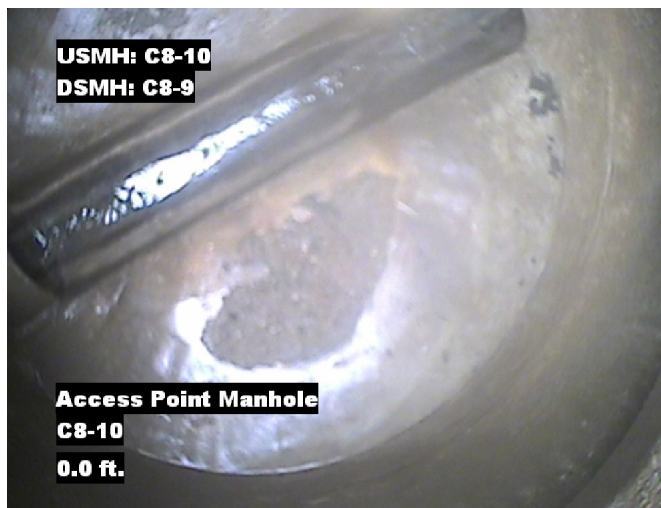
Distance: 0.0 ft. Grade: 0
Condition: Access Point Manhole
Remarks: C8-10

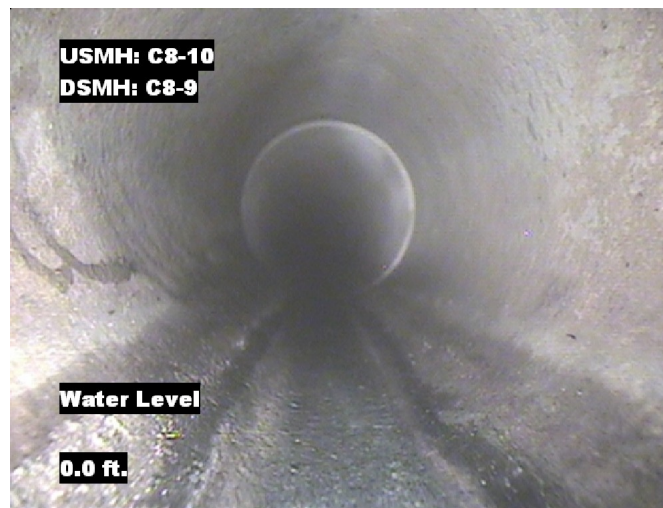
Distance: 0.0 ft. Grade: 0
Condition: Water Level
Remarks: N/A

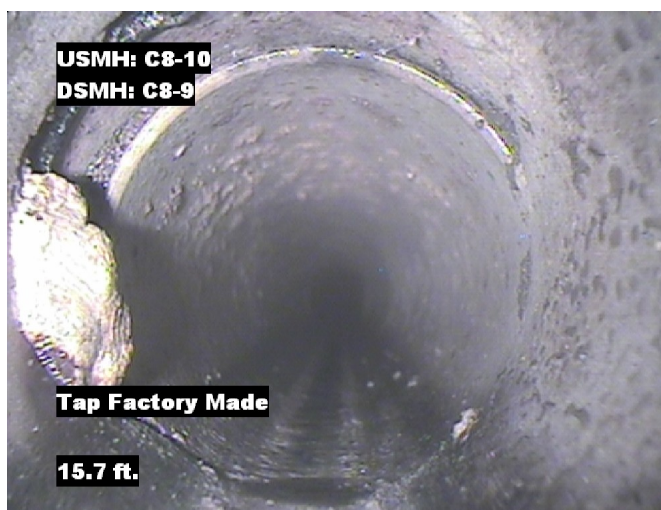
Distance: 15.7 ft. Grade: 0
Condition: Tap Factory Made
Remarks: N/A

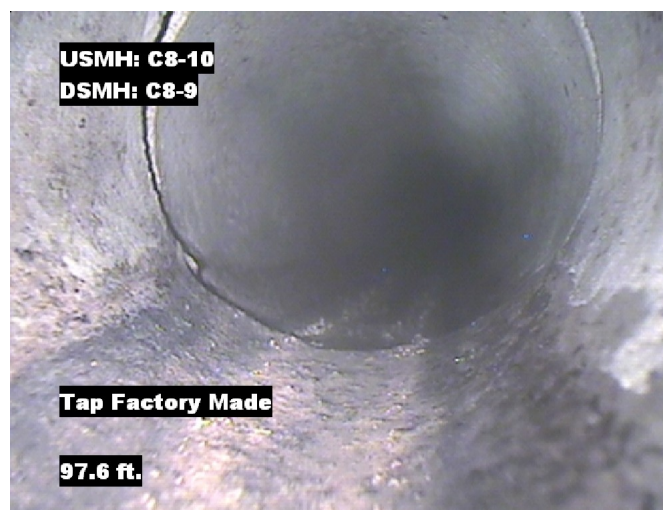
Distance: 97.6 ft. Grade: 0
Condition: Tap Factory Made
Remarks: N/A

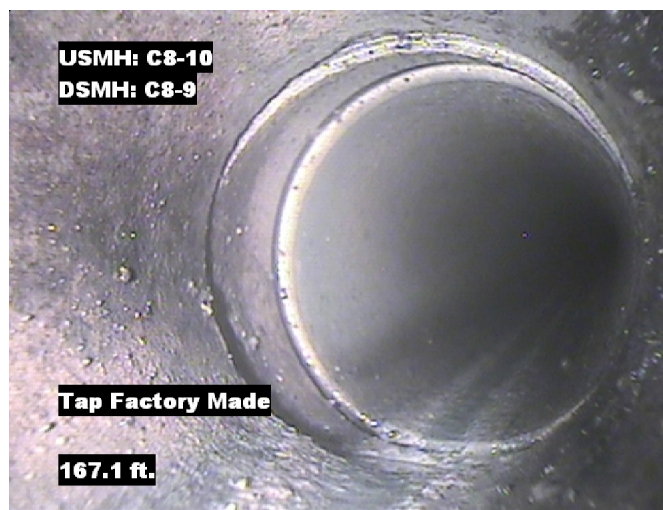
Distance: 167.1 ft. Grade: 0
Condition: Tap Factory Made
Remarks: N/A

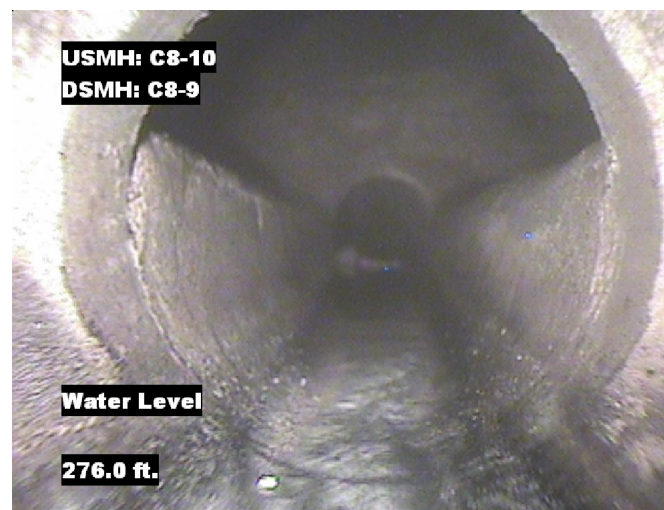
Distance: 275.9 ft. Grade: 0
Condition: Water Level
Remarks: N/A

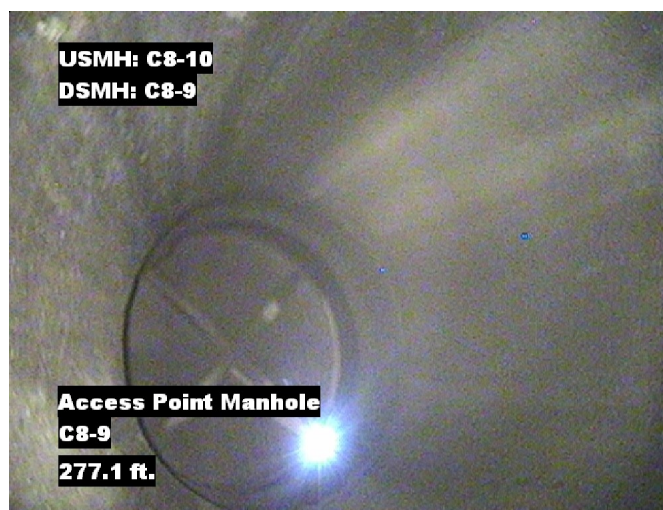
Distance: 277.1 ft. Grade: 0
Condition: Access Point Manhole
Remarks: C8-9
