Defect Listing

Pipe Segment Refere... C8-11_C8-10	City Oliver Springs	Street Dellwood Dr	Material Concrete Pipe (non-...	Location C... Light High...	Sewer Use Sanitary
Upstream MH C8-11	Total Length 242.7	Year Laid	Shape Circular	Location Details	
DS Manhole C8-10	Length surveyed 242.7	Year Renewed	Height 8	Width 8	Pipe Joint... 4

SPR N/A	MPR N/A	PO Number 4397-03	Customer GRW
SPRI N/A	MPRI N/A	Work Order 4397-02	Purpose Pre-Rehabilitation Survey
QSR N/A	QMR N/A		
OPR N/A	Surveyed By Barry Rogers	Direction Downstream	Date 20150720
OPRI N/A	Certificate Number U-1012-16405	Pre-Cleaning Jetting	Time 09:58
	Date Cleaned 20150720	End Time 10:16	Weather Dry
			Additional Info

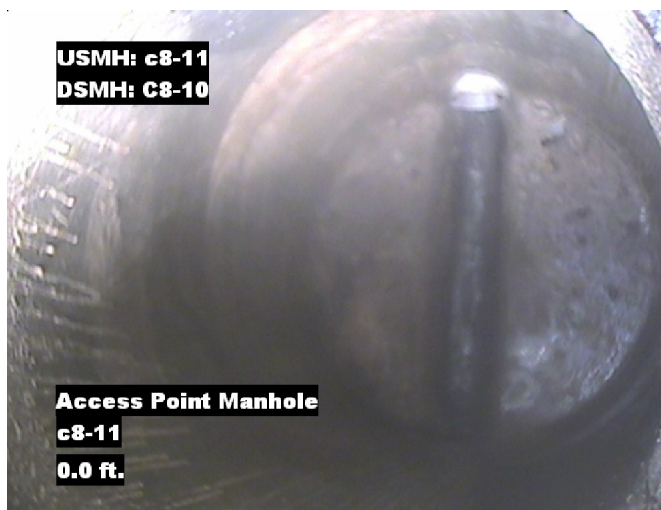
Distance: 0.0 ft. Grade: 0
Condition: Access Point Manhole
Remarks: c8-11

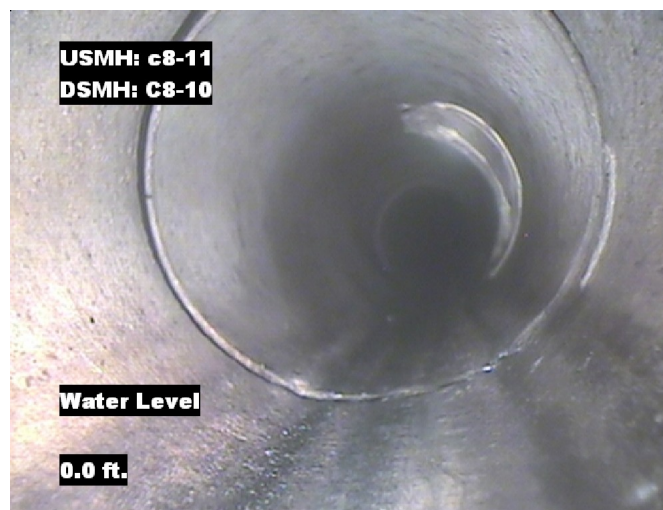
Distance: 0.0 ft. Grade: 0
Condition: Water Level
Remarks: N/A

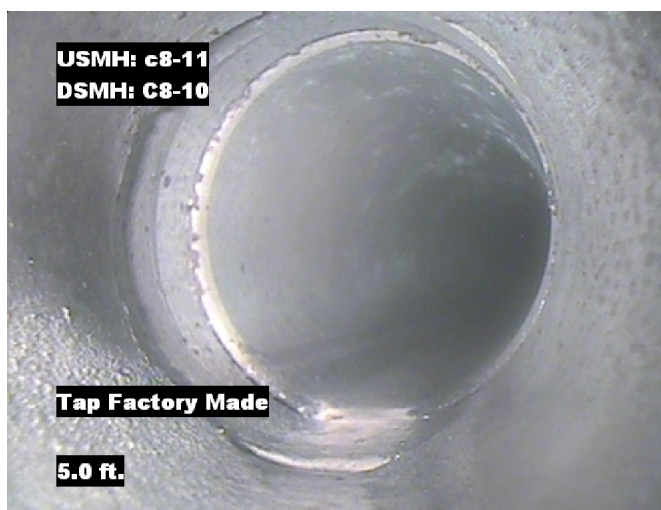
Distance: 5.0 ft. Grade: 0
Condition: Tap Factory Made
Remarks: N/A

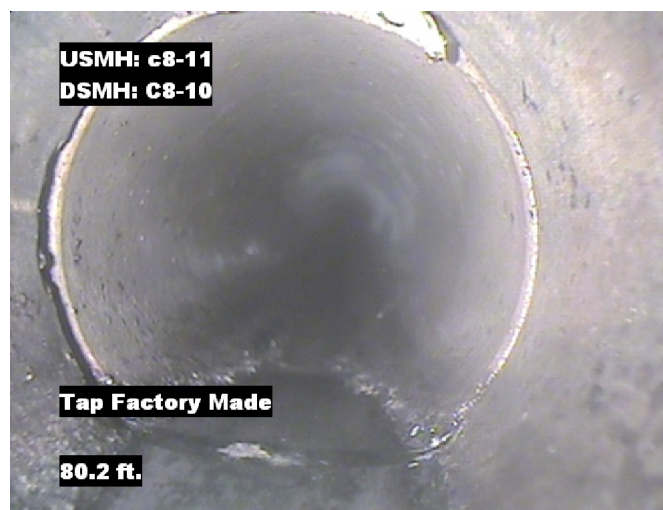
Distance: 80.2 ft. Grade: 0
Condition: Tap Factory Made
Remarks: N/A

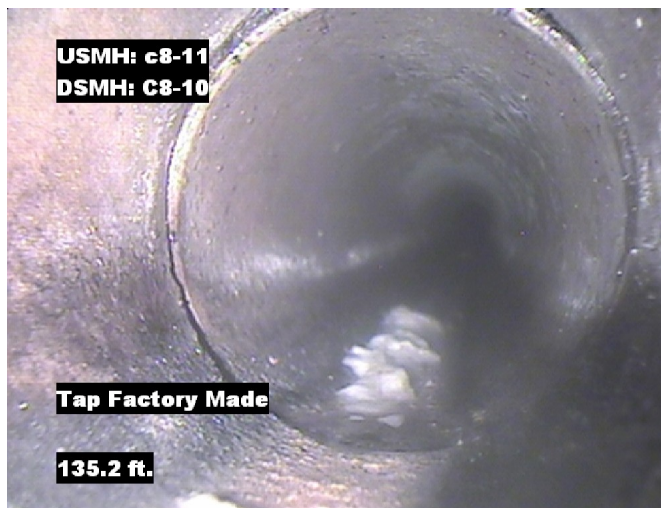
Distance: 135.2 ft. Grade: 0
Condition: Tap Factory Made
Remarks: N/A

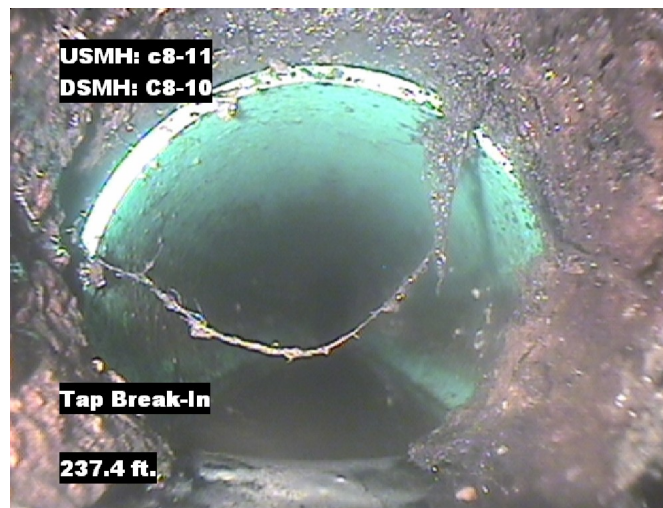
Distance: 237.4 ft. Grade: 0
Condition: Tap Break-In
Remarks: N/A

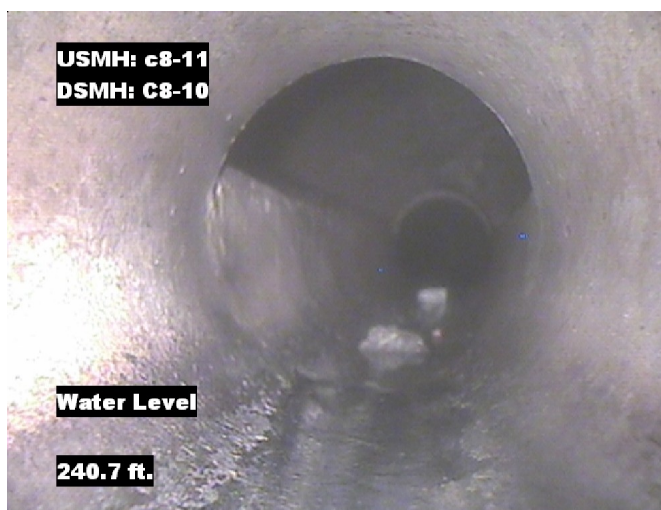
Distance: 240.7 ft. Grade: 0
Condition: Water Level
Remarks: N/A

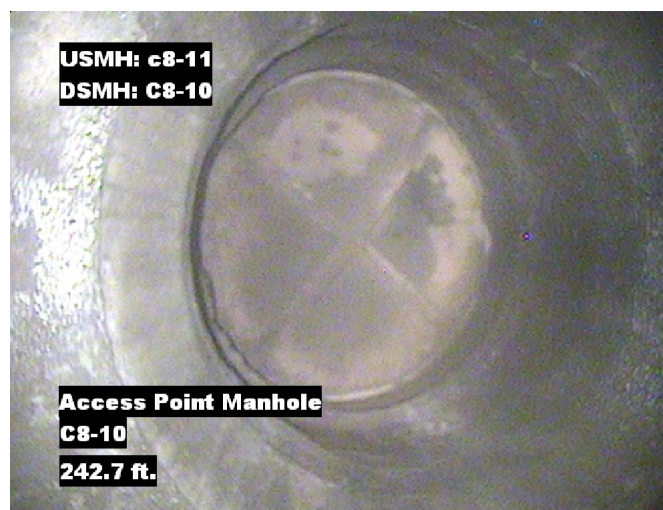
Distance: 242.7 ft. Grade: 0
Condition: Access Point Manhole
Remarks: C8-10
