## Defect Listing

Pipe Segment Refere... <b>C8-12_C8-11</b>	City <b>Oliver Springs</b>	Street <b>Dellwood Dr</b>	Material <b>PolyVinyl Chloride</b>	Location C... <b>Light High...</b>	Sewer Use <b>Sanitary</b>
Upstream MH <b>C8-12</b>	Total Length <b>276.9</b>	Year Laid	Shape <b>Circular</b>	Location Details	
DS Manhole <b>C8-11</b>	Length surveyed <b>276.9</b>	Year Renewed	Height <b>8</b>	Width <b>8</b>	Pipe Joint... <b>13</b>

SPR <b>N/A</b>	MPR <b>N/A</b>	PO Number <b>4397-03</b>		Customer <b>GRW</b>	
SPRI <b>N/A</b>	MPRI <b>N/A</b>	Work Order <b>4397-02</b>		Purpose <b>Pre-Rehabilitation Survey</b>	
QSR <b>N/A</b>	QMR <b>N/A</b>				
OPR <b>N/A</b>	Surveyed By <b>Barry Rogers</b>	Direction <b>Downstream</b>	Date <b>20150720</b>	Media label	
OPRI <b>N/A</b>	Certificate Number <b>U-1012-16405</b>	Pre-Cleaning <b>Jetting</b>	Time <b>09:24</b>	Weather <b>Dry</b>	
Date Cleaned <b>20150720</b>			End Time <b>09:45</b>	Additional Info

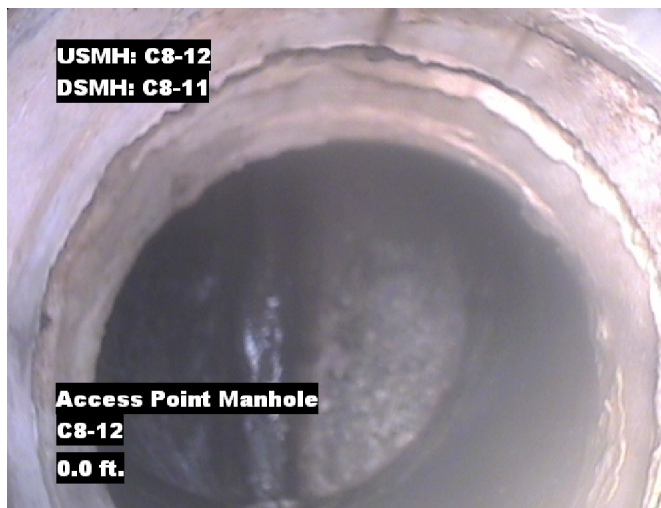
Distance: 0.0 ft. Grade: 0  
Condition: Access Point Manhole  
Remarks: C8-12

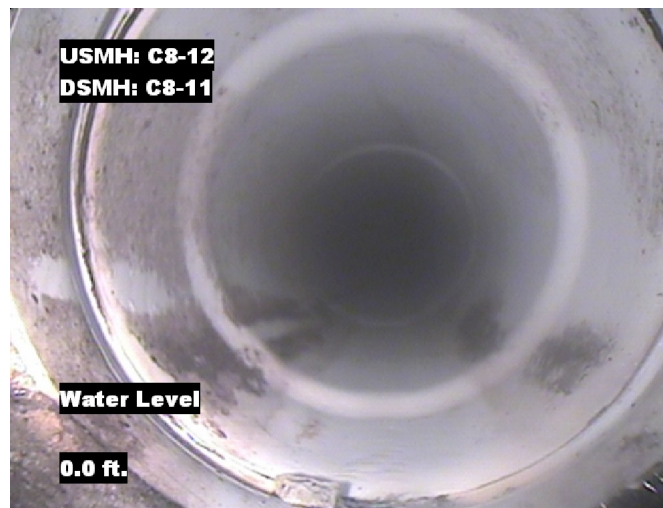
Distance: 0.0 ft. Grade: 0  
Condition: Water Level  
Remarks: N/A

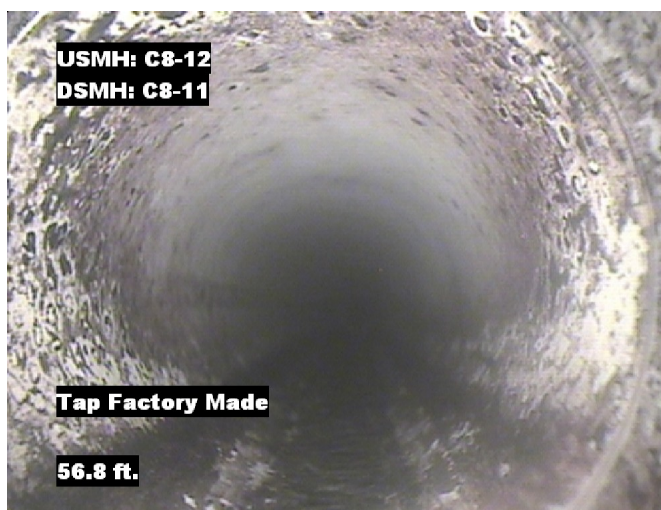
Distance: 56.8 ft. Grade: 0  
Condition: Tap Factory Made  
Remarks: N/A

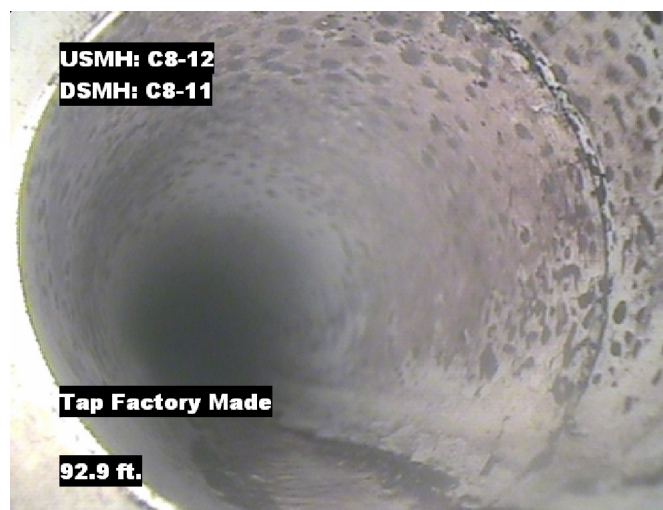
Distance: 92.9 ft. Grade: 0  
Condition: Tap Factory Made  
Remarks: N/A

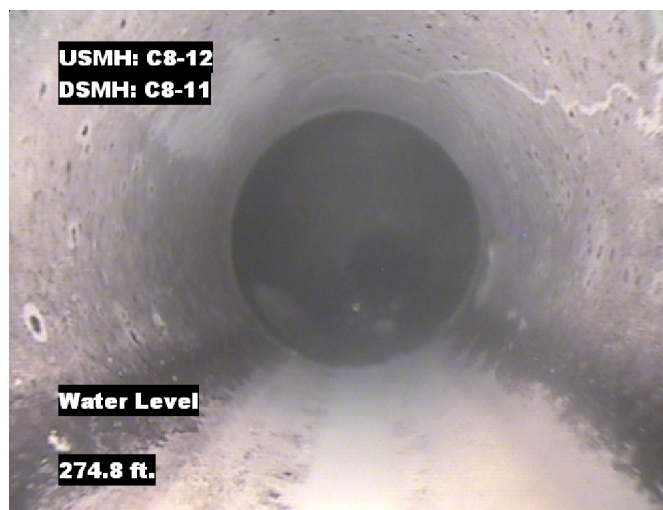
Distance: 274.7 ft.      Grade: 0  
Condition: Water Level  
Remarks: N/A

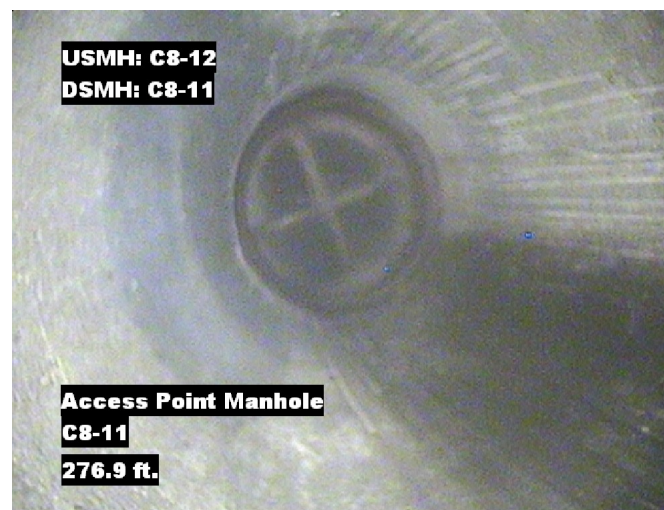
Distance: 276.9 ft.      Grade: 0  
Condition: Access Point Manhole  
Remarks: C8-11
