Defect Listing

Pipe Segment Refere... C8-2_C8-1	City Oliver Springs	Street easement	Material Concrete Pipe (non-...	Location C... Easement/R...	Sewer Use Sanitary
Upstream MH C8-2	Total Length 288.5	Year Laid	Shape Circular	Location Details Behind houses	
DS Manhole C8-1	Length surveyed 288.5	Year Renewed	Height 8	Width 8	Pipe Joint... 4

Image Report 4/Page

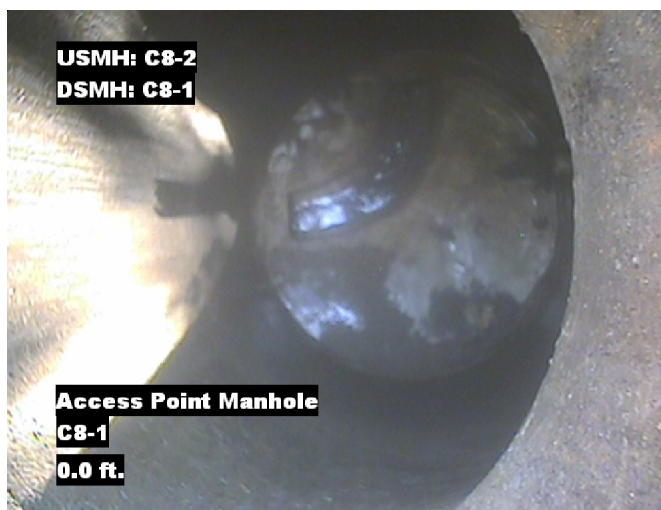
Distance: 0.0 ft. Grade: 0
Condition: Access Point Manhole
Remarks: C8-1

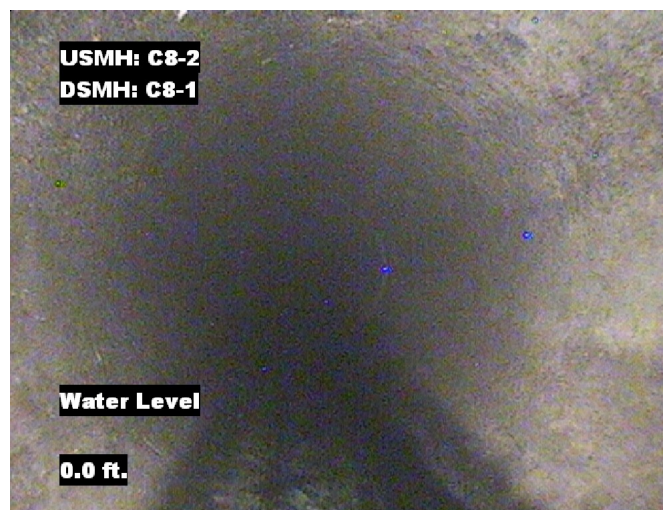
Distance: 0.0 ft. Grade: 0
Condition: Water Level
Remarks: N/A

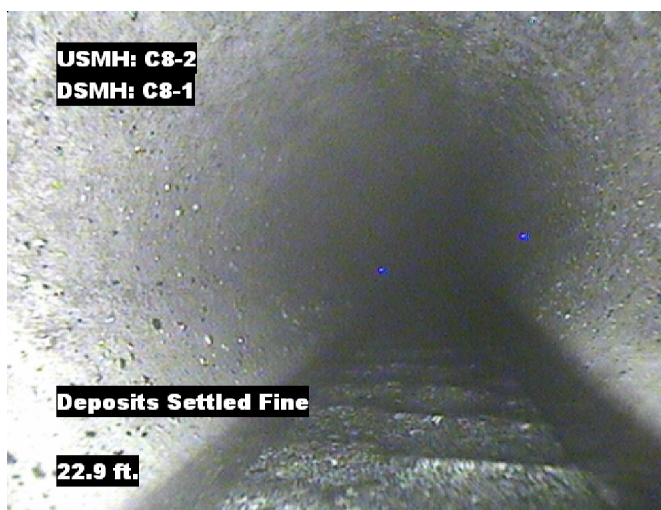
Distance: 22.9 ft. Grade: 2
Condition: Deposits Settled Fine
Remarks: N/A

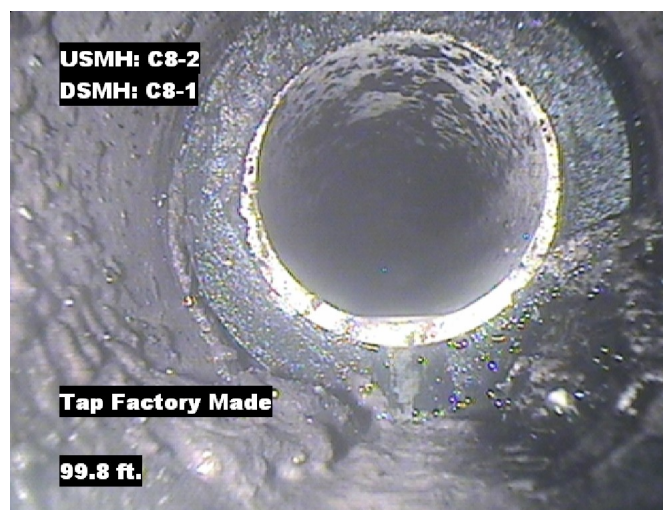
Distance: 99.8 ft. Grade: 0
Condition: Tap Factory Made
Remarks: N/A

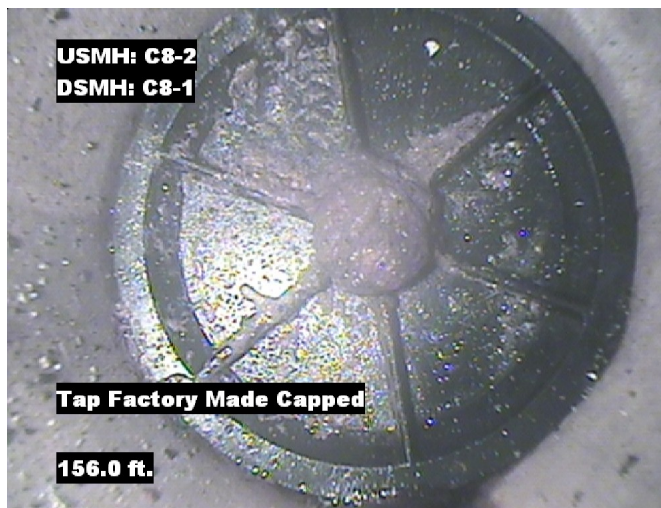
Distance: 156.0 ft. Grade: 0
Condition: Tap Factory Made Capped
Remarks: N/A

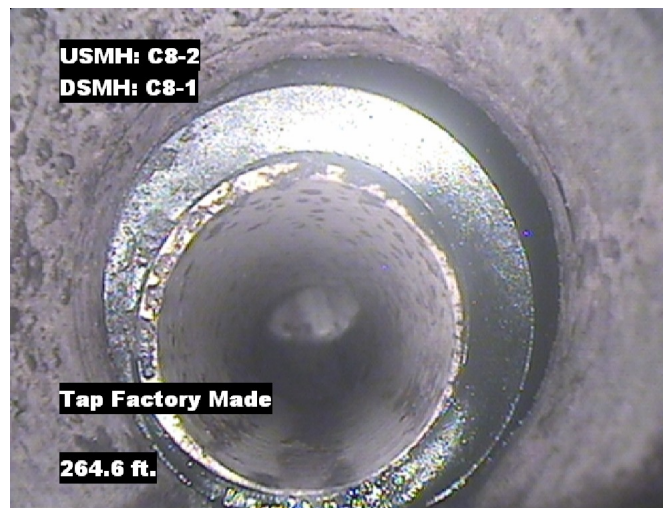
Distance: 264.6 ft. Grade: 0
Condition: Tap Factory Made
Remarks: N/A

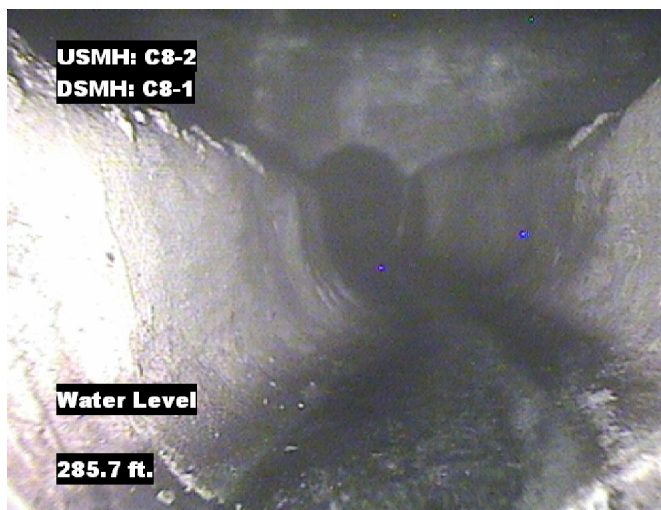
Distance: 285.6 ft. Grade: 0
Condition: Water Level
Remarks: N/A

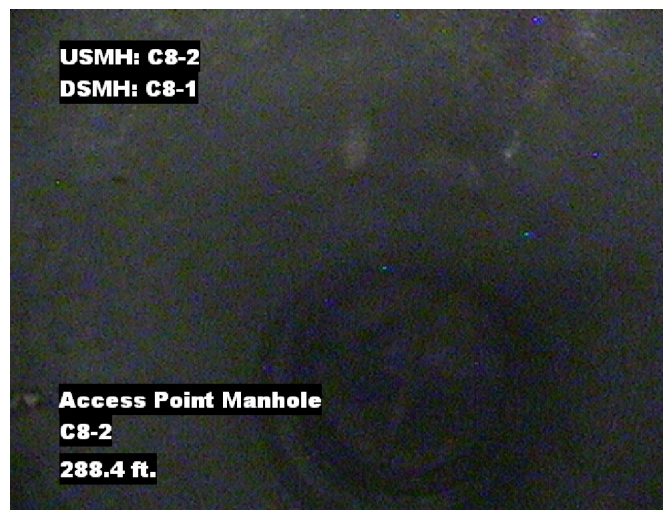
Distance: 288.5 ft. Grade: 0
Condition: Access Point Manhole
Remarks: C8-2
