## Defect Listing

Pipe Segment Refere... <b>C8-3_C8-2</b>	City <b>Oliver Springs</b>	Street <b>Easement</b>	Material <b>Concrete Pipe (non-...</b>	Location C... <b>Easement/R...</b>	Sewer Use <b>Sanitary</b>
Upstream MH <b>C8-3</b>	Total Length <b>227.4</b>	Year Laid	Shape <b>Circular</b>	Location Details	
DS Manhole <b>C8-2</b>	Length surveyed <b>228.6</b>	Year Renewed	Height <b>8</b>	Width <b>8</b>	Pipe Joint... <b>4</b>

SPR <b>N/A</b>	MPR <b>2</b>	PO Number <b>4397-03</b>	Customer <b>GRW</b>
SPRI <b>N/A</b>	MPRI <b>2</b>	Work Order <b>4397-02</b>	Purpose <b>Pre-Rehabilitation Survey</b>
QSR <b>N/A</b>	QMR <b>2100</b>		
OPR <b>2</b>	Surveyed By <b>Barry Rogers</b>	Direction <b>Downstream</b>	Date <b>20150724</b>
OPRI <b>2</b>	Certificate Number <b>U-1012-16405</b>	Pre-Cleaning <b>Jetting</b>	Time <b>07:10</b>
	Date Cleaned <b>20150724</b>	End Time <b>07:18</b>	Weather <b>Saturated</b>
			Media label
			Additional Info

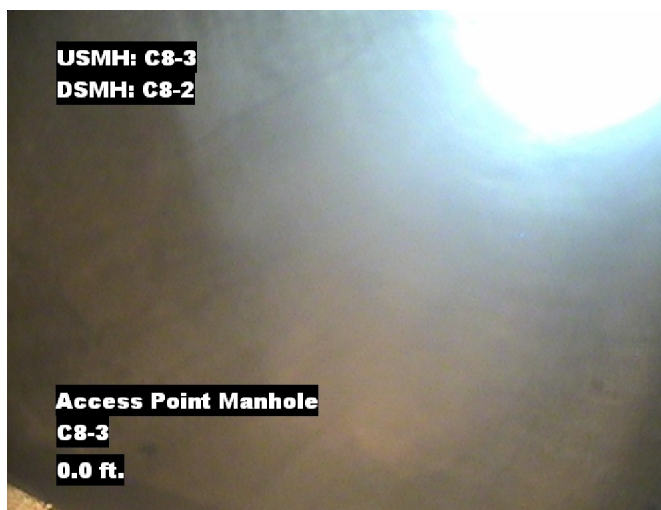
Distance: 0.0 ft. Grade: 0  
Condition: Access Point Manhole  
Remarks: C8-3

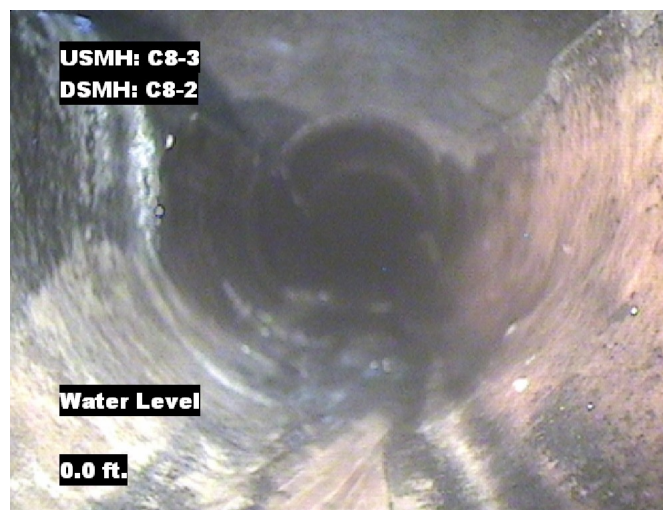
Distance: 0.0 ft. Grade: 0  
Condition: Water Level  
Remarks: N/A

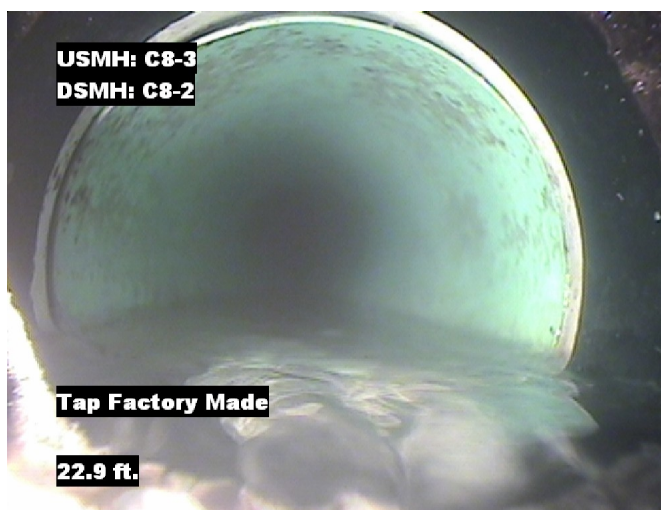
Distance: 22.9 ft. Grade: 0  
Condition: Tap Factory Made  
Remarks: N/A

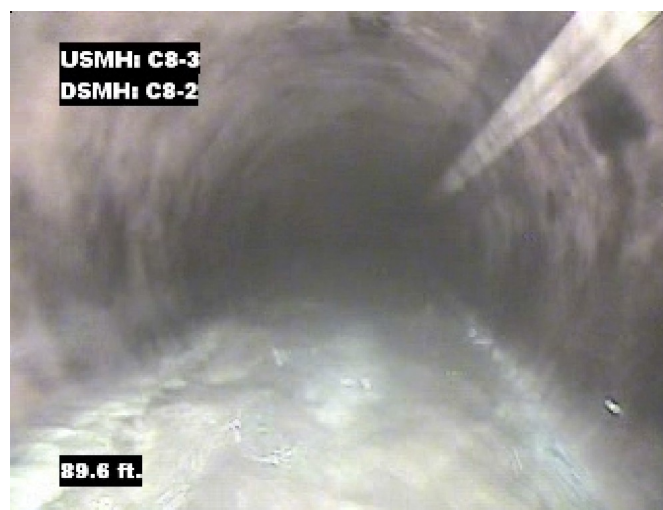
Distance: 89.6 ft. Grade: 2  
Condition: Water Level Sag  
Remarks: N/A

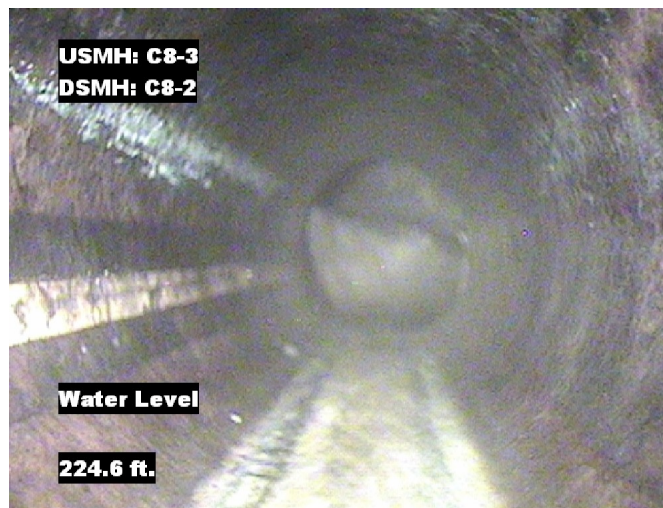
Distance: 224.6 ft.      Grade: 0  
Condition: Water Level  
Remarks: N/A

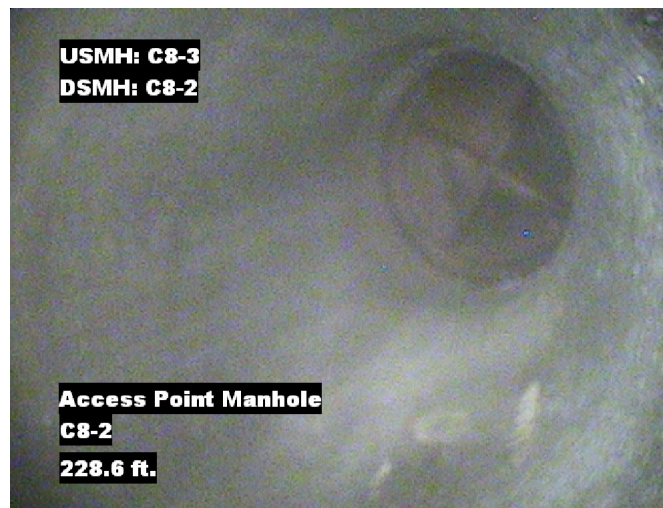
Distance: 228.6 ft.      Grade: 0  
Condition: Access Point Manhole  
Remarks: C8-2
