## Defect Listing

Pipe Segment Refere... <b>C8-4_C8-3</b>	City <b>Oliver Springs</b>	Street <b>Hermitage Dr</b>	Material <b>Fibreglass Reinf...</b>	Location C... <b>Easement/R...</b>	Sewer Use <b>Sanitary</b>
Upstream MH <b>C8-4</b>	Total Length <b>119.6</b>	Year Laid	Shape <b>Circular</b>	Location Details	
DS Manhole <b>C8-3</b>	Length surveyed <b>117.3</b>	Year Renewed	Height <b>8</b>	Width <b>8</b>	Pipe Joint... <b>N/A</b>

SPR <b>3</b>	MPR <b>N/A</b>	PO Number <b>4397-03</b>	Customer <b>GRW</b>
SPRI <b>3</b>	MPRI <b>N/A</b>	Work Order <b>4397-02</b>	Purpose <b>Pre-Rehabilitation Survey</b>
QSR <b>3100</b>	QMR <b>N/A</b>		
OPR <b>3</b>	Surveyed By <b>Barry Rogers</b>	Direction <b>Downstream</b>	Date <b>20150724</b>
OPRI <b>3</b>	Certificate Number <b>U-1012-16405</b>	Pre-Cleaning <b>Jetting</b>	Time <b>06:59</b>
	Date Cleaned <b>20150724</b>	End Time <b>07:06</b>	Weather <b>Saturated</b>
			Media label
			Additional Info

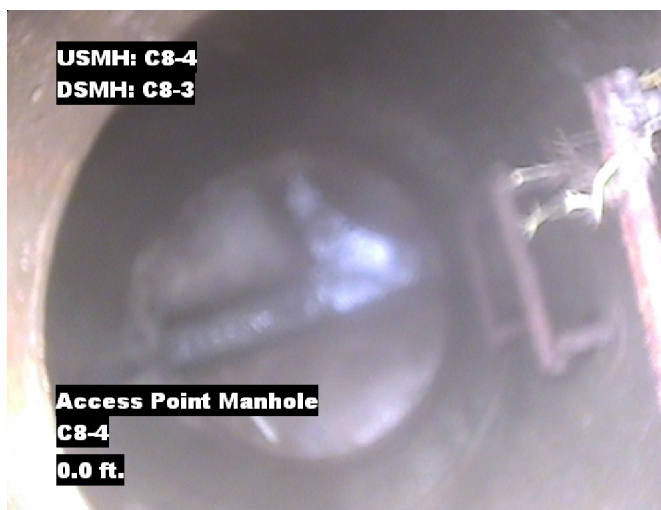
Distance: 0.0 ft. Grade: 0  
Condition: Access Point Manhole  
Remarks: C8-4

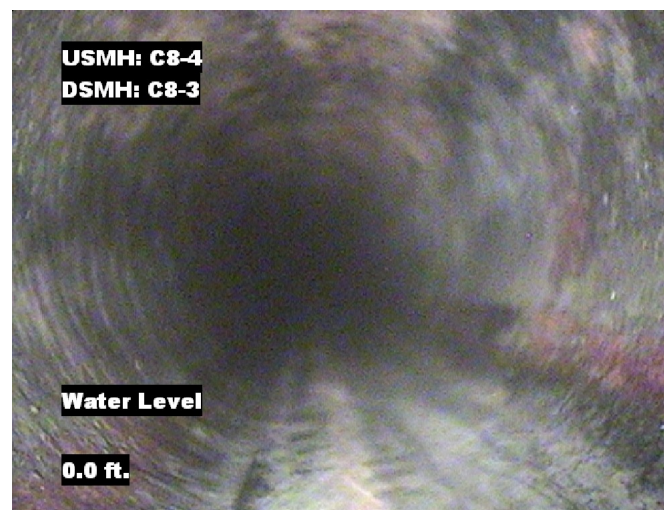
Distance: 0.0 ft. Grade: 0  
Condition: Water Level  
Remarks: N/A

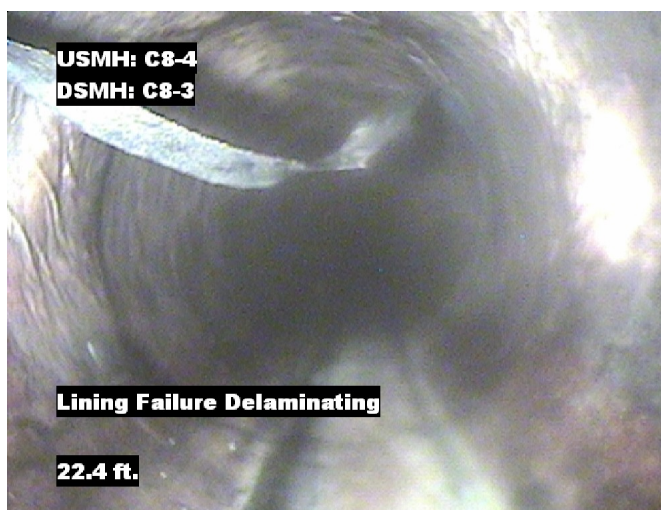
Distance: 22.4 ft. Grade: 3  
Condition: Lining Failure Delaminating  
Remarks: N/A

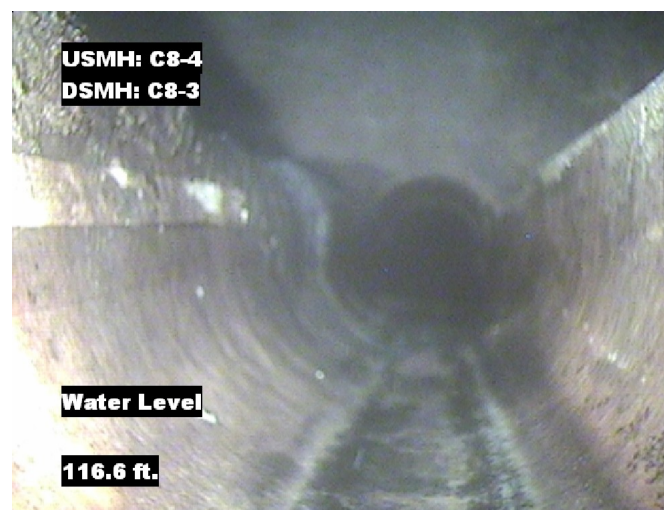
Distance: 116.6 ft. Grade: 0  
Condition: Water Level  
Remarks: N/A

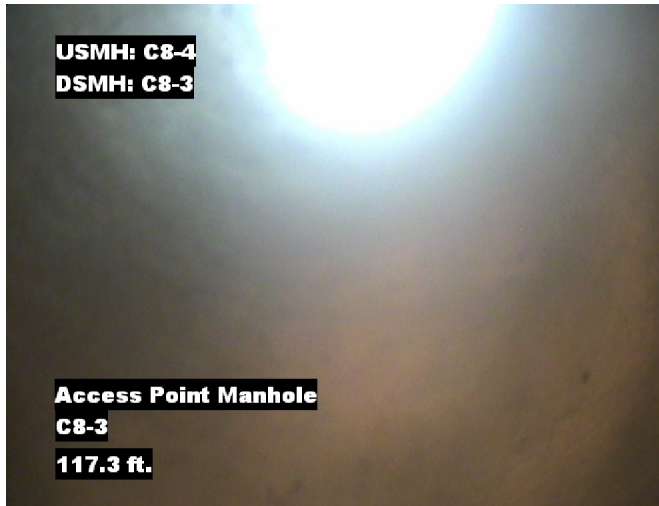
Distance: 117.3 ft. Grade: 0  
Condition: Access Point Manhole  
Remarks: C8-3
