## Defect Listing

| Pipe Segment Refere...<br><b>C8-5_C8-4</b> | City<br><b>Oliver Springs</b> | Street<br><b>Herimtage Dr</b> | Material<br><b>Fibreglass Reinforc...</b> | Location C...<br><b>Light High...</b> | Sewer Use<br><b>Sanitary</b> |

| SPRI<br><b>N/A</b> | MPRI<br><b>2</b> | Work Order<br><b>4397-02</b> | Purpose<br><b>Pre-Rehabilitation Survey</b> |

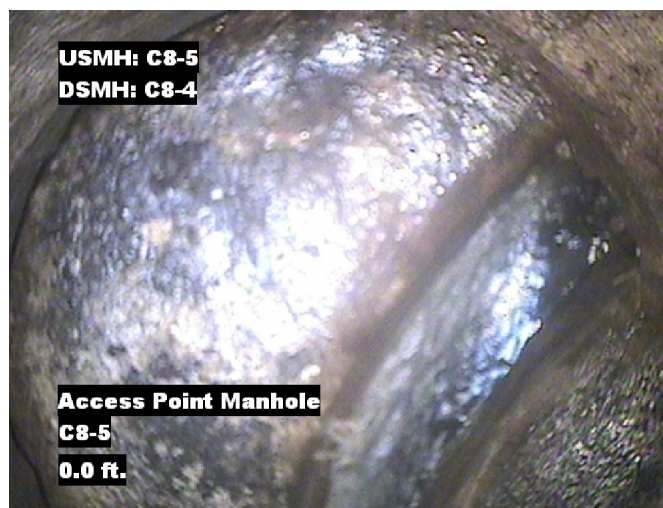
Distance: 0.0 ft. Grade: 0  
Condition: Access Point Manhole  
Remarks: C8-5

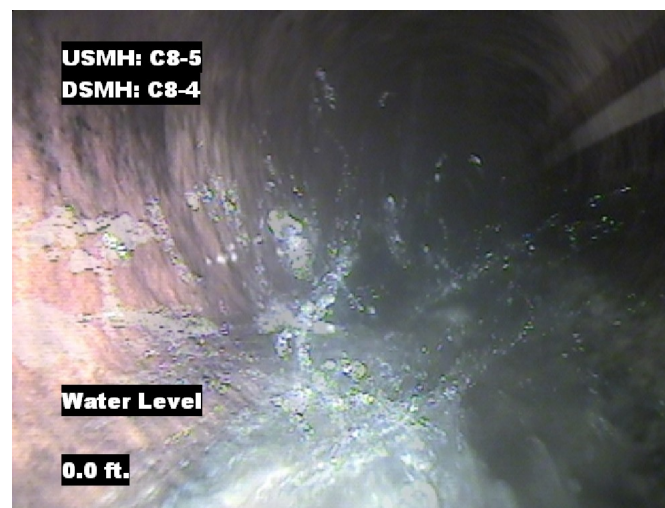
Distance: 0.0 ft. Grade: 0  
Condition: Water Level  
Remarks: N/A

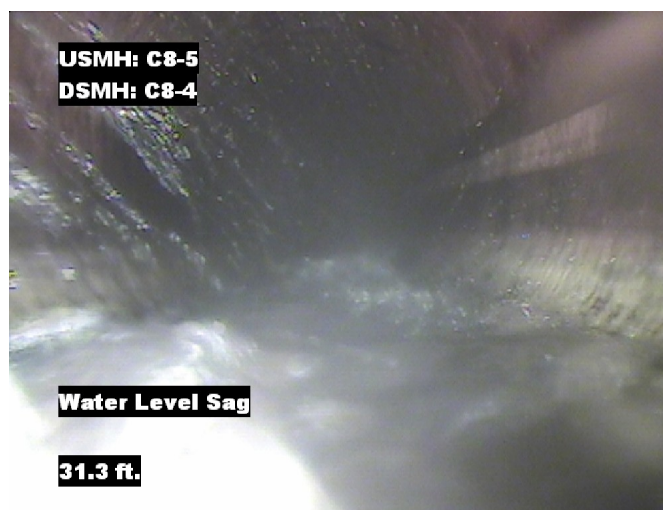
| Distance | Condition | Cont. Dfct. | Values | | | Joint | Clock Position | | Grade |
|---|---|---|---|---|---|---|---|---|---|
| 31.3 ft. | Water Level Sag | | | | 20 | <input type="checkbox"/> | | | 2 |

Distance: 31.3 ft. Grade: 2  
Condition: Water Level Sag  
Remarks: N/A

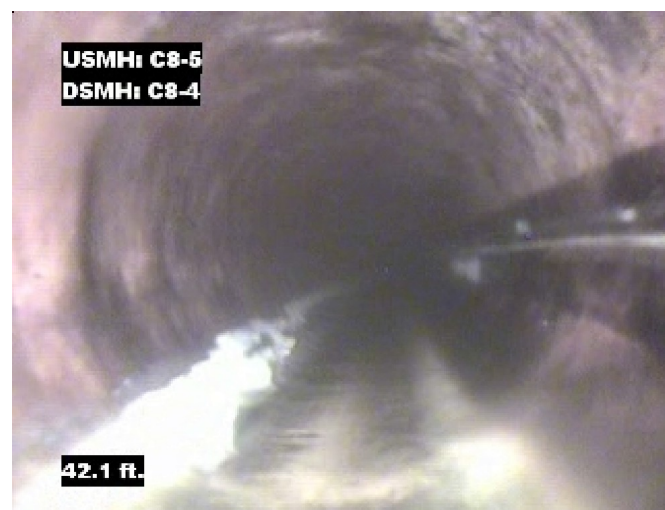
| Distance | Condition | Cont. Dfct. | Values | | | Joint | Clock Position | | Grade |
|---|---|---|---|---|---|---|---|---|---|
| 42.0 ft. | Deposits Attached Grease | | | | 5 | <input type="checkbox"/> | 8 | | 2 |

Distance: 42.0 ft. Grade: 2  
Condition: Deposits Attached Grease  
Remarks: N/A

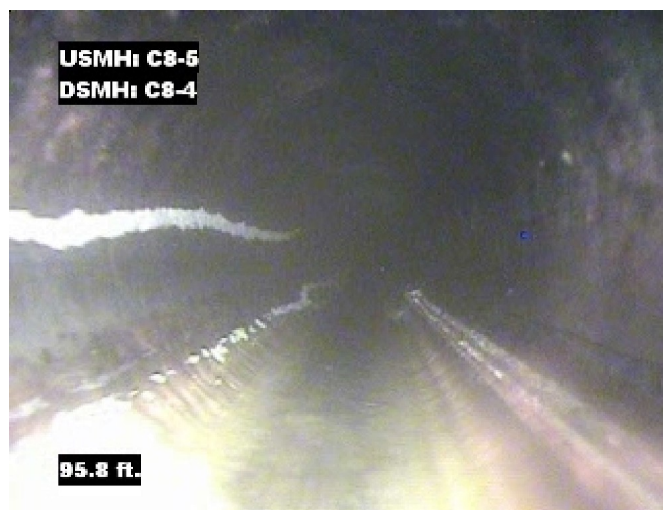
| Distance | Condition | Cont. Dfct. | Values | | | Joint | Clock Position | | Grade |
|---|---|---|---|---|---|---|---|---|---|
| 95.8 ft. | Deposits Attached Grease | | | | 5 | <input type="checkbox"/> | 9 | 10 | 2 |

Distance: 95.8 ft. Grade: 2  
Condition: Deposits Attached Grease  
Remarks: N/A

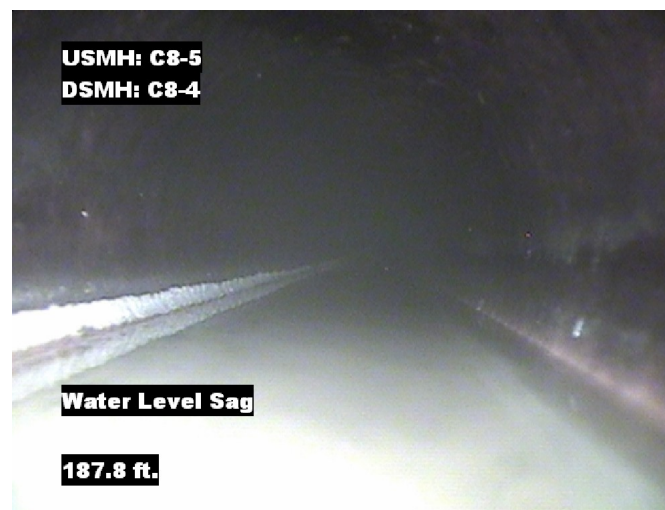
| Distance | Condition | Cont. Dfct. | Values | | | Joint | Clock Position | | Grade |
|---|---|---|---|---|---|---|---|---|---|
| 187.8 ft. | Water Level Sag | | | | 15 | <input type="checkbox"/> | | | 2 |

Distance: 187.8 ft. Grade: 2  
Condition: Water Level Sag  
Remarks: N/A

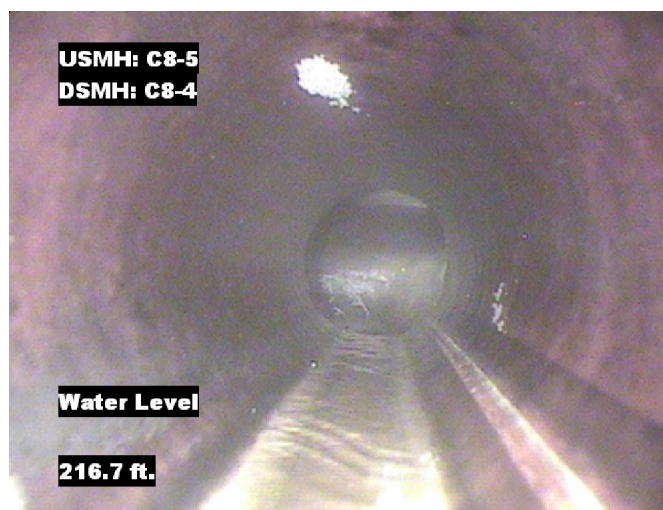
Distance: 216.6 ft. Grade: 0  
Condition: Water Level  
Remarks: N/A

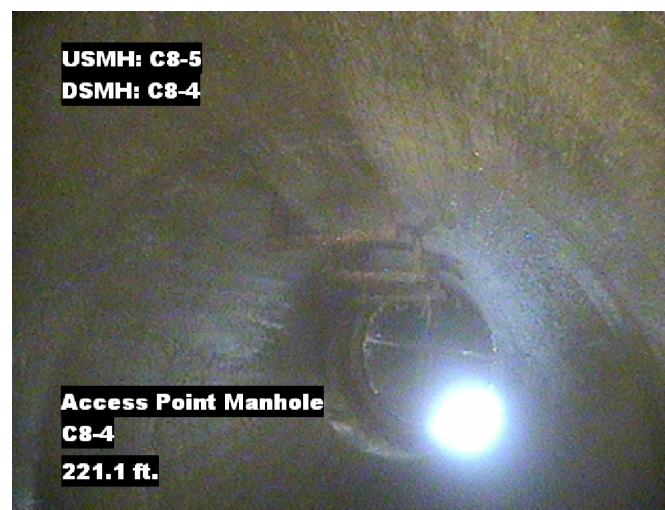
Distance: 221.1 ft. Grade: 0  
Condition: Access Point Manhole  
Remarks: C8-4
